*The Study on Comprehensive Disaster Prevention
around Mayon Volcano*

SUPPORTING REPORT (1)

(Part I : Master Plan)

**SUPPORTING REPORT (1)-III
FACILITY DESIGN**

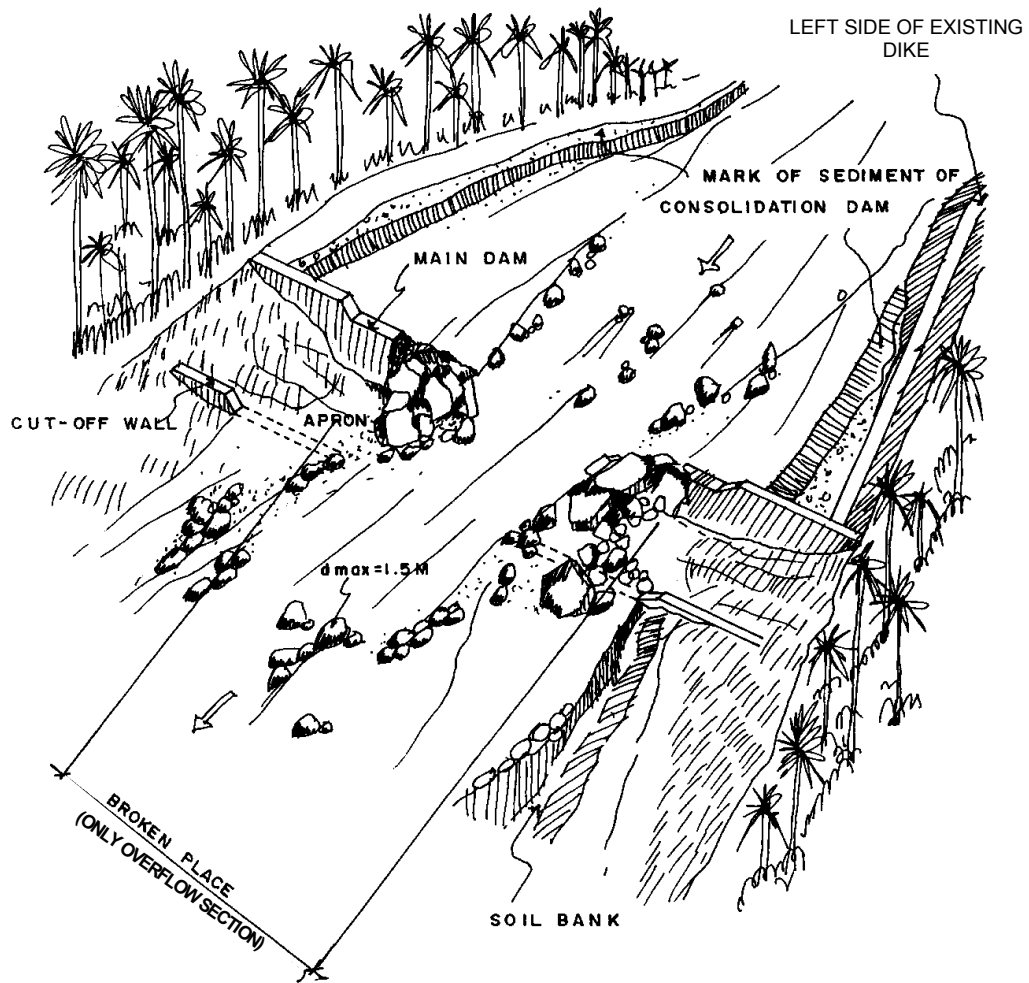
Situation of Failure of Consolidation Dam in Basud River

- The base of the consolidation dam consists of a loose fresh sediment material, so that the downstream part of the facilities is easy eroded.
- It is considered that the apron length of the existing consolidation dam, which is been induced by the field empiric is too short to protect the piping of sand and gravel base.

- There are lots of large boulders, 1.0m to 1.5m in diameter, along the channel downstream of the dam site, which are considered to be transported with mudflows. Although the large boulder probably bumped the wing section of the consolidation work, both sides of it were not destroyed.

- The traces of sedimentation soils along both sides of the five upstream of the dam show the consolidation work that consolidation work itself was in a state full of sands.

- It is considered that the failure of the consolidation dam was caused by the destruction of the front apron by the erosion under vertical wall and impact of large boulders.

1. BROKEN CONDITION OF CONSOLIDATION DAM (H = 5.0M)

(600M UPSTREAM FR. NATIONAL ROAD)

- The front apron of dam must be protected from itself failing.
- Control of abrasion of apron and erosion under vertical wall.
- If the apron of dam break, consolidation dam must be designed not to spread an effect of failure to the main dam body.
- Proposed facility must resolve the problem of piping and low allowable bearing capacity.

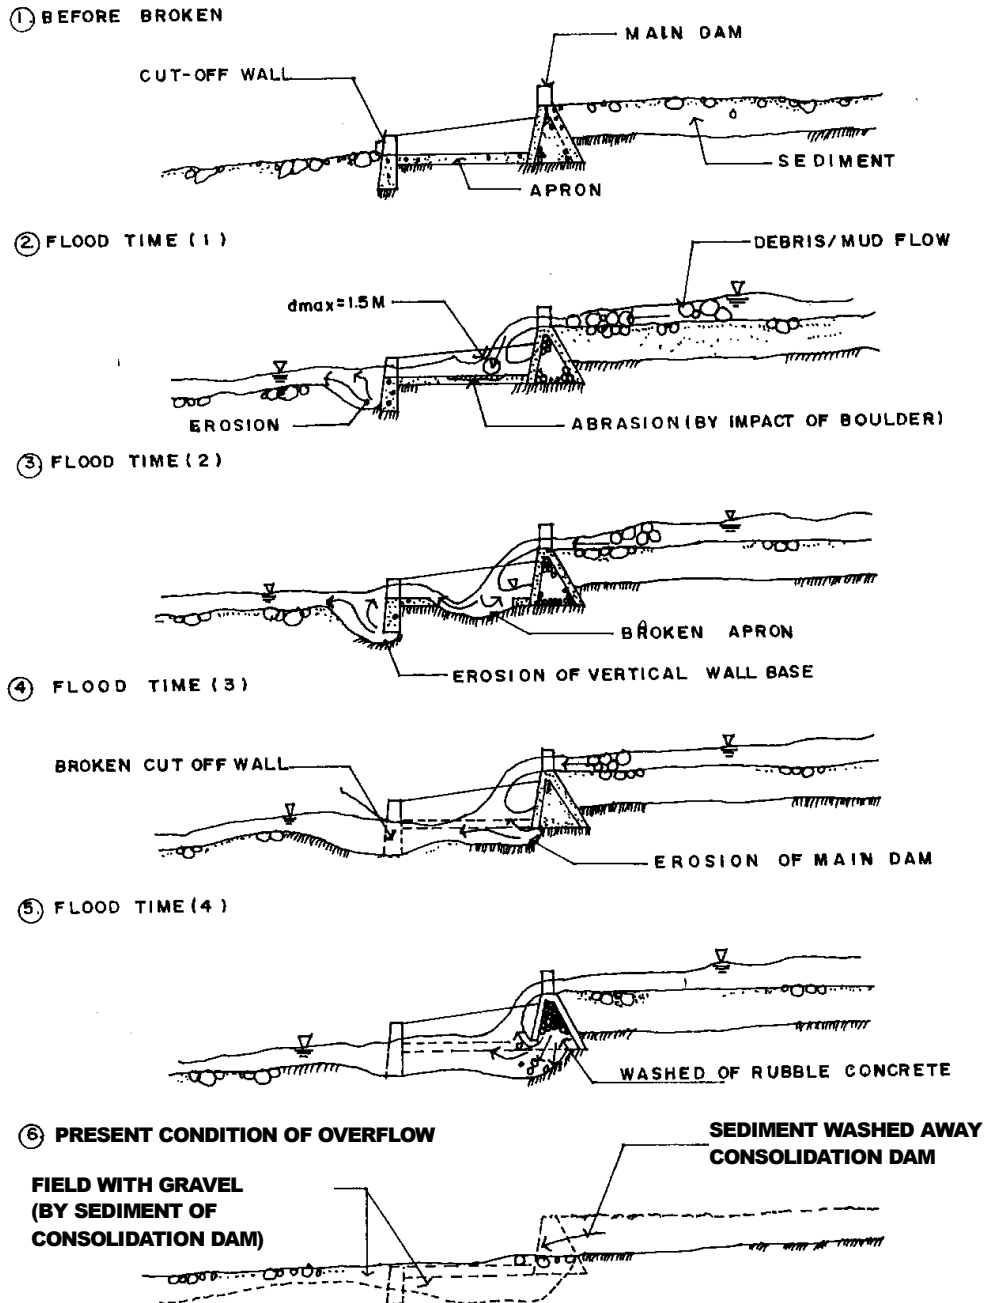
Process of Failure of Consolidation Dam in Basud River

- a) Since large boulders had fallen on to the main consolidation work, the front apron was under abrasion. At the same time, the vertical wall downstream of the body was broken away.
- b) A part of the front apron was destroyed by the impact of boulders. Then a large part of the foundation with the apron was scoured off, and the apron became unsteady.
- c) After both the front apron and the vertical wall were destroyed, the foundation of the body was eroded away.
- d) Owing to enlarged erosion on the foundation, loose boulder concrete inside the dam body was flowed out.

2. PROCESS OF BROKEN CONSOLIDATION DAM (OVERFLOW SECTION)

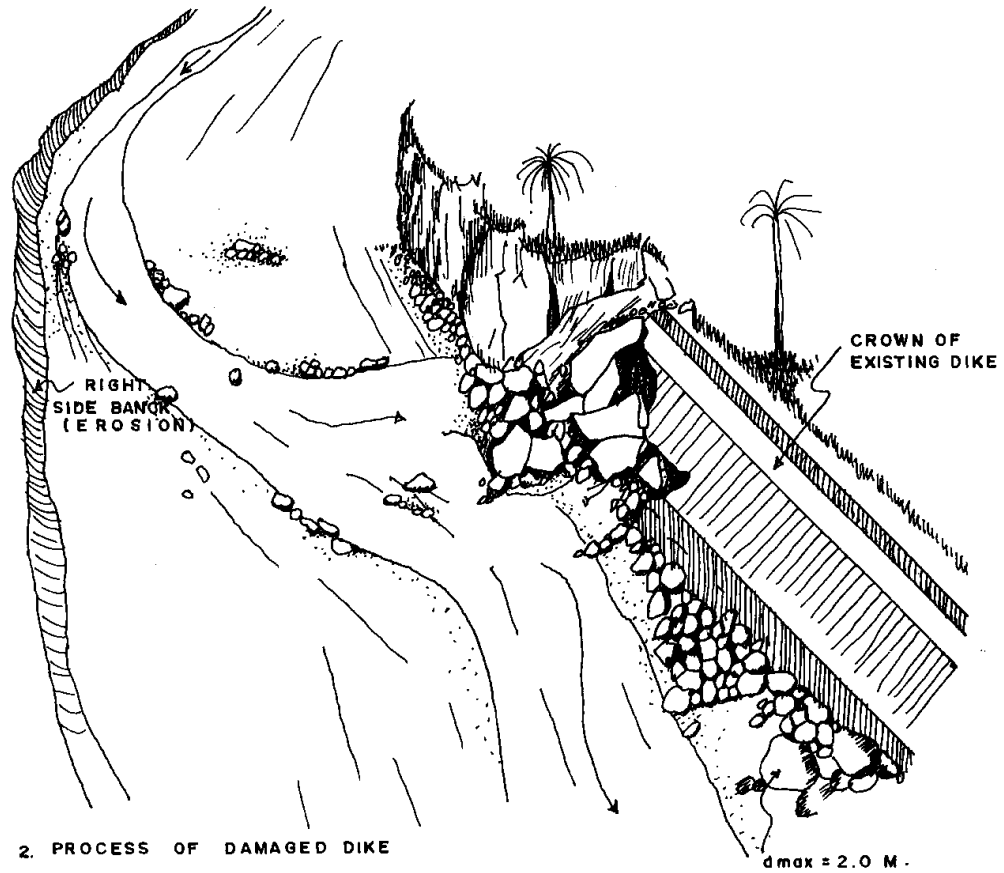
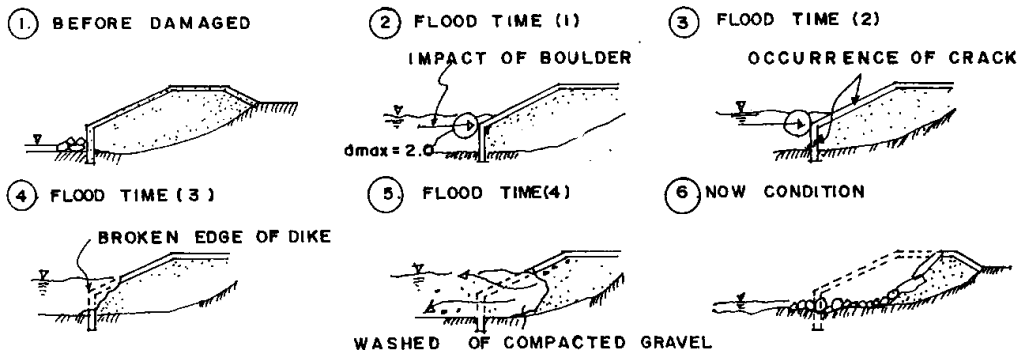
Situation of Failure of Spur Dike in Bulawan River

- The main cause of failure of the spur dike in the Bulawan River is considered to be from being bumped by boulders.
- The main cause of failure of the spur dike in the Anolin River is considered to be from both the erosion of the basement and being bumped by boulders.
- The cause of failure of the spur dike in the Padang River is considered that a part of the foundation of the dam eroded away and was mainly destroyed, so fill material in dike was washed away, and the broken portion was expanded more by impact of boulders.

1. DAMAGE CONDITION OF LEFT SIDE DIKE (UPSTREAM FROM N.R.)

2. PROCESS OF DAMAGED DIKE

- Fill material in dike must not be setting and flowing away.
- Facing wall and inside material must strengthen to be protected from impact of boulder.
- If the foundation of dike is eroded, whole dike body must be strong enough to prevent the failure spreading to the main body.

- Easy construction work, low cost, and high local content
- The foundation depth of the existing spur dike is 1m. These foundations have been scoured by debris flow in some location. The foundation will be the depth of 2m, which is commonly used on sand and gravel area in Japan.

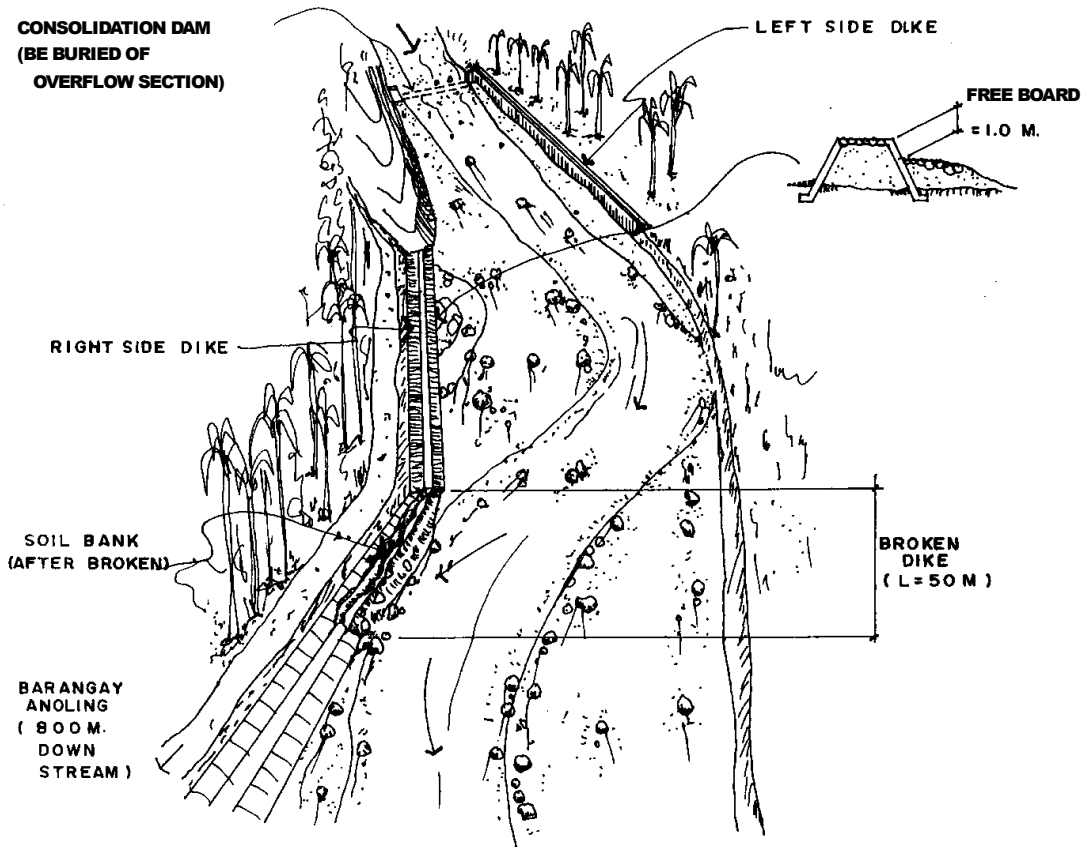
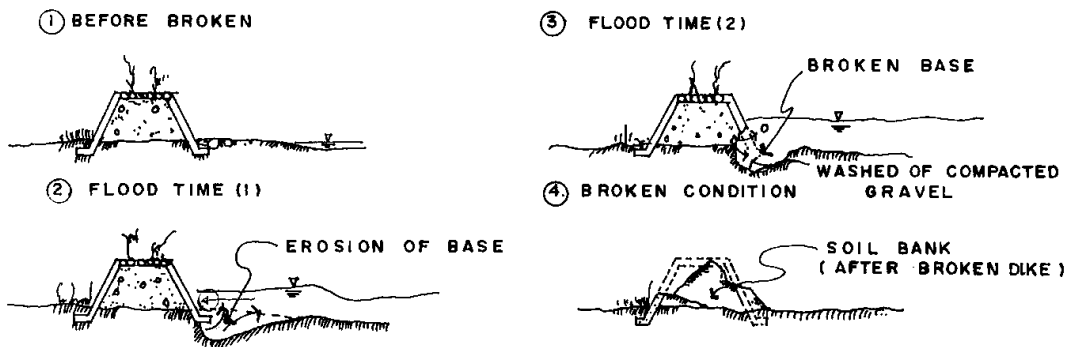
Situation of Failure of Spur Dike in Anoling River

ANOLING RIVER (1) BROKEN CONDITION OF DIKE

(2) PROCESS OF BROKEN DIKE

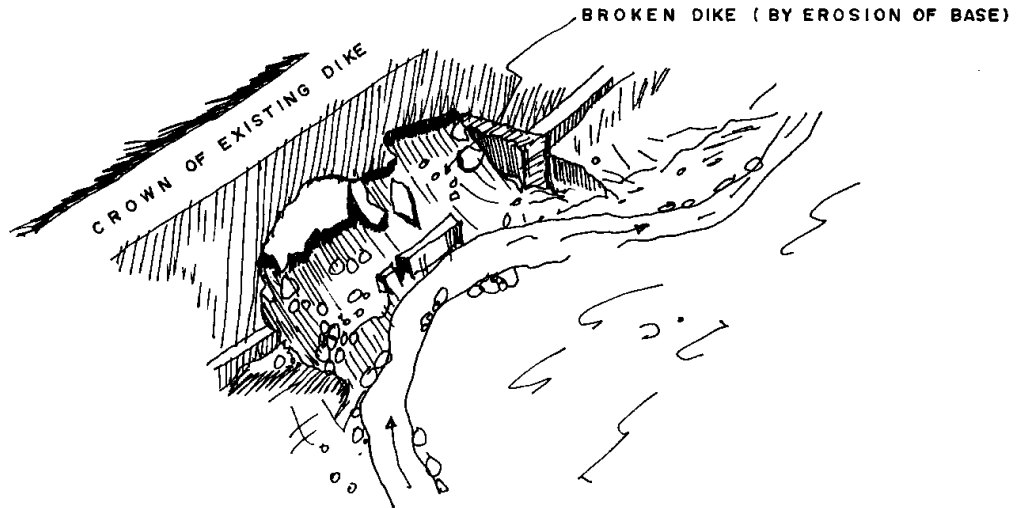
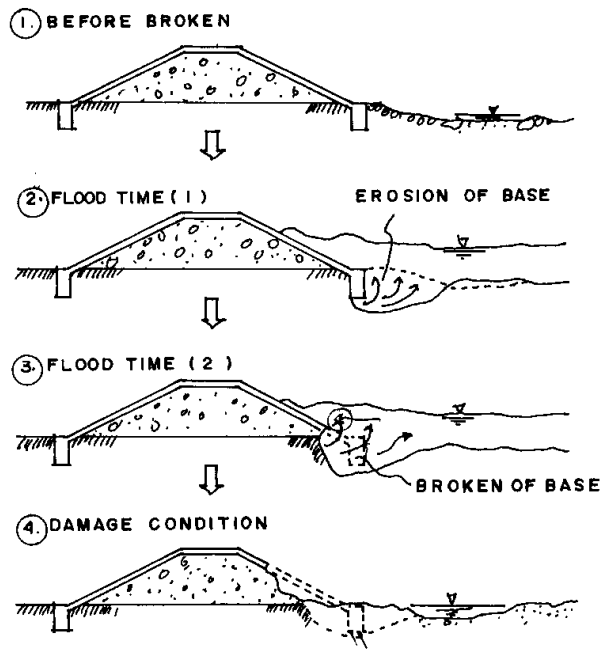
Situation of Failure of Spur Dike in Padang River

1. DAMAGE CONDITION OF LEFT SIDE DIKE

2. PROCESS OF DAMAGED DIKE
