CHANNEL CONDITION (1/2)

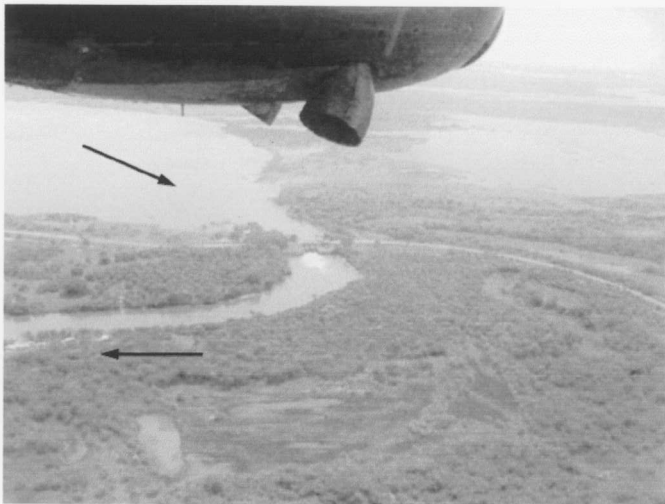
PHOTO - 13

The **Manamo Gate** at 188 km upstream, constructed in 1960's for flood control and agricultural development in Tucupita area.

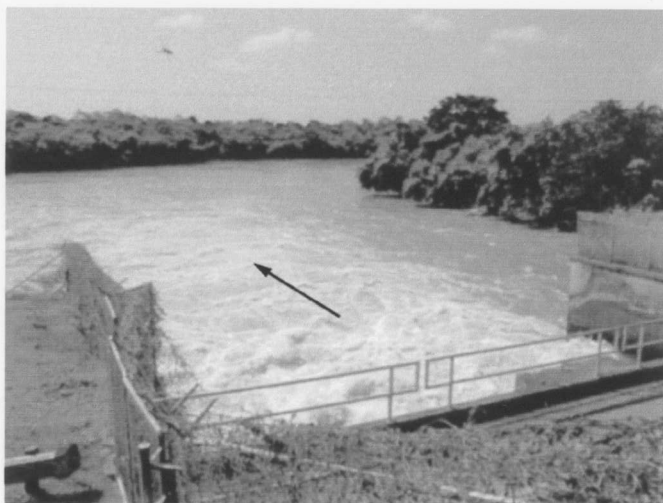
PHOTO - 14

The **Downstream of Manamo Gate** with a maintenance discharge of 130 - 200 m³/s throughout the year.

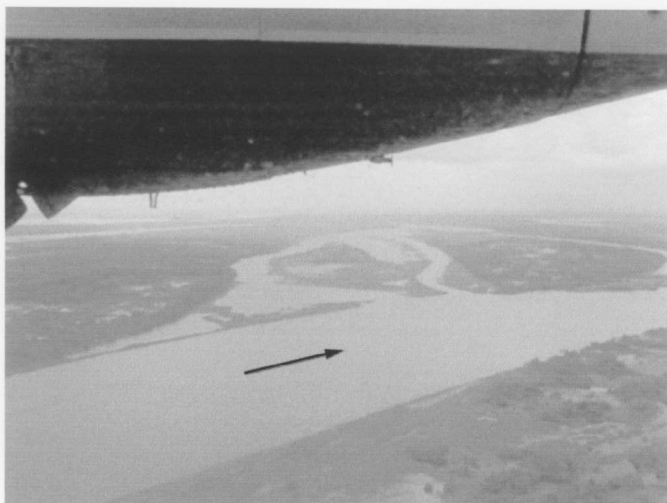
PHOTO - 15

The **Macareo - Manamo Bifurcation** at 174 km upstream of Macareo, with sand bars formation due to high sedimentation.
