## CHANNEL CONDITION (2/2)

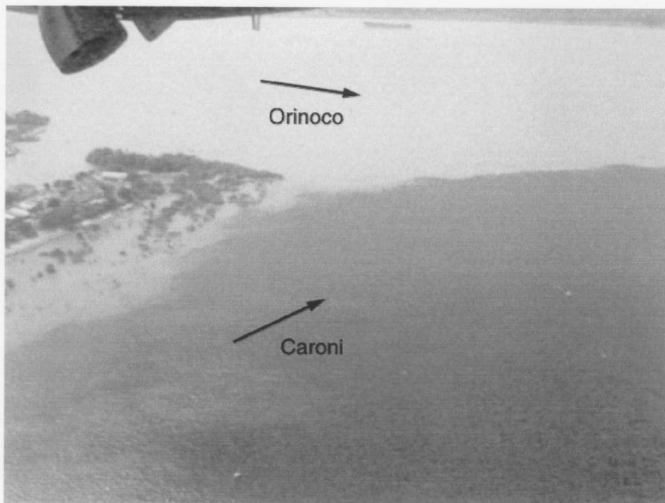
**PHOTO - 16**

The view of **Orinoco - Caroni River Confluence** at 339 km upstream of Rio Grande, with a discharge of black, dissolved carbon and low sedimentation from Caroni river.

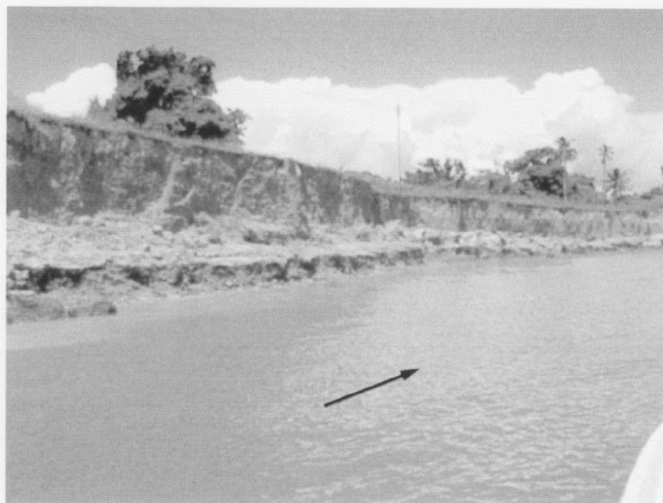
**PHOTO - 17**

The vertically collapsed eroded **left bank of Guargopo - Barrancas section** at 270km upstream, composed of silt and clay.

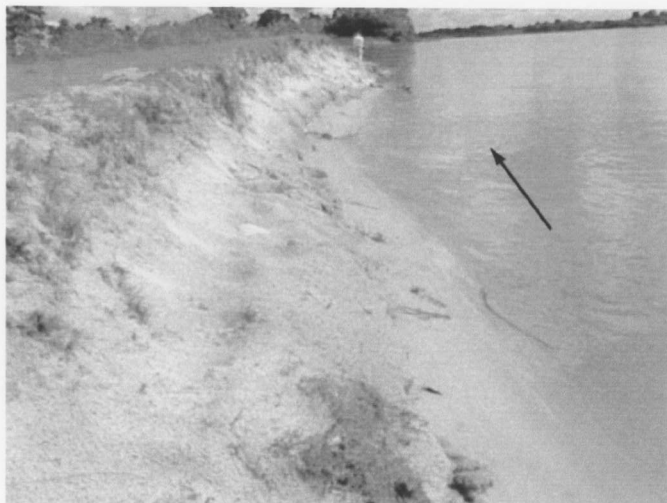
**PHOTO - 18**

The **Macareo Channel Condition** at 270km upstream with a mild slope, fine sand and erodible banks.
