6.4.4 Evaluation of Current Dredging Activities

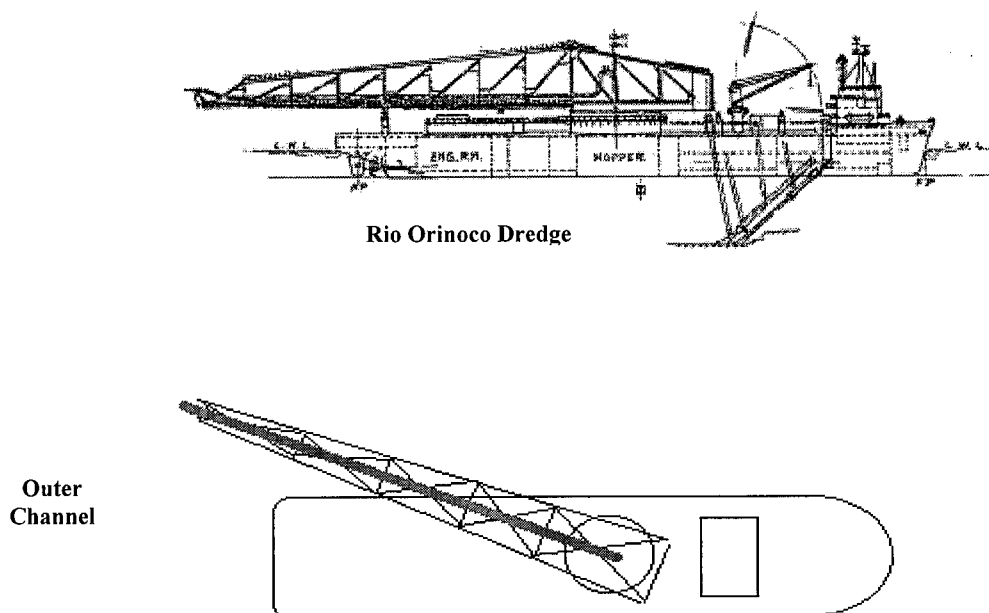
Fig. 6-4-19 Method of Disposal of Dredged Materials (Outer Channel)

Materials dredged from the Outer Channel are disposed by the side casting method except in the case of the Guayana dredge. The discharge arm of the dredge is constructed to rotate at an angle of 90 degrees from the longitudinal axis of the vessel to ensure that dredged spoils are discharged outside of the Outer Channel. However, the arm is actually rotated at about 15 degrees only, as can be seen in Fig. 6-4-19 below, due to stability reasons which according to INC is caused by strong wind and wave actions. Apparently, the dredged materials are being disposed inside the Channel, thus, the accumulation of deposits is just being transferred from one place to another within the Channel. It could be effective to some extent as vessels can still navigate through the fluff as long as the fluff remains loose. However, as the fluff consolidates it becomes difficult for vessels to navigate safely.

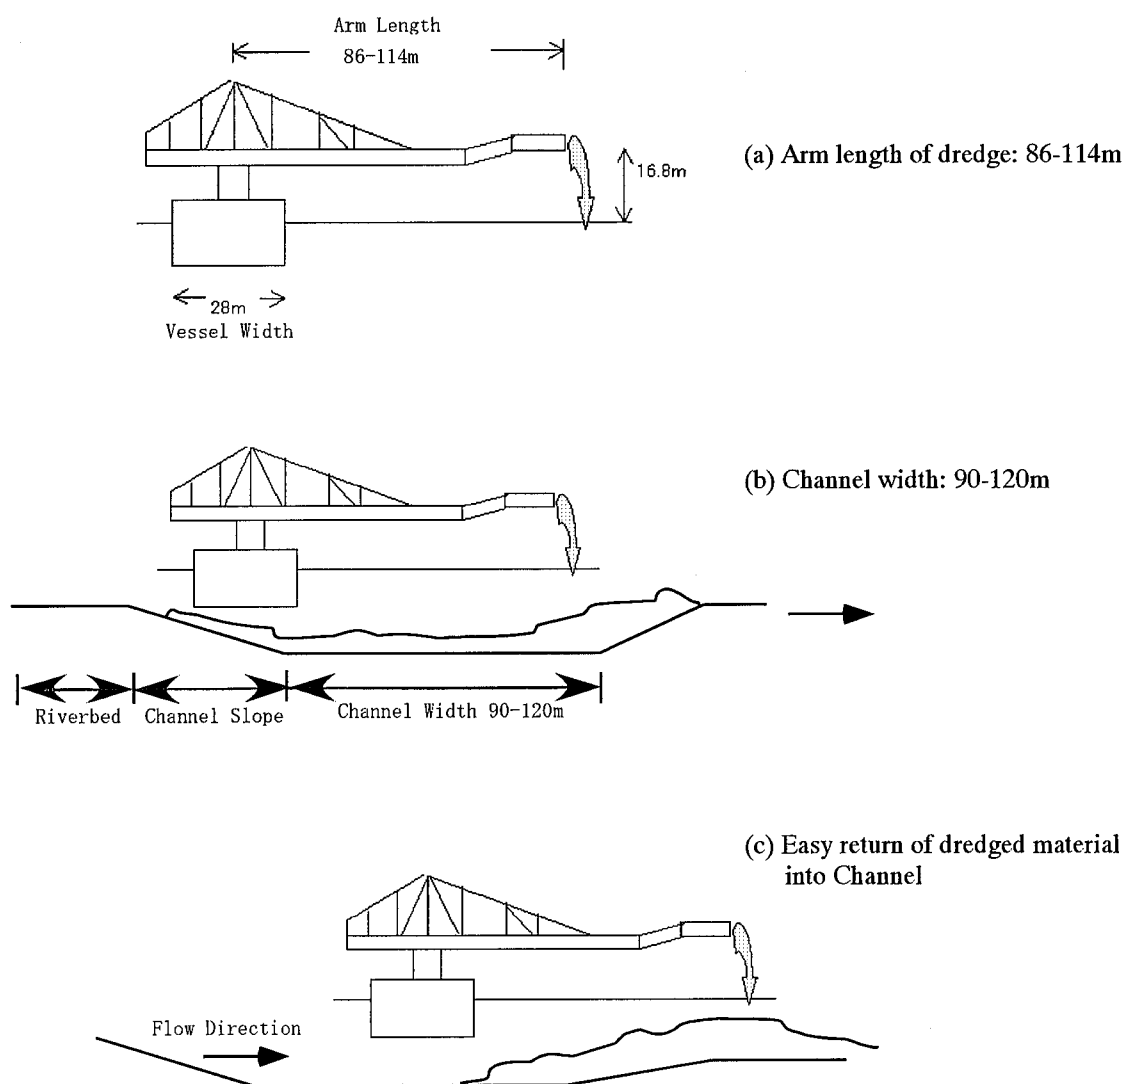
Fig.6-4-20 Method of Disposal of Dredged Materials (Inland Channel)

In the case of the Inland Channel, the discharge arm of dredge is generally rotated perpendicularly to the axis of vessel to discharge dredge materials far away from the Channel. However, shorter length of discharge arm compared to the Channel width would only permit the disposal of dredged materials either into the Channel or immediately adjacent to the Channel. Hence, return of dredged materials partially into the Channel is unavoidable. Especially, at the meandering reaches of river where Channel alignment is not parallel to river flow such as Macareo bifurcation reach as shown in the Fig. 6-4-20, return of dredged material would be quite high since it is obliged to dispose in to only one side of navigation channel (downstream side of river flow) to minimize easy return of dredged material from the opposite side by river flow.

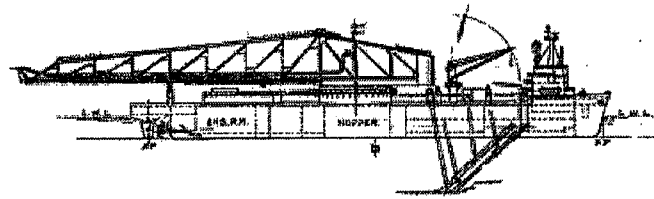
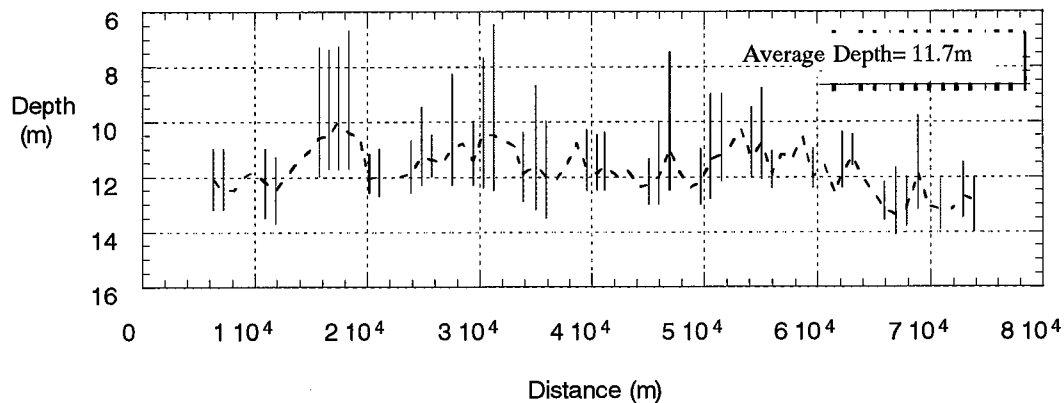
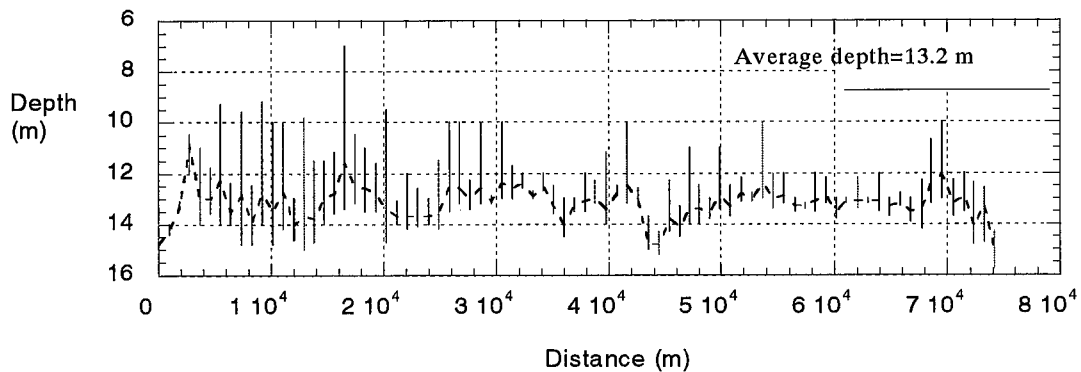
Fig.6-4-21 Method of Disposal of Dredged Materials

Fig. 6-4-21 shown below derived from INC sounding chart data illustrates a sample of a section of the Channel dredged by a trailer suction dredge. As shown, the dredged channel bottom is extremely irregular and contains many peaks and valleys. Considering safe passage of the vessels, the navigable depth of the Channel should be measured from the highest peak of the dredged bottom to the water level. In such case, as can be seen from the figure, the over dredging sections of the channel bed become useless or worthless.

The differences between the average depths and the highest peak of the dredged bottoms in April and September in 1997 are 4.0 m and 3.2 m, respectively. It is very important to minimize the differences between the average depths and the highest peak of the dredged bottoms in order to obtain the maximum depth while minimizing the volume to be dredged.

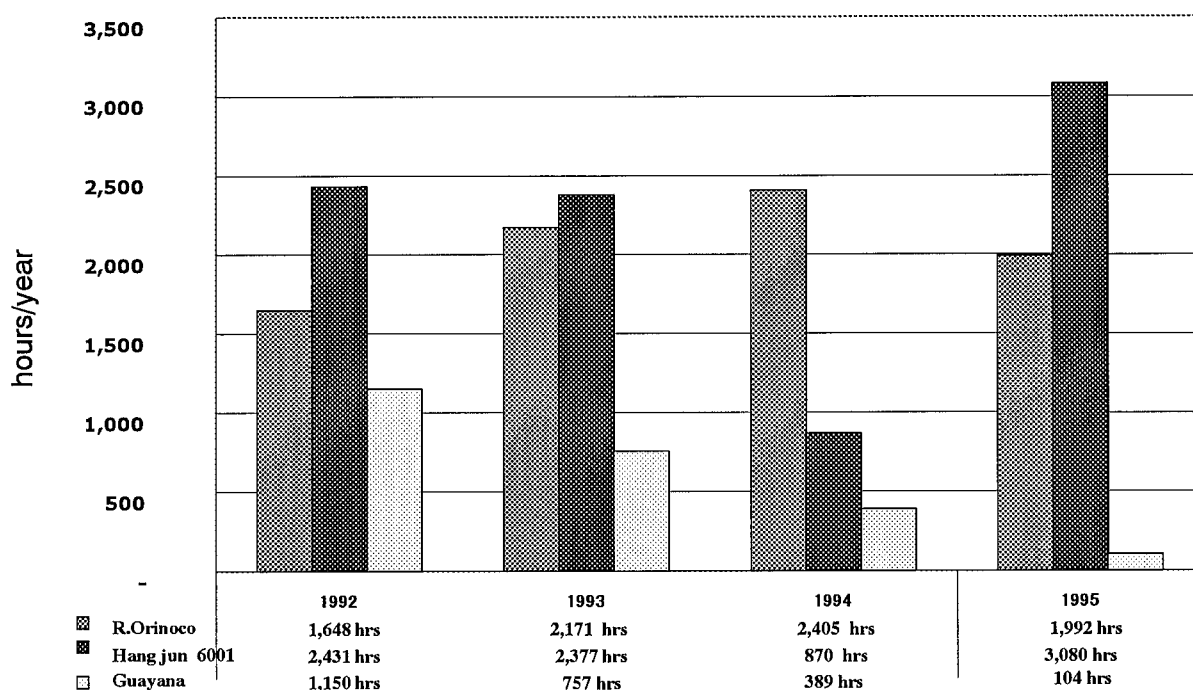
Fig. 6-4-22 Annual Dredging Operation Record

Fig. 6-4-22 hereunder shows the annual operation dredging record of the three (3) dredges equipment in recent years. Based on the record, Rio Orinoco and Hang Jun 6001 have been operating on an average of six (6) hours and ten (10) hours per day only, respectively. Among others, Guyana yields minimal output of dredging and Icoa is no longer operational.

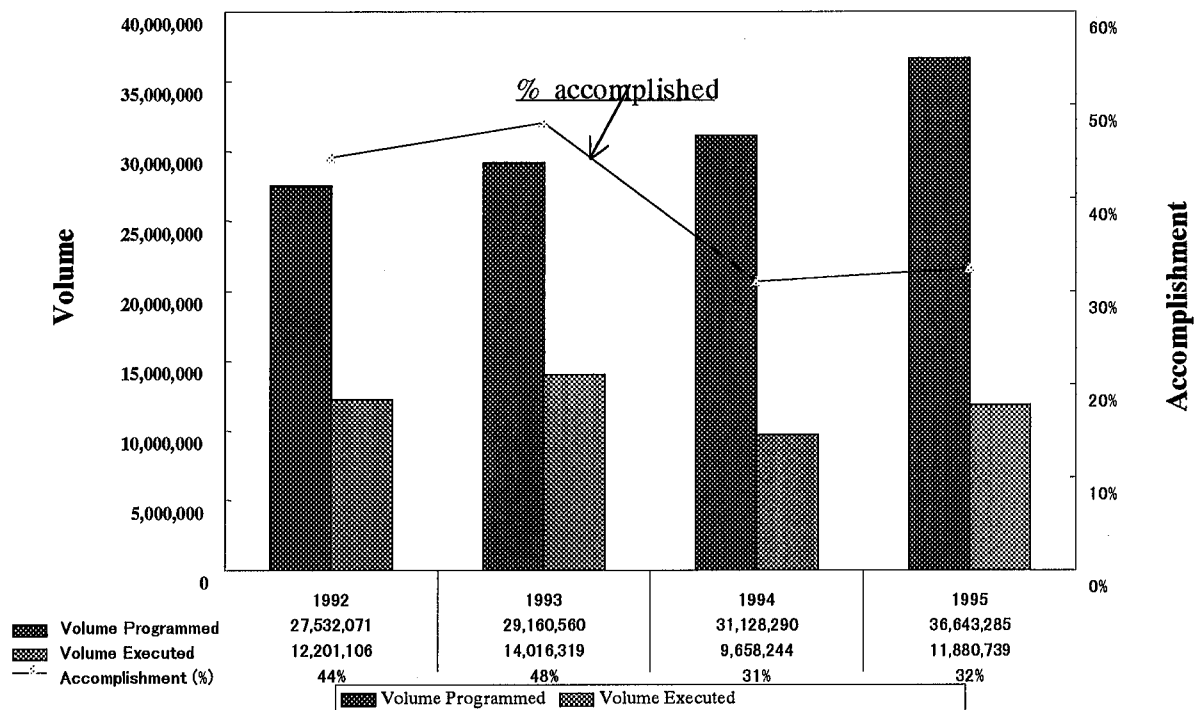
Fig. 6-4-23 Planned Accomplishment versus Actual Accomplishment

Fig. 6-4-23 shows the planned volume of materials to be dredged against the actual accomplishment covering the period 1992 to 1995. The primary contributory factor to the low performance ranging from about 30% to 50% of the planned accomplishment is considered to be due to the low operating time of the dredge which resulted to a backlog of under dredging of about 15 million cubic meters.

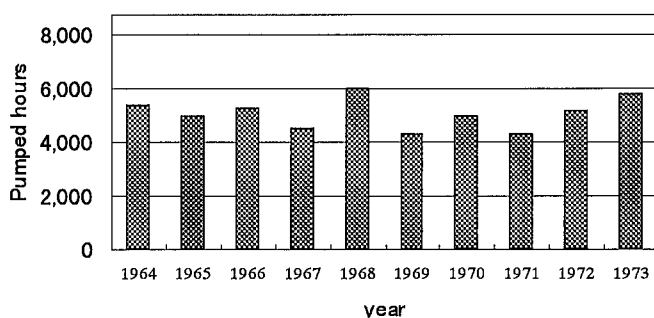
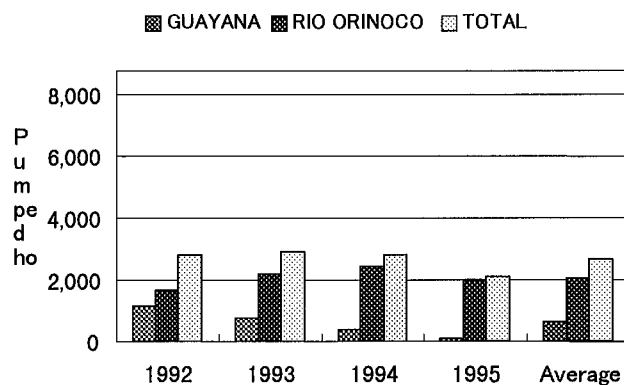
Fig. 6-4-24 Yearly Cumulative Pumped Time

Based on information, Icoa is the only dredge maintaining the navigable channel depth. From INC record (Fig. 6-4-24), the average pumped time of Icoa over a 9 year period (1964 to 1973) is 5,065 hours per year. This is only about 66% of total time in a year.

The average pumped time of Orinoco and Guyana from 1992 to 1995 is 2,000-3,000 hours/year only, which is only about half of Icoa. Guayana's operational time from January to September 1999 is only 30% and, the operational time appears to be extremely short.

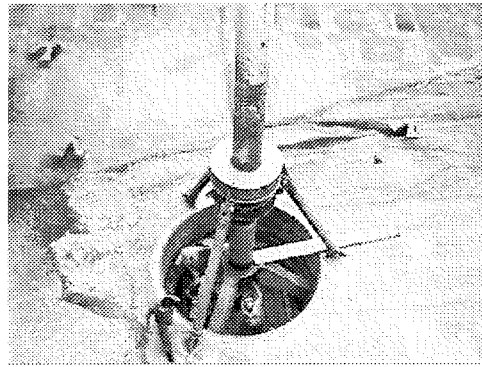
Fig. 6-4-25 Hopper Bottom Cover of Guayana Dredge

- 2) For every three (3) weeks of operation, five (5) days are spent on maintenance of the dredge. This is the primary reason why the operating time of the dredge fleet is greatly reduced;
- 3) The Guayana dredge is continuously in trouble, hence it is almost non operational. The discharge system of the hopper is confronted with many troubles particularly on the closing and opening system of the hopper bottom cover (see Fig. 6-4-25) which discharges the dredged spoils. In addition, Rio Orinoco dredge has stability problem;

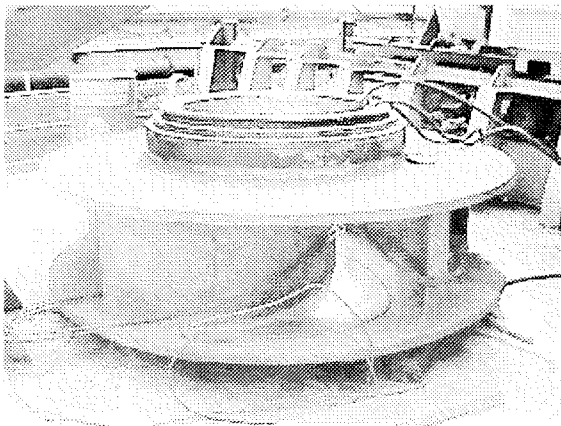
Fig.6-4-26 Shape of Impeller

- 4) The requisition for the procurement of the needed spare parts sometimes takes more than six (6) months before the spare parts are made available;
- 5) Spare parts are being damaged due to the high temperature exhaust of the engine.
- 6) The impeller as shown in Fig. 6-4-26 is being subjected to rapid severe abrasion particularly at the inner side of the impeller.

Rapid abrasion is due to the following.

The capacity of the four (4) pumps is 48,000 m³/hr or 12,000 m³/hr per pump. The flow velocity of the 1,600 mm diameter merged pipe is 6.5 m/s as shown in Fig. 6-4-27. However, all the pumps are not always operational and most of the time, only two are operational. With two pumps in operation, the flow velocity would be 3.0 meters per second only. A part of the delivery pipe is vertical being perpendicular to the deck of ship. As a result of low flow velocity in the vertical pipe, settling of sand inside the pipes occur and it causes pumps to be filled with sand, thereby subjecting the impeller to severe abrasion.

The material of the impeller now in used is quite strong and durable. However, in order not to subject it to severe abrasion, the size of pipe diameter should be reduced to prevent the pumps from being filled with sand.
