(3) Road Traffic

1) Present Situation of the Project Area

The project area is located in Ulaanbaatar City having 780,000 population that accounts for 31 % of national population. As stated earlier, the components of the Project comprise the improvement of Teeverchid Road and three intersections of East Crossroads, West Crossroads and In front of Geser Temple.

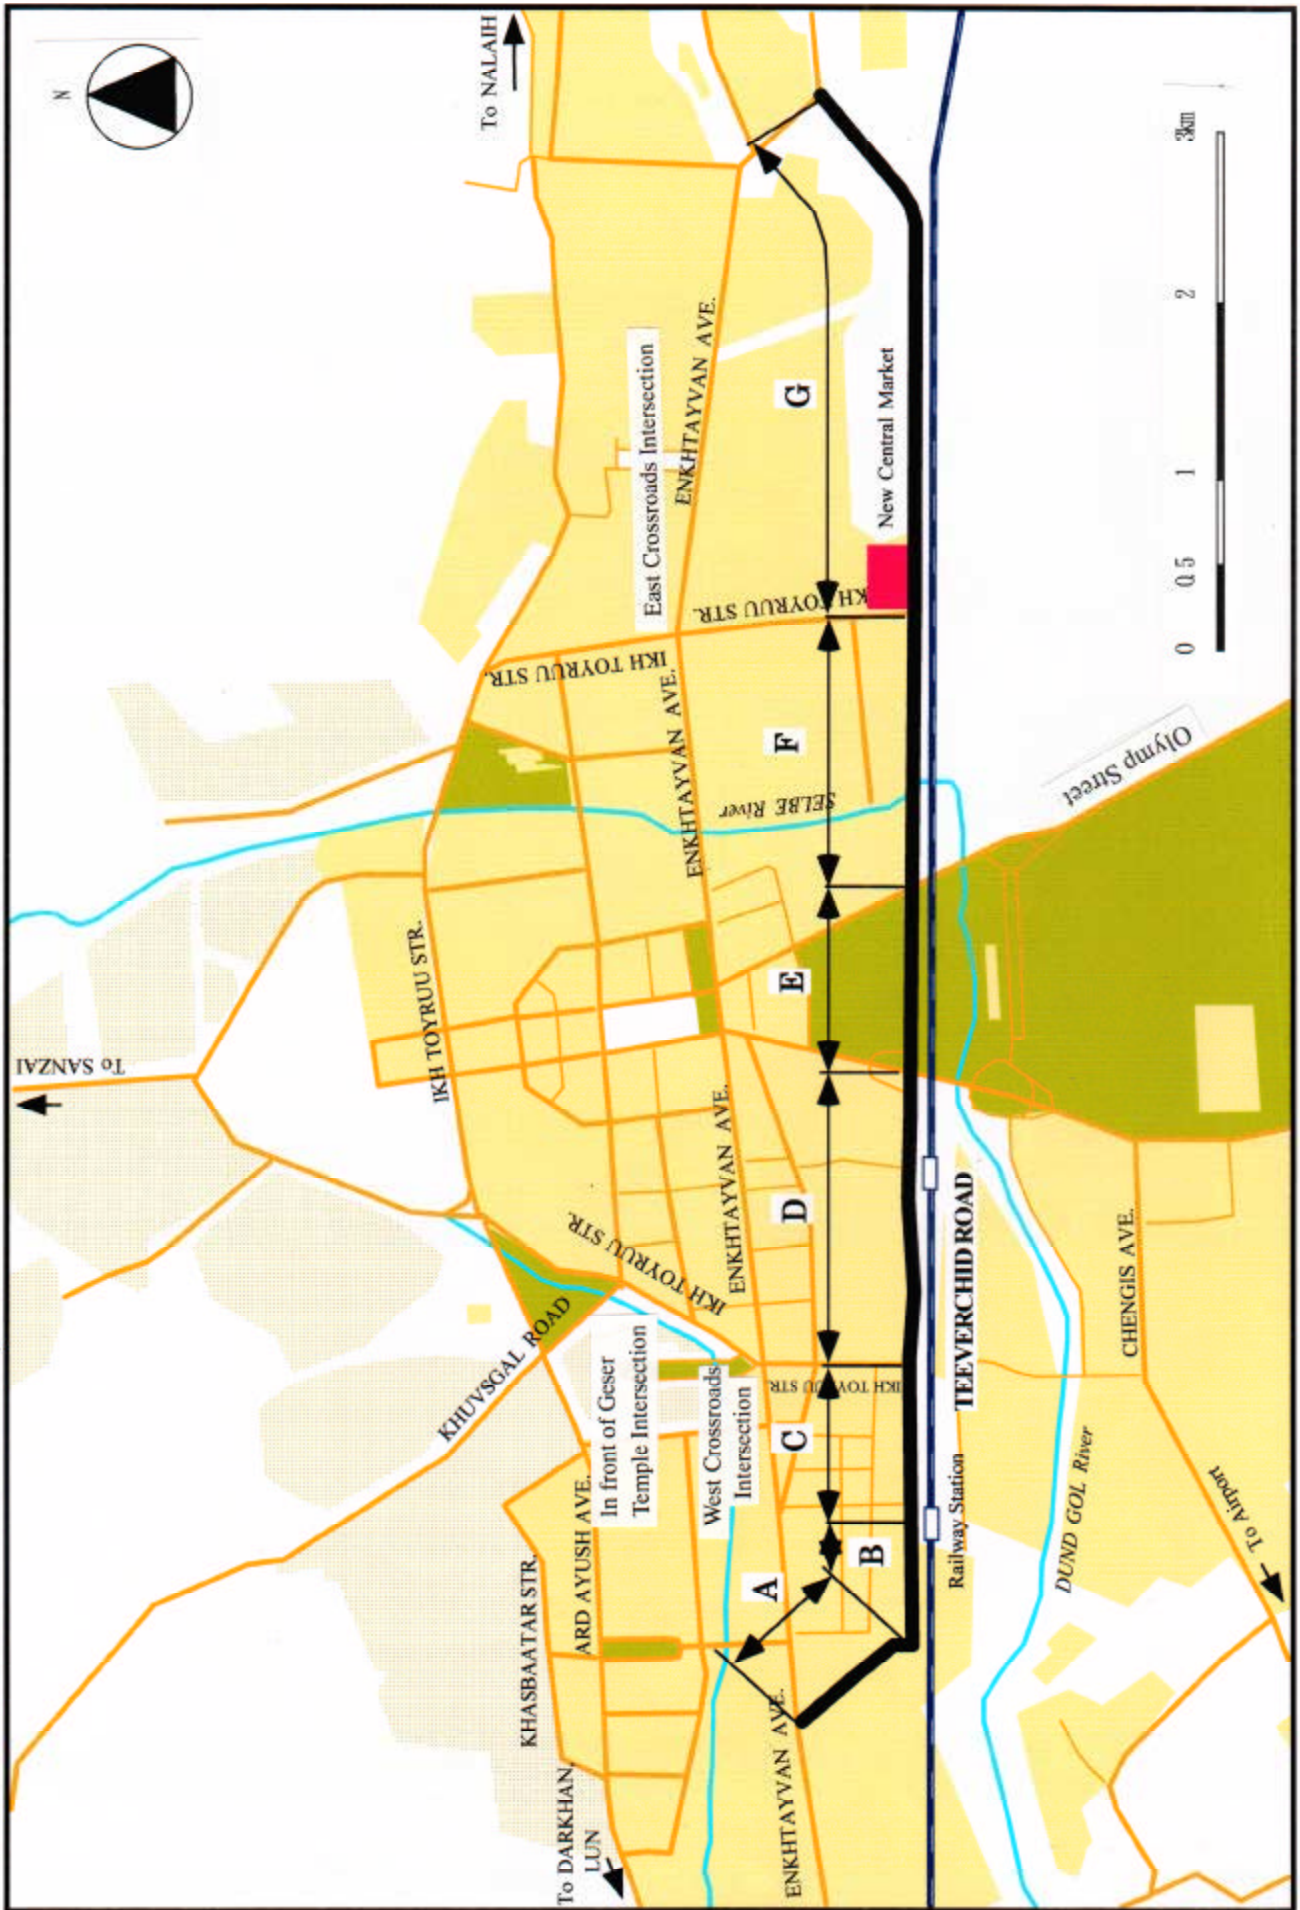
Fig. 2-3-10 Intersection for Road Conditions Survey

Road Surface Conditions along Teeverchid Road were surveyed. For this, Teeverchid Road was divided into seven parts as shown in Fig. 2-3-10. The result of this survey are shown in Table 2-3-3. And, the result of JICA Master Plan Study (1998) are shown in Table 2-3-4 for comparison.

A comparison and quantitative analysis between these two studies reveal that the road surface of Teeverchid Road has become worse during these years.

Pavement structure of Teeverchid Road is unsuitable for heavy vehicle due to low cost road pavement. Therefore, cracks and gaps spread out over the road. Moreover, it is frequently observed that damage of pavement reaches to base course due to lack of maintenance.

However, Sections C, D and E including concrete pavement are relatively better than the others as they are maintained very well. And, fast deterioration isn't observed as a comparison between these two studies.

Evaluation rank of other sections is under 2.2. The deterioration of pavement is intense, and the reconstruction seems to be the necessity, since the smooth traffic flow is prevented. Especially, on Section A, the rainfall is easy to do the flooding, and it becomes that the surface layer comes off and that the subbase course begins to peel it.

The reconstruction is a necessary level generally under evaluation rank of 2.5. Though the evaluation rank is an index. And, as a synthetic judgment, the reconstruction of whole section is not to the necessity.

Three intersections will basically be improved by overlay because of the observations that they are maintained very well.
