## (5) Bridge

### 1) Conditions of Existing Bridges on Teeverchid Road

2) Soundness Survey of Bridges

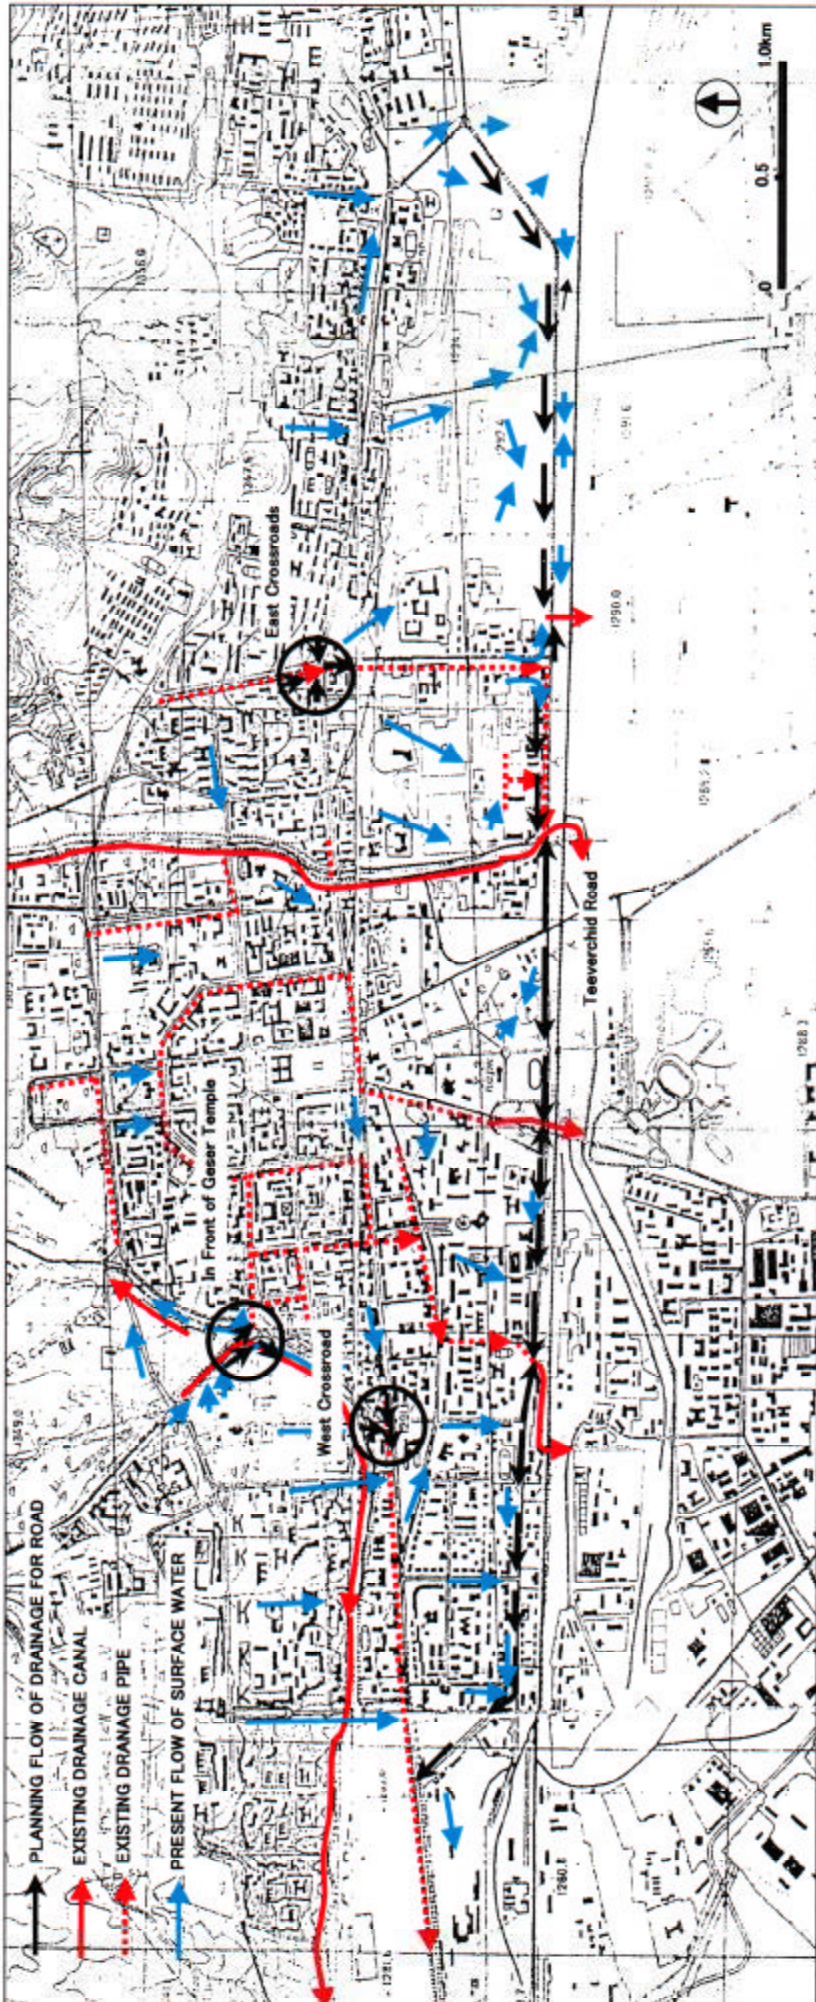
Fig. 2-3-11 Existing Drainage Facilities in Ulaanbaatar

Teeverchid Road is located on the foot hills in the north and on the railway embankment in the south. As a result, water stagnation occurs during the rainy season as drainage facilities rarely set on Teeverchid Road. Flood induced damages mainly hit the western part of Teeverchid Road, because of its relatively lower height.

In East Crossroads Intersection, drainage facilities are set on Ikh Truu Road parallel, and the maintenance is also carried out. Though, rainfall is accumulated on the intersection after rain, due to drainage facilities on Ikh Truu Road are inadequate.

In West Crossroads Intersection, drainage facilities are set on along Enkhtayvan Avenue, and the maintenance is also carries out. On the other hand, drainage facilities are inadequate along Ikh Truu Road. Though, rainfall is not accumulated on the intersection after rain, due to longitudinal slope has been given along Ikh Truu Road. However, the rainfall, which gathered from the circumference, flows the road. And, the road becomes the drainage. As the result, it becomes the disturbance of the smooth travel.

In front of Geser Temple Intersection, drainage facilities are inadequate. Though, rainfall is not accumulated on the intersection after rain, due to longitudinal slope has been given along Ikh Truu Road. However, the rainfall, which gathered from the circumference, flows the road. And, the road becomes the drainage. As the result, it becomes the disturbance of the smooth travel.

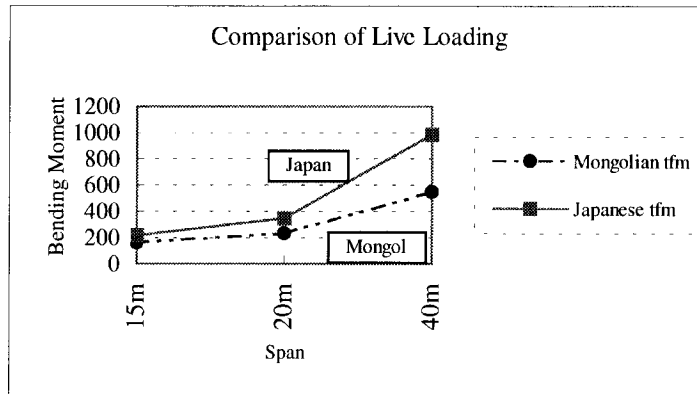
**Fig. 2-3-13 Comparison of live Load using Mongolian and Japanese Methods**

As shown in Fig. 2-3-13, which compares loading system between Mongolian and Japanese [B-live loading system], Mongolian live load system is lower than Japanese live loading system.

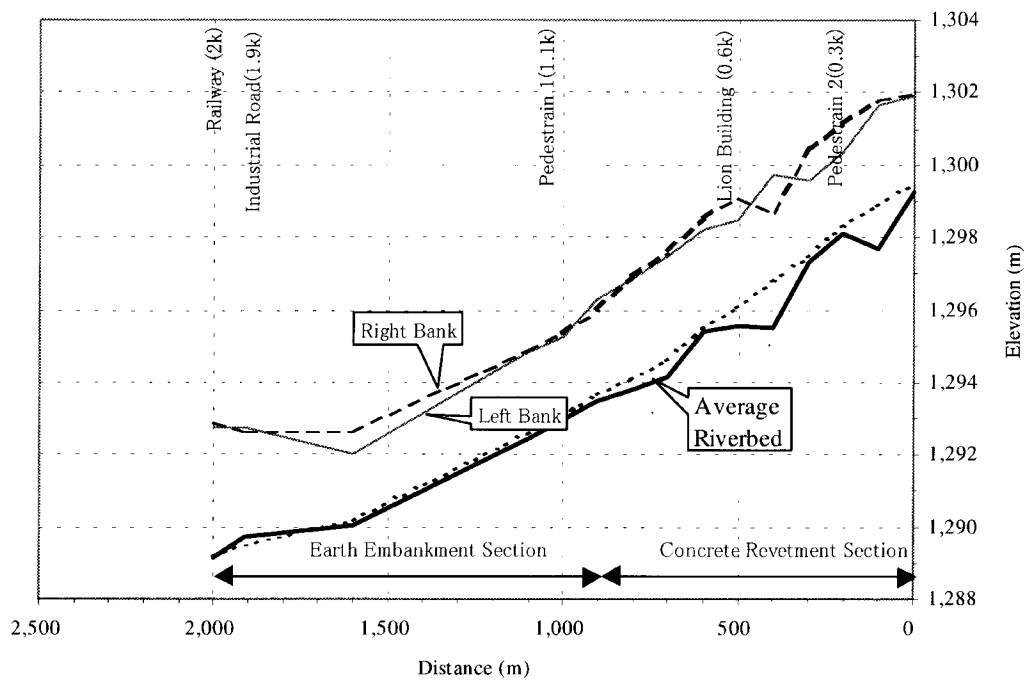
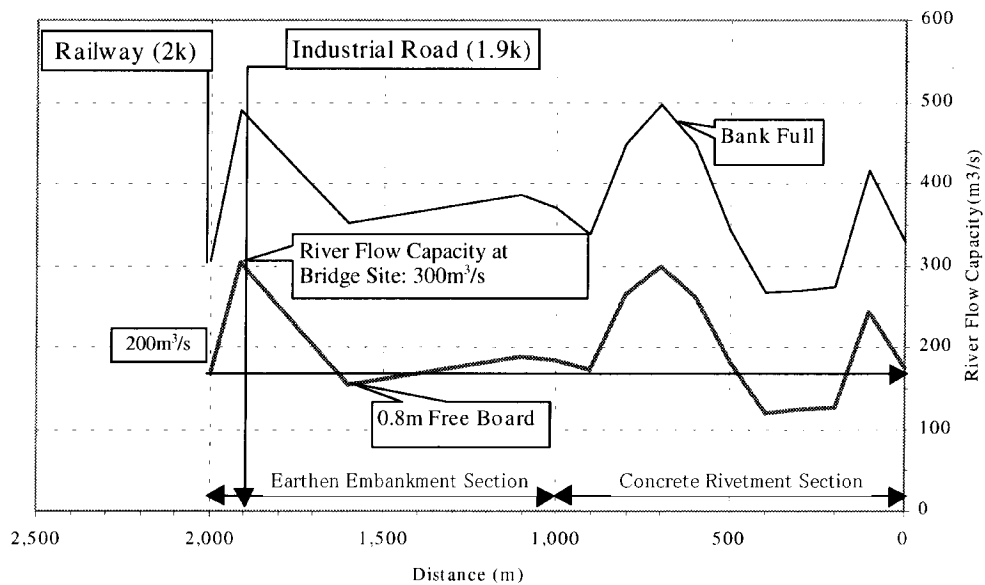
**Fig. 2-3-14 River Capacity of Present River Condition**

The data on existing river facilities and sections are limited. Hence, a site survey was conducted in the reach from downstream of railway to 2 km upstream. The site survey results, reveal that about 3.5-km reaches in the city section is composed of both an earthen embankment and concrete revetment with 35 to 40 m-river width. The riverbed slope within the city

section ranges from 1/150 to 1/260 and categorized as considerably steep slope. The river flow capacity at the proposed bridge site with freeboard of 80 cm is estimated at about 300 m<sup>3</sup>/s, while the capacity of upper reaches at about 1 km is about 200 m<sup>3</sup>/s (see Fig. 2-3-14 and Table 2-3-12). The present embankment and revetment, for which construction documents were not available, were constructed after 1996 floods by volunteer activities of the citizens. During the field investigations, it was observed that the crown elevation is not linear and quality of the concrete for revetment seems to be not good.
