## **6-5: Soundness of Bridges**

### Table-A Bridge Soundness Sheet (Sheet No.1)

NAME OF BRIDGE: Dood Selbe River B Trunk Road		CROSSING: Selbe River		INSPECTION BY		INSPECTION: 2000, June 9		INSPECTION BY			
Design Information		* Yes No		Construction By China		Date of Construction: 1963		Maintenance by			
Superstructure		Reinforced Concrete T-Girder		Reinforced Concrete		Russian 22 ton		Load limitation *No			
Substructure		Reinforced Concrete		Reinforced Concrete		Reversed		Design Loading			
Substructure		Reinforced Concrete		Reinforced Concrete		Tetrapole column		Design Standard			
Pier		45.6m		Span		4@11.4m		Skew of Bridge			
Overall		9.0m		Carriage: 7.0m		Pedestrian: 2@1m		Condition of Crossing			
Kind: communication		Number		4		Ratio of Heavy Veh. 2.3 (0veh./day)		Others			
Traffic Volume		19,500veh./day		Ratio of Heavy Veh. 2.3 (0veh./day)		Others		Others			
Pavement		Deck Slab		Main Beam		Painting		Expansion Joint			
Others		Others		Others		Others		Others			
Component		Conditions Of Damage		Rating		Component		Conditions of Damage		Rating

Table-B Photo for Existing Conditions of Bridge (No.1-1)

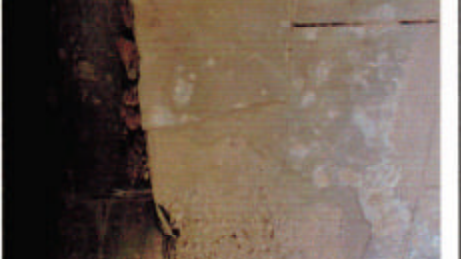
<p>Comments</p> <p>General view of beam, sub-structure:                      Poor conditions, scaling of beam &amp; slab                      Scouring at piers</p>	<p>Location</p>

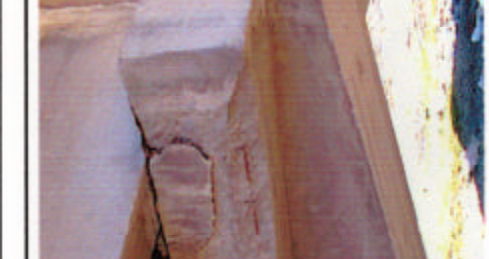
<p>Comments</p> <p>East abutment:                      Spalling, destruction at shoe beds                      None shoes</p>	<p>Comments</p> <p>West abutment:                      Spalling, destruction at shoe beds (10cm depth)                      None shoes</p>
<p>Location</p>

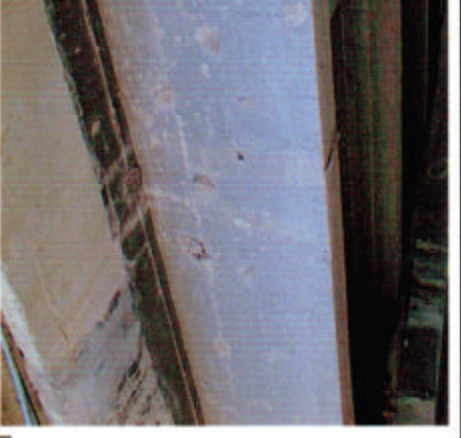
<p>Beam conditions:                      Vertical crack at beam end (1 to 3 cm )                      Lime-water leakage, scaling at beams                      Shoe beds broken                      Heavy damage of all structures</p>
Location	Location

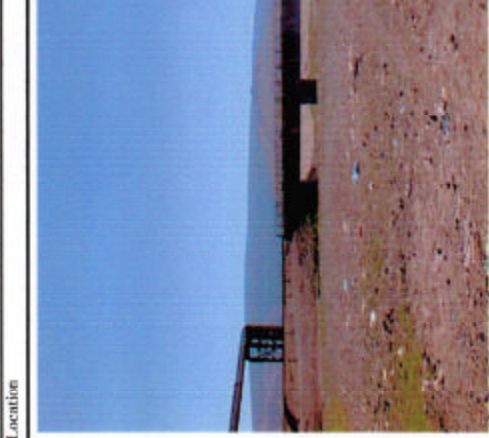
<p>Comments                      Embankment part of East side: RC pipe for drain <math>\phi</math> 1.2m, thickness 8cm</p>
Comments	Comments

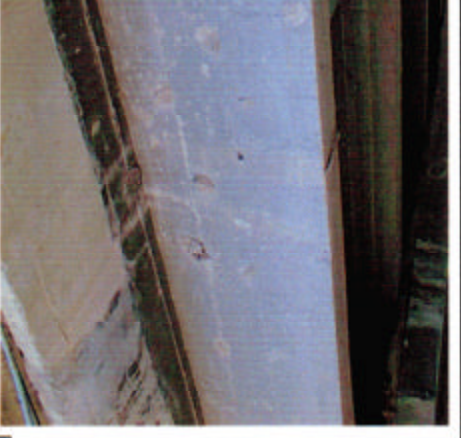
<p>Beam conditions:                      Vertical cracks at outside beams (less than 0.5mm width)</p>
Comments	Comments

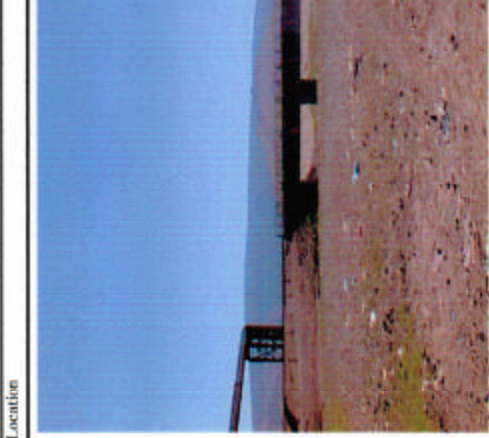
<p>Comments                      Railway at downstream                      Bridge length 40m, 3 span (from North to South)</p>

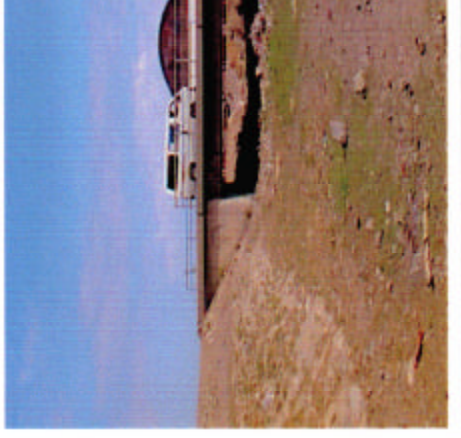
<p>Kind</p>	<p>1. Road</p>	<p>2. Bridge</p>	<p>Investigated on</p>	<p>Photo by</p>
<p>Location</p>	<p>14th Khorocotol Bridge 5K815m</p>	<p>2000, June 7, 8</p>	<p>Y.TAKAI</p>	<p>Comments</p>
<p>General view of bridge:                  Bridge length 11.4m                  Carriageway 7m                  Sidewalk 2@1m                  Surface of unevenness,                  wear,deformed,                  broken curb by                  car collided</p>

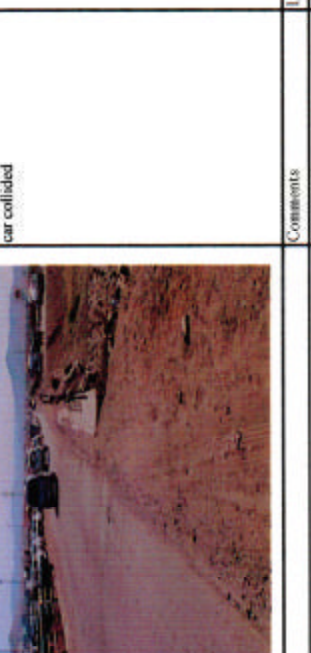
<p>Profile, revetment of bridge:                  Ground for market parking                  at upstream side                  No river at upstream side                  (from downstream)</p>	<p>Comments</p>
<p>Location</p>	<p>Main beam, cross beam:</p>	<p>Leakage of water, lime at                  slab joints</p>	<p>Defects at cross beam due                  to joint gap (not rigid)                  Overage of all concrete                  structures</p>	<p>Beam conditions:                  Vertical cracks at out side                  beams                  (less than 0.5mm)</p>
