Bridge Inventory SER No. 5

NAME OF BRIDGE Mangdi Bridge		CLASS OF LOAD N.H.Rt.No.4		CROSSING: NAME OF RIVER OR ROAD Mangdi River		COMPLETED 1965		MAINTENANCE BY DOR (Shermang)	
Design Information		Yes		No		DATE of Inspection 19/Apr/2000		Inspected by	
Type of Bridge		Superstructure Bailey Suspension		Deck Timber		Design Loading		Load Limitation	
		Substructure Abutment Masonry		Pier		Design Standard		No	
Length of Bridge		97.6		Span m		Skew of Bridge		Deg.R= 9.0	
Width of Bridge		4.02		Carriageway m		Condition of Crossing		Skew deg	
Affixed Articles Traffic Volume		Overall		97.4		Others		Design Quantity m ³ /sec	
Final Record of Repair		Pavement		Deck Slab		Expansion Joint		Free Board m	
		Others		Greasing & Cleaning at Apr. 1999		Substructure		m	
		Pavement		Main Beam		Painting		m	
		Deck Slab		Ratio of Heavy Vehicle %		Apr/1999		m	
		Main Beam		Painting		Apr/1999		m	
		Ratio of Heavy Vehicle %		Painting		Apr/1999		m	
		Painting		Apr/1999		Apr/1999		m

Bridge Inspection Form

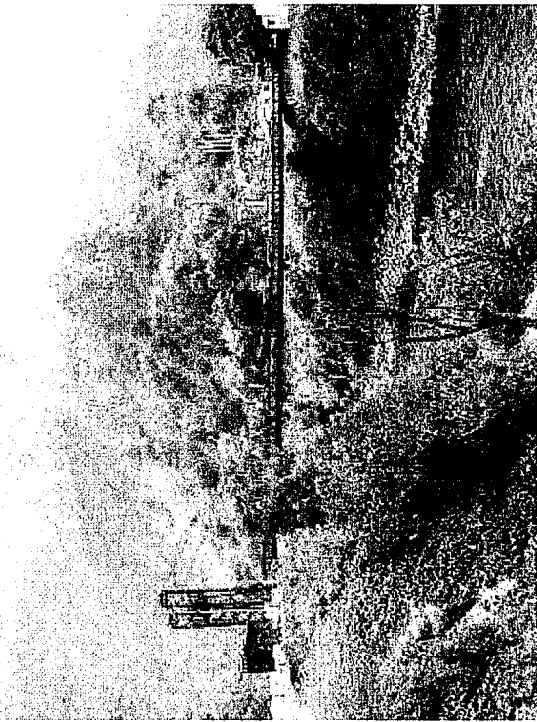
General View

Notes
1. Sag of main girders is 46cm.

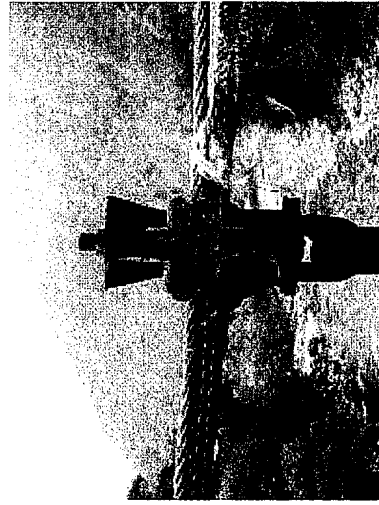
Cable band was broken.

Note: Further inspection shall be carried out on the "major damage" detected in the inspection.
