APPENDIX 4A-7

DETAILS OF DETECTED LEAKS

Location of Leakages in NRW Reduction Pilot Project Area

THE DETAILED DESIGN STUDY ON THE PROJECT FOR REDUCTION OF
NON-REVENUE WATER IN THE GREATER COLOMBO AREA IN THE
DEMOCRATIC SOCIALIST REPUBLIC OF SRI LANKA

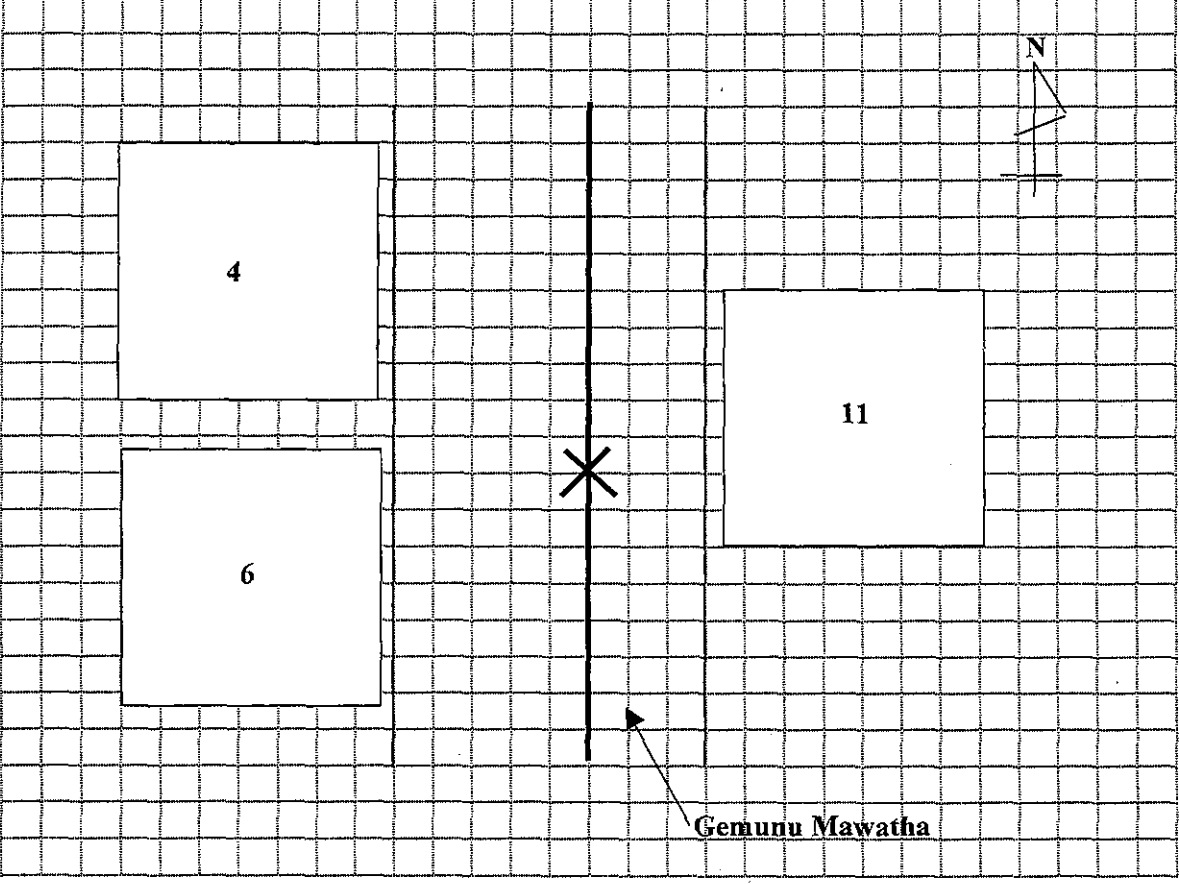
Name of Lane	Gemunu Mawatha	Leakage No.	Leakage No.5
Nearest House	No. 6		
Scale of Leakage (Estimate)	Large / Medium / <u>Small</u>

Date(s) of Repair		No. of Repair Workers	persons
No. of Time Required for Repair			hrs
Materials Used for Repair			
Pipe Material	1.CIP	2.PVC	3.GIP 4.Others()
Pipe Diameter		Depth	
Landownership Classification	1.Public		2.Private
Pipe Classification	1.Distribution Pipe		2.Service Pipe
Surface	1.Asphalt	2.Concrete	3.Soil / Gravel 4.Others
The point of leakage	1.Pipe Body	2.Pipe Joint	3.Valve 4.Fire hydrant
	5.Service Pipe	6.Ferrule	7.Water Meter 8.Others()
Comments (Sketch) : Leakage could not be traced

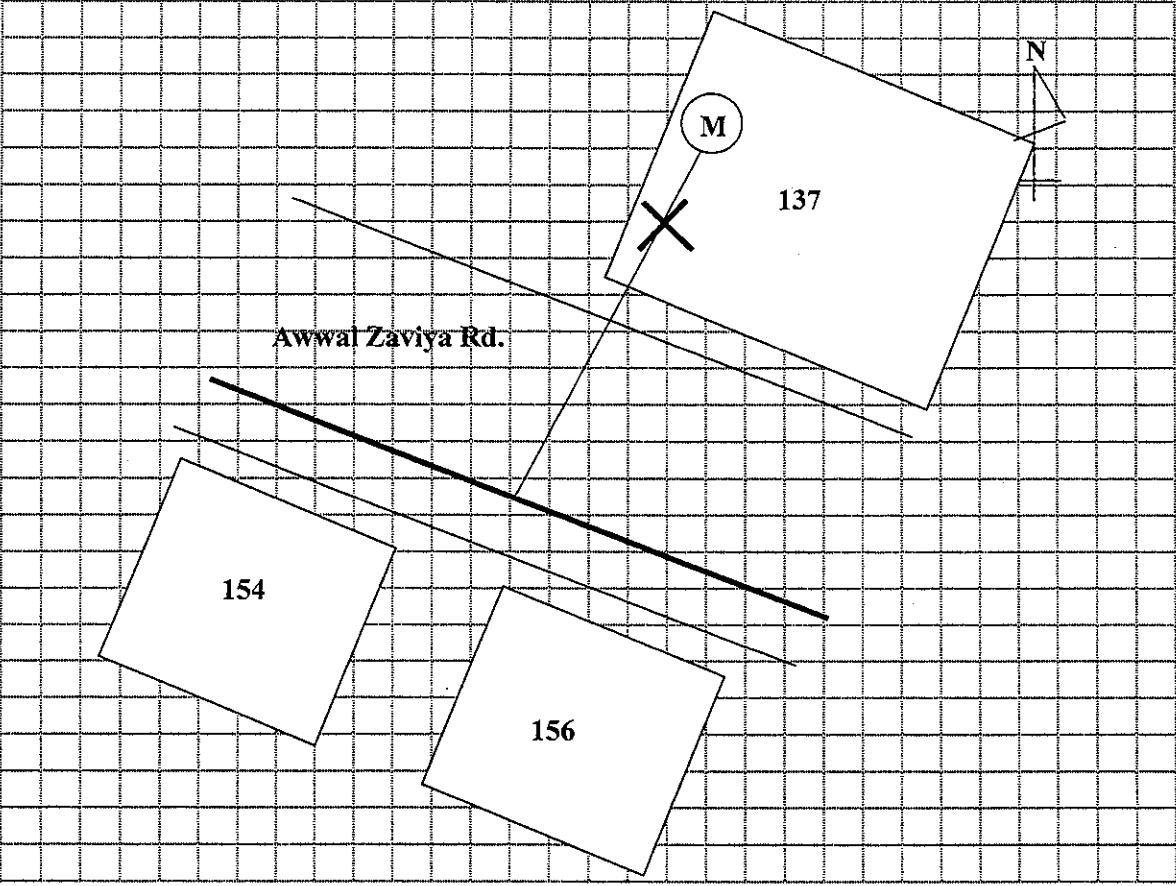
Name of Lane	Awwal Zaviya Rd.	Leakage No.	Leakage No.9
Nearest House	No. 137		
Scale of Leakage (Estimate)	Large / Medium <u>Small</u>

Date(s) of Repair	No. of Repair Workers		persons
No. of Time Required for Repair		hrs	
Materials Used for Repair			
Pipe Material	1.CIP	2. PVC	3.GIP 4.Others()
Pipe Diameter	Depth		
Landownership Classification	1.Public		2.Private
Pipe Classification	1.Distribution Pipe		2.Service Pipe
Surface	1.Asphalt	2.Concrete	3.Soil / Gravel 4.Others
The point of leakage	1.Pipe Body	2.Pipe Joint	3.Valve 4.Fire hydrant
	5.Service Pipe	6.Ferrule	7.Water Meter 8.Others()
Comments (Sketch) : Leakage could not be traced

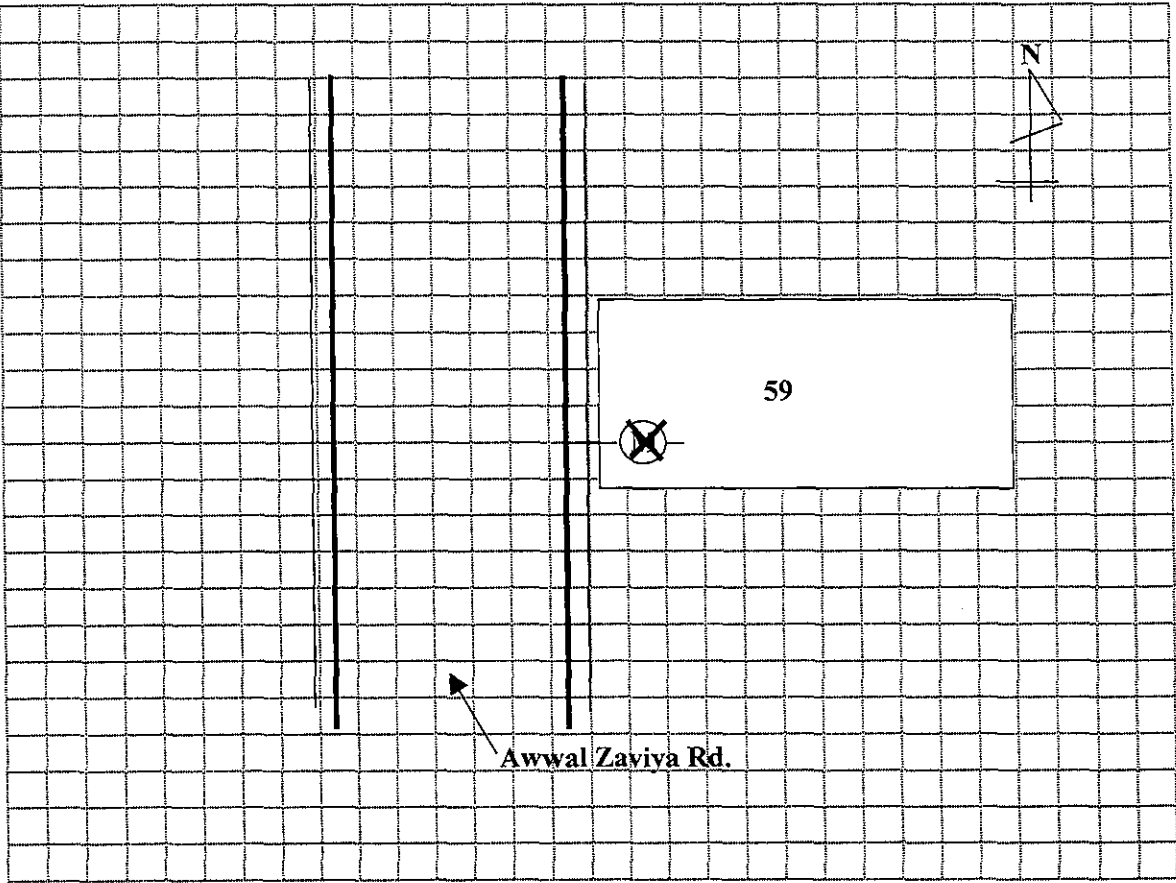
Name of Lane	Awwal Zaviya Rd.	Leakage No.	Leakage No.22
Nearest House	No. 59		
Scale of Leakage (Estimate)	Large / Medium / Small

Date(s) of Repair	No. of Repair Workers		persons
No. of Time Required for Repair		hrs	
Materials Used for Repair			
Pipe Material	1.CIP	2. PVC	3.GIP 4.Others()
Pipe Diameter	Depth		
Landownership Classification	1.Public		2.Private
Pipe Classification	1.Distribution Pipe		2.Service Pipe
Surface	1.Asphalt	2.Concrete	3.Soil / Gravel 4.Others
The point of leakage	1.Pipe Body	2.Pipe Joint	3.Valve 4.Fire hydrant
	5.Service Pipe	6.Ferrule	7.Water Meter 8.Others()
Comments (Sketch) : Leakage could not be traced

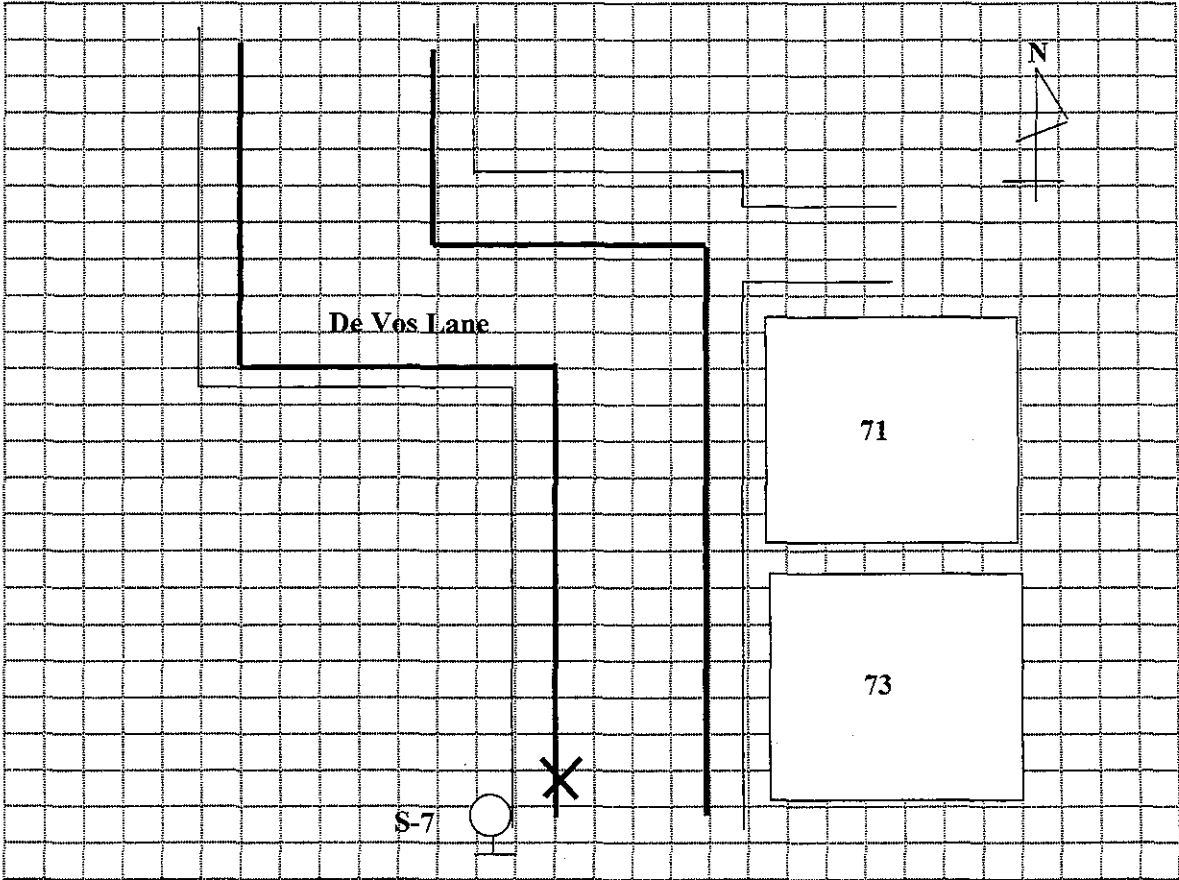
Name of Lane	De Vos Lane	Leakage No.	Leakage No.29
Nearest House	No. 73		
Scale of Leakage (Estimate)	Large / Medium Small

Date(s) of Repair	6-Dec-2000	No. of Repair Workers	4 persons
No. of Time Required for Repair	3 hrs		
Materials Used for Repair			
Pipe Material	1.CIP <input checked="" type="checkbox"/> 2.PVC <input checked="" type="checkbox"/> 3.GIP <input checked="" type="checkbox"/> 4.Others()		
Pipe Diameter	1"	Depth	0.5 m
Landownership Classification	<input checked="" type="checkbox"/> Public	2.Private	
Pipe Classification	1.Distribution Pipe		2.Service Pipe
Surface	<input checked="" type="checkbox"/> Asphalt	2.Concrete	3.Soil / Gravel 4.Others
The point of leakage	<input checked="" type="checkbox"/> 1.Pipe Body	2.Pipe Joint	3.Valve 4.Fire hydrant
	<input checked="" type="checkbox"/> 5.Service Pipe	6.Ferrule	7.Water Meter 8.Others()
Comments (Sketch) :
