APPENDIX 5B

RESULTS OF LEAKAGE SURVEY

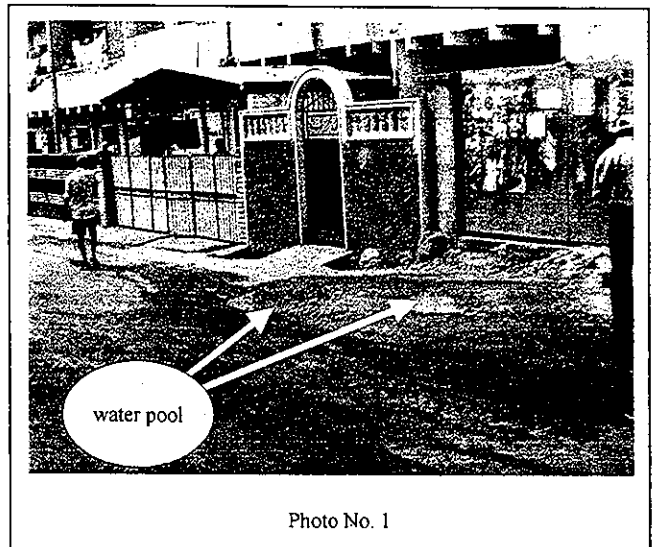
Pipe Material	Cast Iron
Nominal Internal Dia. (inch)	4
Age Group	70 to 100 years
Pipe Location	under Roadway (paved)
Detected by:	Visual Inspection on the Ground
Leakage from:	Previously Repaired Leak
Leakage Volume	Small

Notes
 • Leakage observed on the ground as shown in Photo No. 1

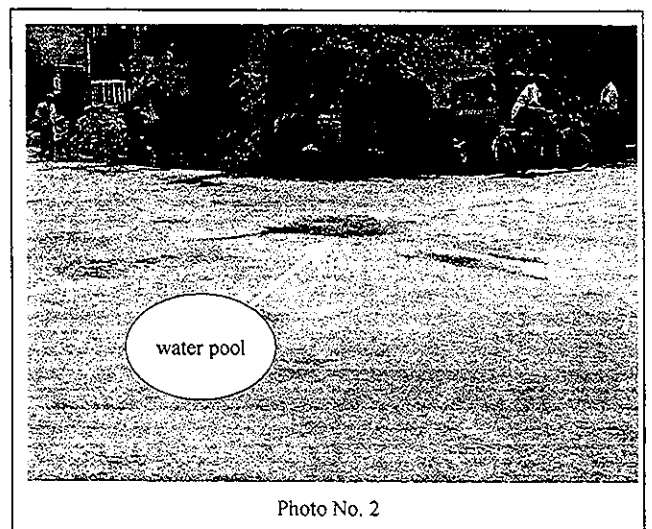
Pipe Material	Cast Iron
Nominal Internal Dia. (inch)	7
Age Group	over 100 years
Pipe Location	under Roadway (paved)
Detected by:	Visual Inspection on the Ground
Leakage from:	Valve Head
Leakage Volume	Medium

Notes
 • Leakage observed on the ground as shown in Photo No. 2

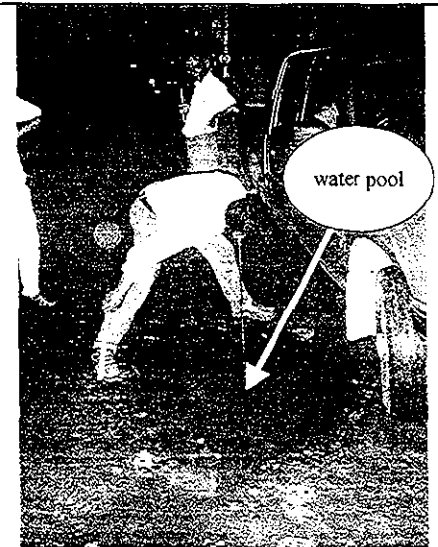
Photo No. 1

Pipe Material	Cast Iron
Nominal Internal Dia. (inch)	3
Age Group	over 100 years
Pipe Location	under Roadway (paved)
Detected by:	Visual Inspection and Leak Detector
Leakage from:	N. A.
Leakage Volume	Small

- Due to the relatively high system pressure, leakage sound was much clearer than in other areas (Photo No.1)

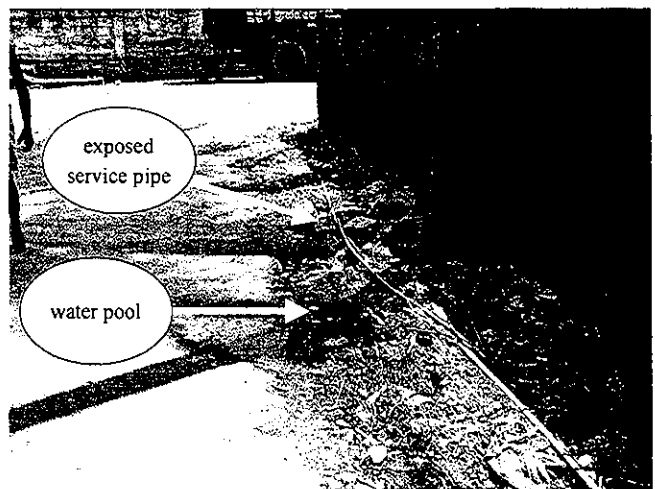
Photo No.1

Pipe Material	PVC (Service Pipe)
Nominal Internal Dia. (inch)	3/4
Age Group	unknown
Pipe Location	see Notes
Detected by:	Visual Inspection on the Ground
Leakage from:	Joint
Leakage Volume	Medium

- Many small leaks were observed near the joint
- Some part of service pipe were exposed on the ground and leaking from joint
- Service pipe shown in photo No.1 and No.2 was connected to the house 500m away from distribution main drawn as below

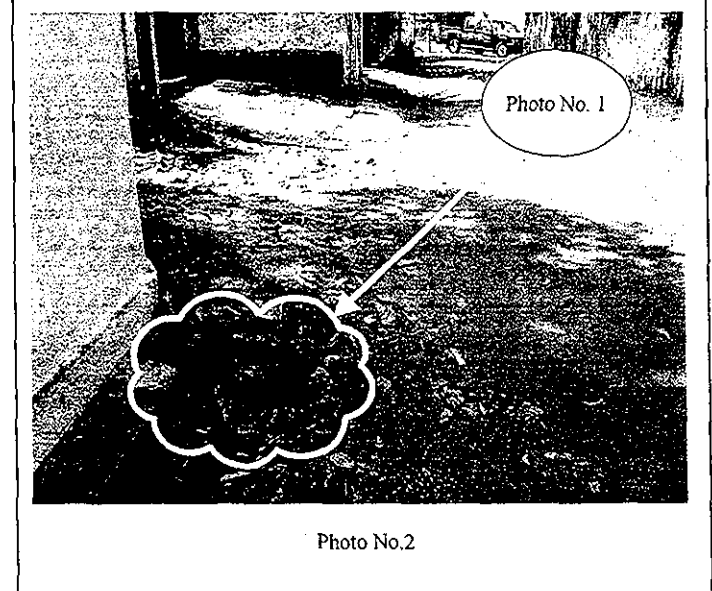
Pipe Material	unknown
Nominal Internal Dia. (inch)	unknown
Age Group	unknown
Pipe Location	under Roadway (paved)
Detected by:	Visual Inspection on the Ground
Leakage from:	Unknown
Leakage Volume	Medium

- There was leaking water flowing in the trench shown in photos
- It could be leakage from service pipe
- It was very difficult to hear the leakage sound because water pressure was extremely low

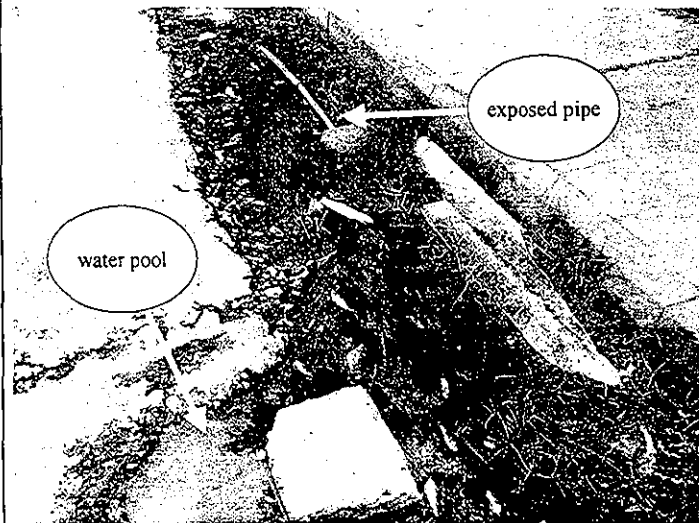
Photo No. 1

Pipe Material	PVC (Service Pipe)
Nominal Internal Dia. (inch)	3/4
Age Group	unknown
Pipe Location	see Notes
Detected by:	Visual Inspection on the Ground
Leakage from:	Joint
Leakage Volume	Small

- Some part of service pipe were exposed on the ground and leaking from joint
- Service pipe show in photos was connected to the house 400 m away from distribution drawn as below

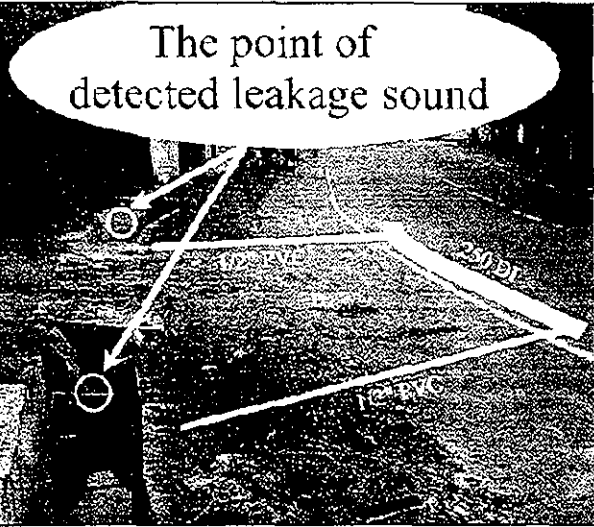
Pipe Material	Unknown
Nominal Internal Dia. (inch)	Unknown
Age Group	20 to 50 years
Pipe Location	under Roadway (paved)
Detected by:	Sounding Bar
Leakage from:	Unknown
Leakage Volume	Medium

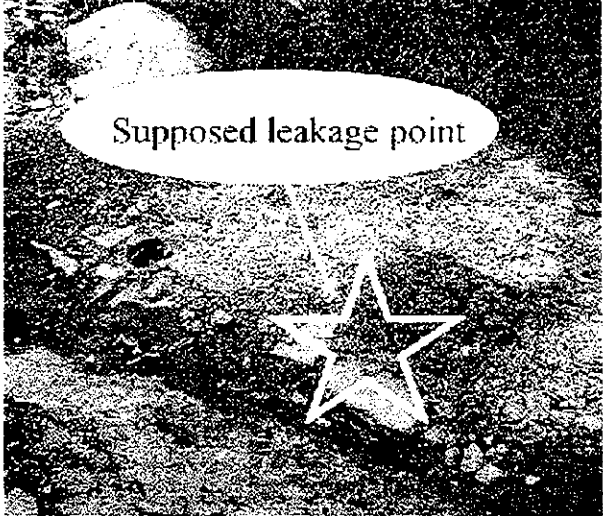
Photo No. 1

Pipe Material	Cast Iron
Nominal Internal Dia. (inch)	4
Age Group	20 to 50 years
Pipe Location	under Roadway (paved)
Detected by:	Leak Detector
Leakage from:	Unknown
Leakage Volume	Medium

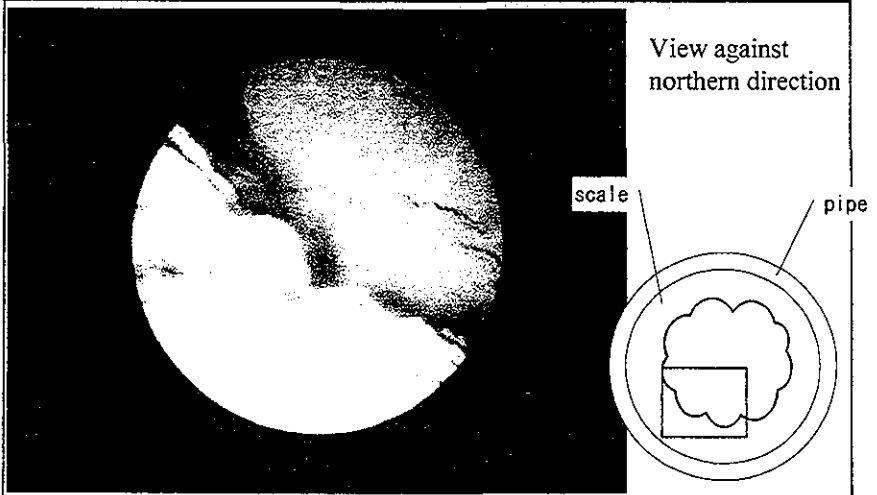
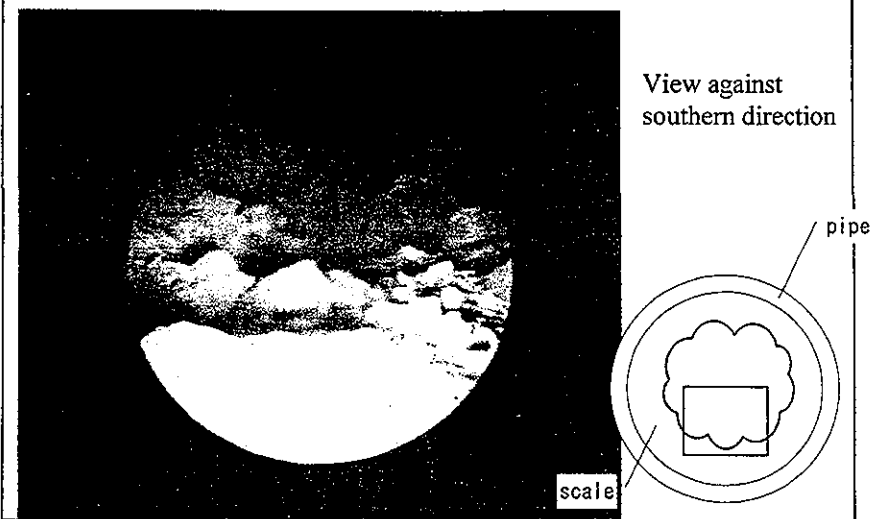
Pipe Material	Cast Iron
Nominal Internal Dia. (inch)	4
Measured Circumference (mm)	388
Age Group	over 100 years
Previous Scraping	None
Pipe Depth (m)	0.5
Pipe Location	under Roadway (paved)
Pipe Wall Condition	Slightly Corroded
Water Pressure (kgf/cm ²)	0.60
Max Scale Thickness (mm)	15
State of Encrustation	Medium
Effective Cross Section Area	36%
Bubbles	Low
Residual Chlorine	N. A.
pH	N. A.
EC	N. A.

- It was observed that color distribution of scale of this pipe was partly different
- Direction of flow was changing
