NO. 93 existing bridge condition

Location		Road No.	Name of road	V- Da-4
	Province	District	Road No.	Name of foat	Km Post
L	Middle	Kandy	AA005	Peradeniya-Badulla-Chenkaladi	21/4

NO. 122 existing bridge condition

NO. 154 existing bridge condition

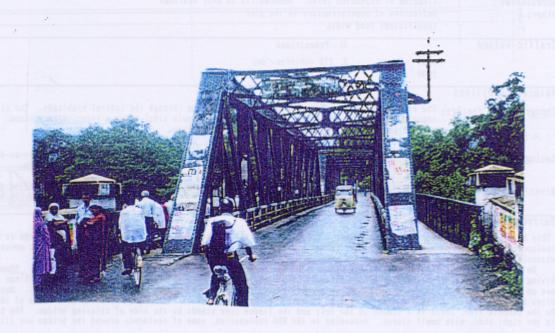
The general view (longitudinal direction to the bridge axis)

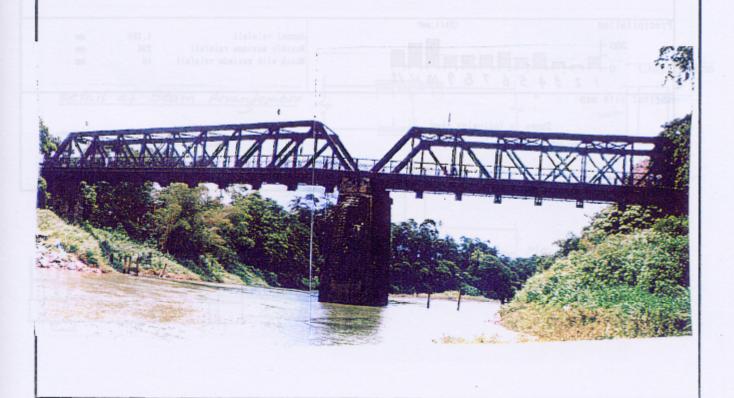
The side view (perpendicular direction to the bridge axis)

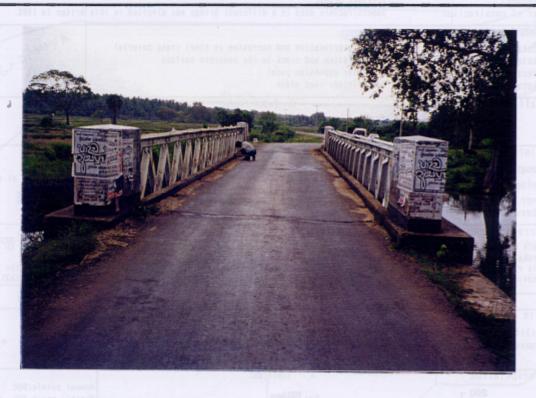
The general view (longitudinal direction to the bridge axis)

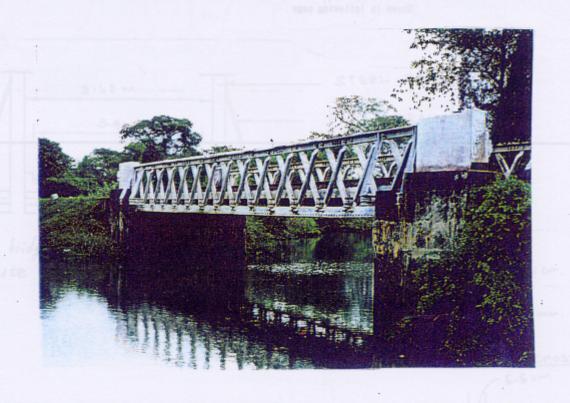
The side view (perpendicular direction to the bridge axis)

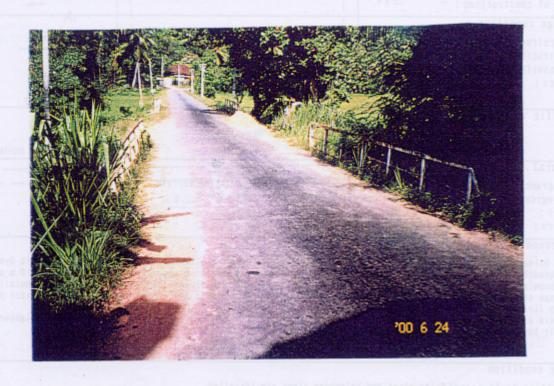
The general view (longitudinal direction to the bridge axis)

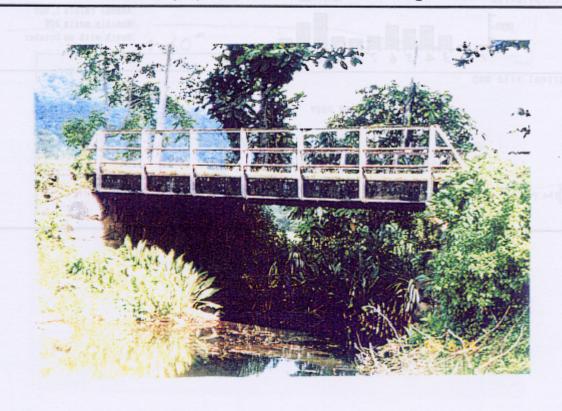
The side view (perpendicular direction to the bridge axis)

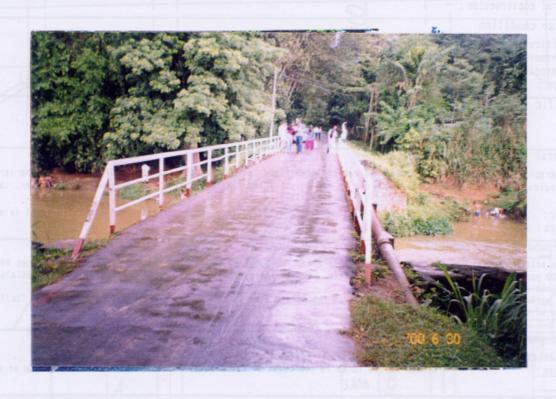
The general view (longitudinal direction to the bridge axis)

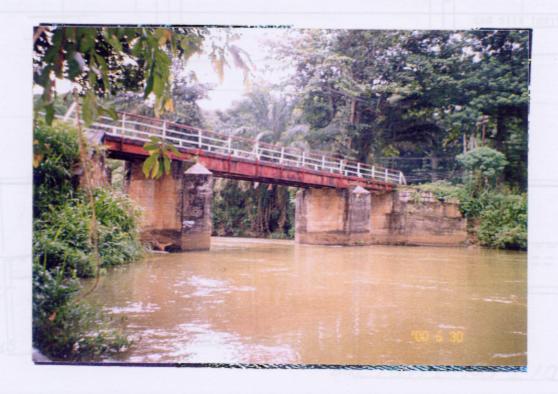
The side view (perpendicular direction to the bridge axis)
