NO. 158 existing bridge condition

NO. 181 existing bridge condition

NO. 200 existing bridge condition

NO. 239 existing road condition

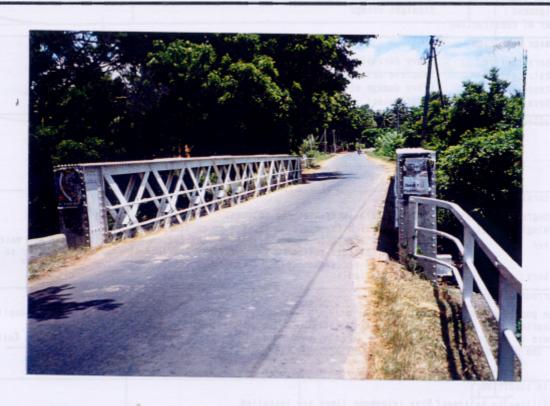
The general view (longitudinal direction to the bridge axis)

Heavy corrosion of steel truss members

Concrete deterioration and crack Heavy damage of guardrails

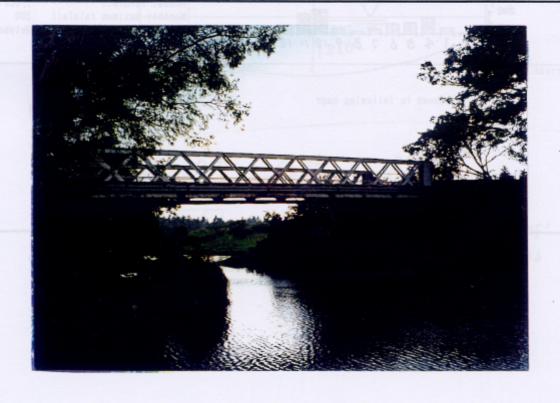
The side view (perpendicular direction to the bridge axis)

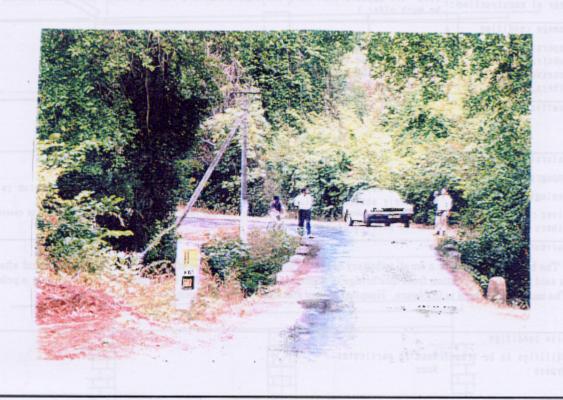
The general view (longitudinal direction to the bridge axis)

Corrosion of main girder (steel I-girder) and crack in slab concrte

Damage in stone masonry block Shoe seat surface fixed with bricks

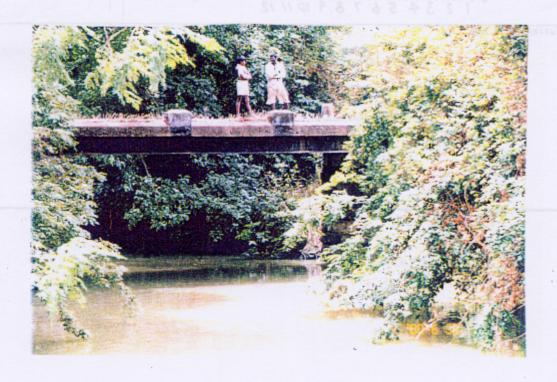
The side view (perpendicular direction to the bridge axis)

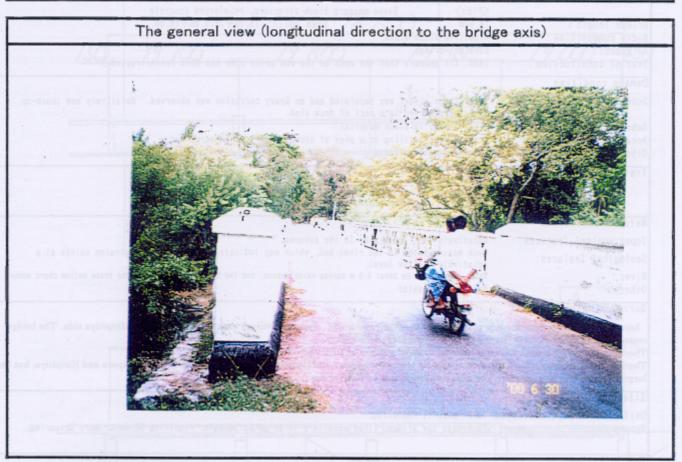
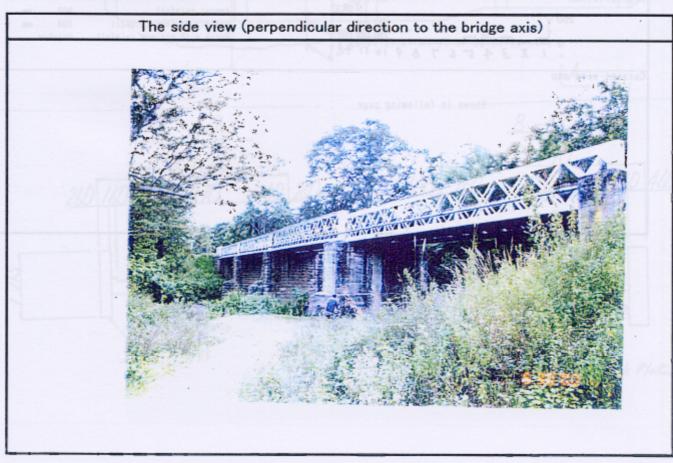
Steel truss girder was repainted and no heavy corrosion was observed. Relatively new touch-up

Minor damage in stone material

Truss girder settling in a pier of stone masonry block structure.

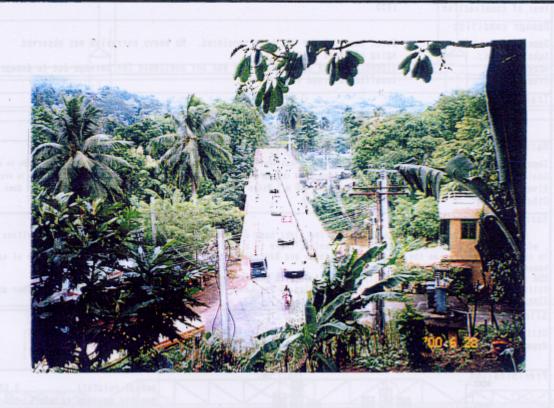
The general view (longitudinal direction to the bridge axis)

Steel truss girder has been repainted. No heavy corrosion was observed.

Sidewalk on the downstream side was not available for passage due to damage.

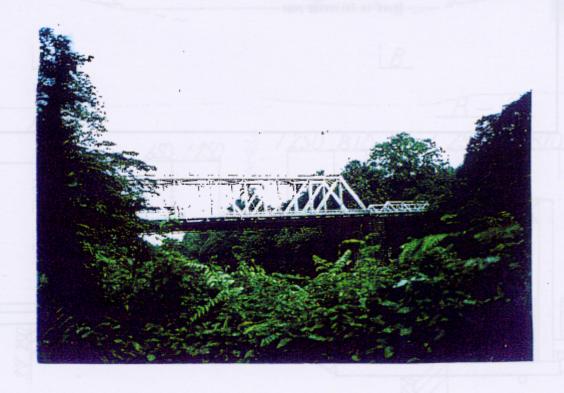
The side view (perpendicular direction to the bridge axis)
