APPENDIX D REPORT ON QUICK PROJECTS

APPENDIX D-1 WATER LEAKAGE CONTROL IN DILI

The Study on Urgent Improvement Project for the Water Supply System in East Timor

D.2 CONSTRUCTION OF INFILTRATION GALLERY IN MANATUTO

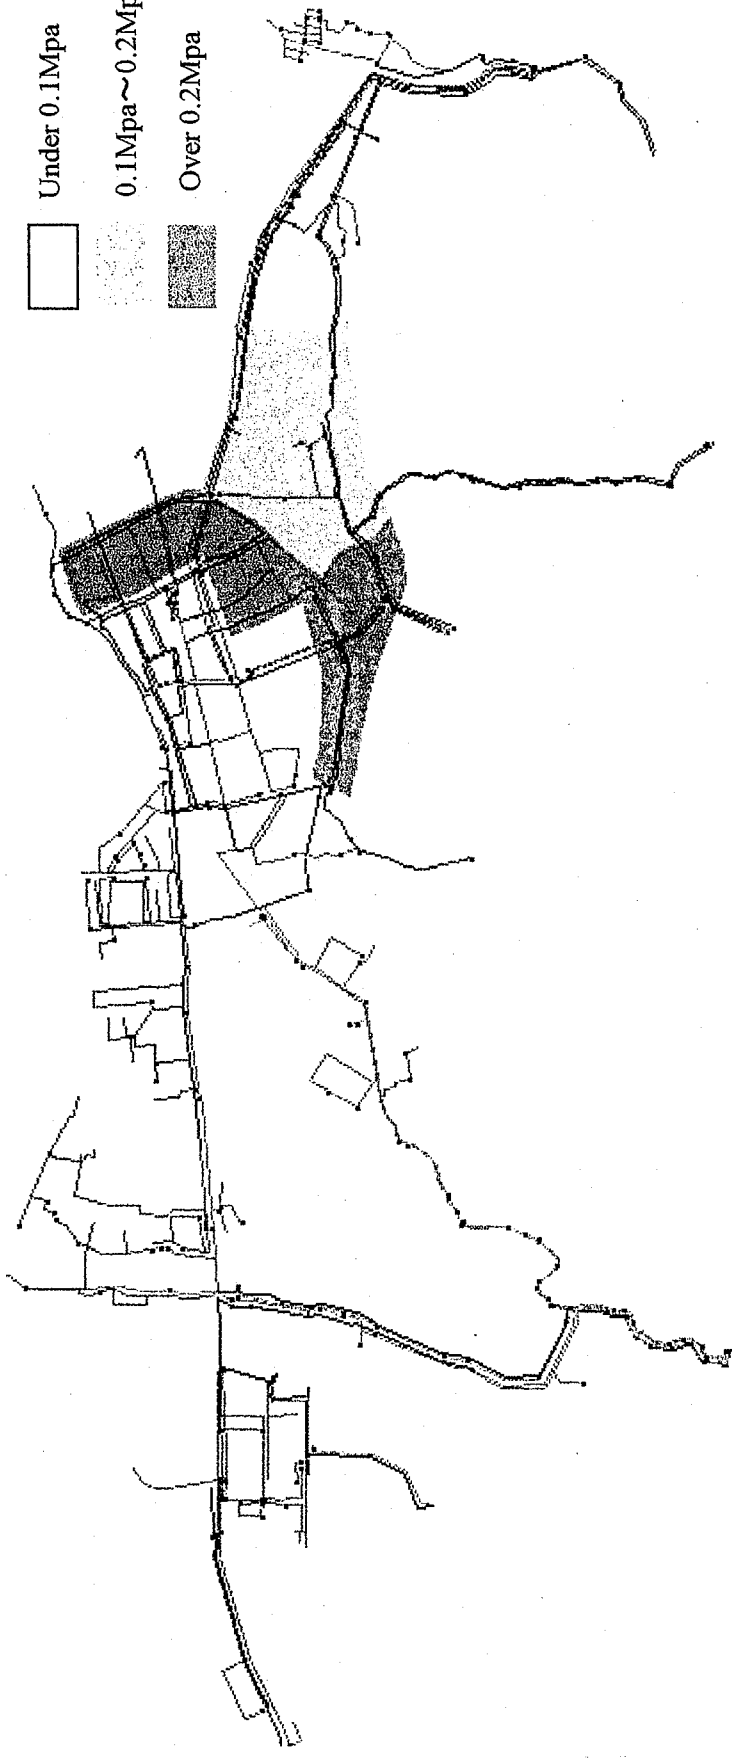
D-1

Water pressures were measured using the momentary water-pressure gauge at 154 households in Dili. The measurement was carried out between 10 May and 20 May as dry season investigation, and between 15 November and 25 November as wet season. In only dry season investigation, it was found out that the Lahane Timur area where the water supply from Bemori water source without treatment has been cut off two (2) years ago. The water supply situation is hardly any water from the heart of Dili Township to the area along the west coast.

In wet season investigation, the condition of the Lahane Timur area was observed substantial improvement of water pressure recovery to 0.4 Mp. Because of impossible to procure the repairing materials of the damaged 400A pipe, there is no significant improvement after the investigation. On the other hand, the decline of water pressure was observed in Santa Cruz area, but unknown causes.

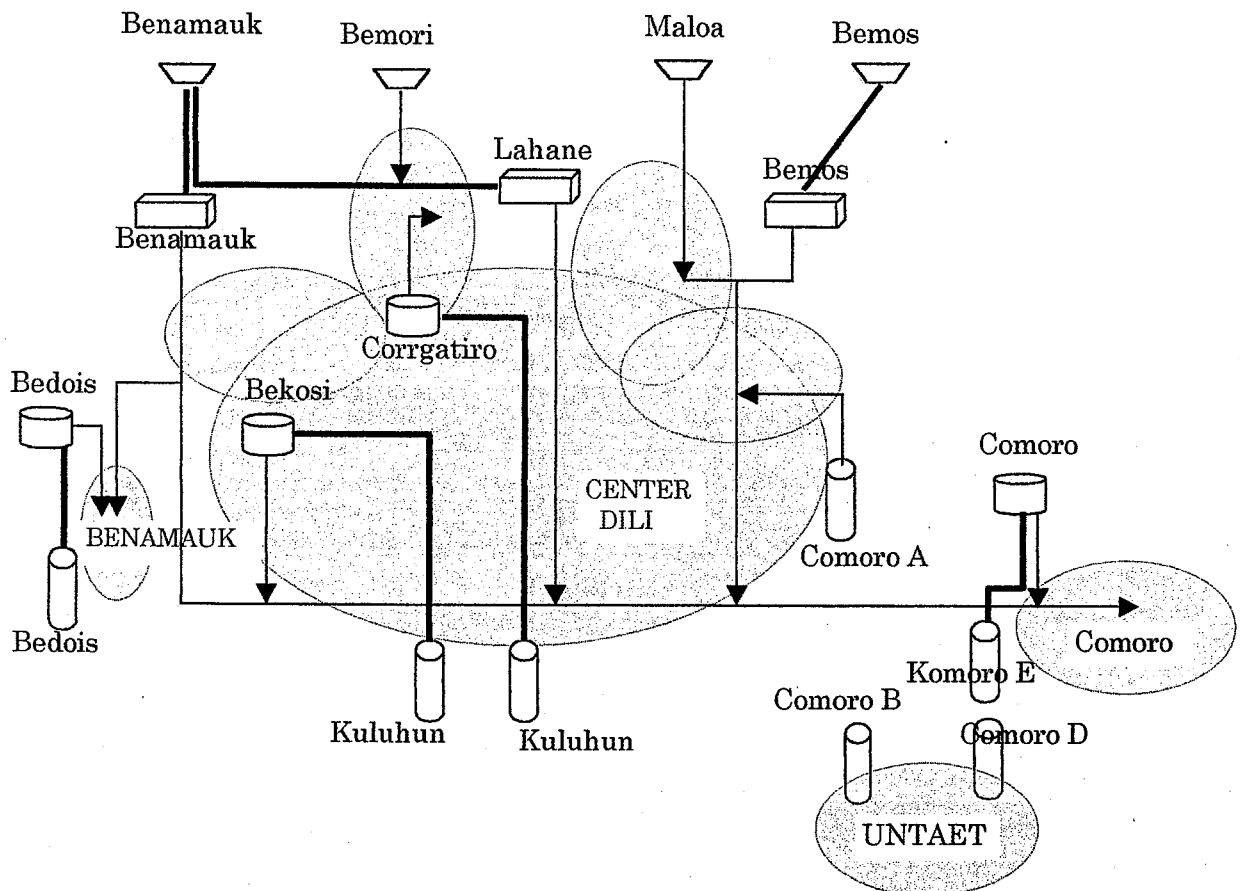
D-2

The potable water of Dili except Hera area distributes from three (3) reservoirs originating in four (4) surface water sources and seven (7) boreholes. An amount of daily water distribution is observed. **Figure D-1** shows water distribution system in Dili. Total amount of water distribution is 16,690 m³/day (See table for each value). It is thought that 40 percent of daily water distribution is consumed effectively but the rest 60 percent is wasted on the leakage with careless construction and the discharge of water without control.

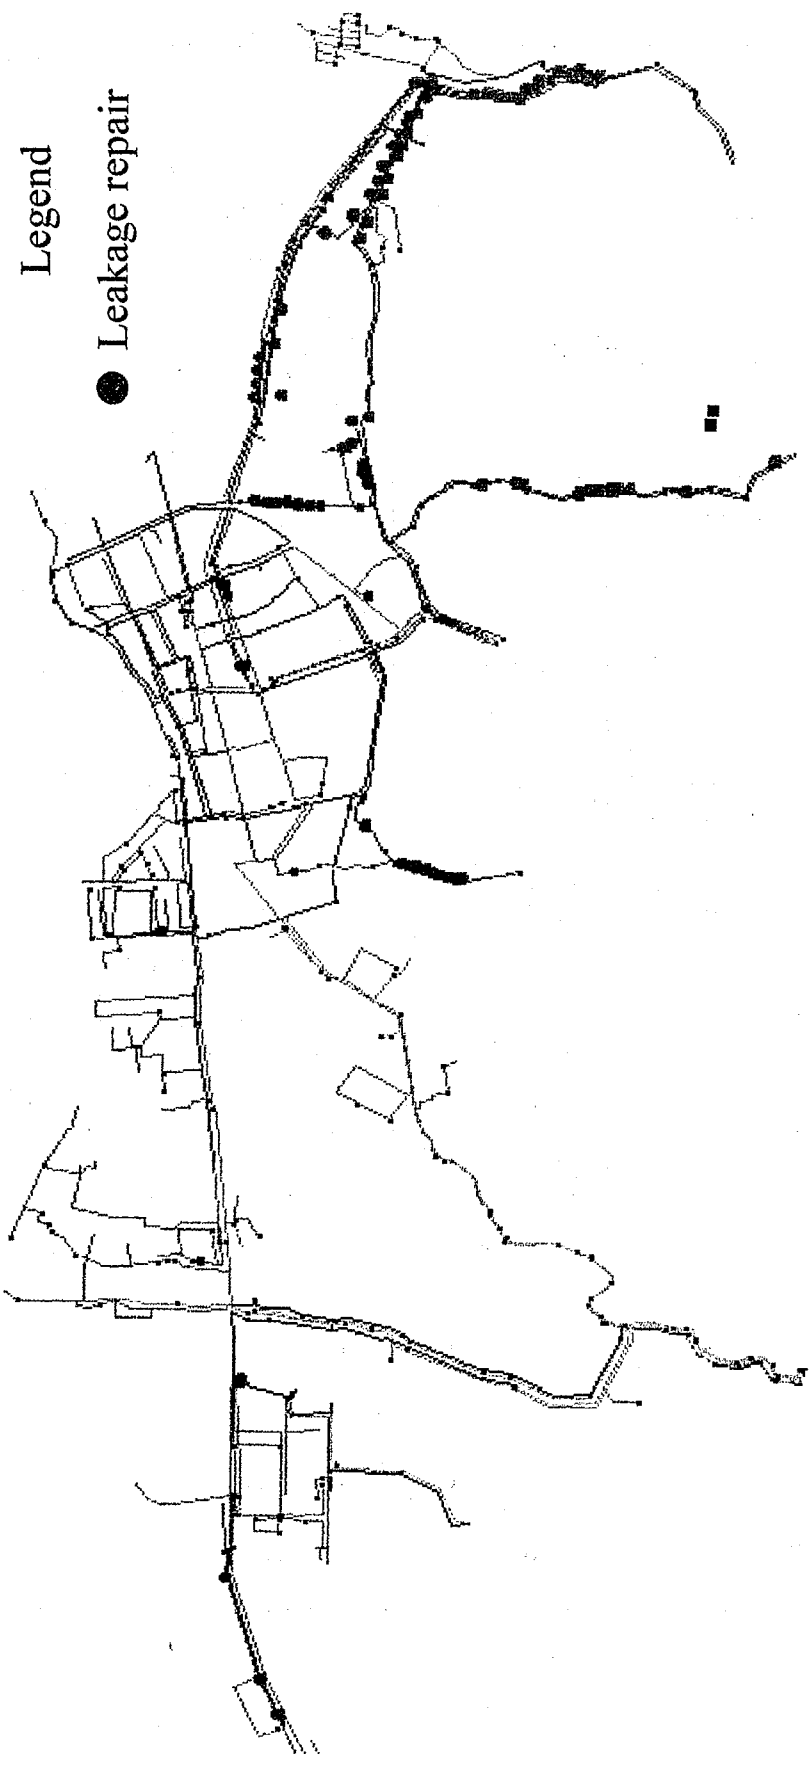
D-3

A breakdown of eleven (11) points of leakage repairing is six (6) points of ACP pipe and five (5) points of steel pipe. Particularly, the leakage causes by inferiority of rubber packing using at the joint part of bolts. A leakage point of ACP 150A pipe located 1 km downstream of Bemori water source, it has not been taken the water two years ago due to the tree roots have trespassed upon the inside of pipe from the point to obstruct a water path. Many ACP pipes remain using in the center of the town. Although it is required to inspect all

rubber packing at the joint part, an inspection has never performed because of inadequate water pressure. 174 points (96.7%) of all leakage in service pipe happened entirely in the steel pipe. The majority of leakage type is bad condition at joint part. It was very difficult to execute a partially repair due to a corrosion is reached a fairly worsen stage in the screws that have no rust prevention and in addition a rubber belt winds around the pipe instead of joint materials.
