Town: Dili	No. & Facility: 01- Bemos Intake	Year of Construction 1986	Financed by:
Existing Condition: <i>Structure:</i> concrete weir <i>Shape:</i> <i>Dimension:</i> <i>Capacity:</i> 60L/sec intake rate <i>Function:</i> raw water intake <i>Ground level:</i> <i>Accessories:</i> Collecting chamber with two inlets laid at the upper basin Grit chamber at 50m downstream		Photograph:

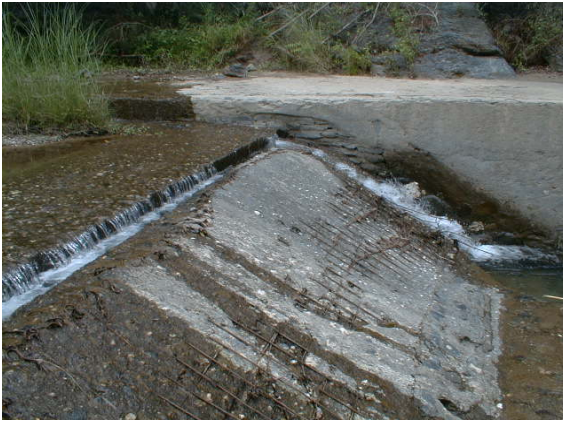
(Date: Nov 2000)	
Evaluation: Working but due to flood, concrete apron is damaged.			
Rehabilitation Plan: 1) <i>Basic Calculation</i> Minor repair is required. It is in urgent need to avoid foreign matters such as silts, sand and leaves from entering into the collection chamber and to protect the inlets from the flood. Stones and gravels with sufficient size should be laid surrounding the inlet perforated pipes. 2) <i>Civil Work:</i> Repair of weir and concrete apron Excavation 3m x 3m x 2m depth and filled by stones and gravel 3) <i>Piping work:</i> none 4) <i>Mechanical work:</i> none 5) <i>Electrical work:</i> none 6) <i>Miscellaneous:</i> none

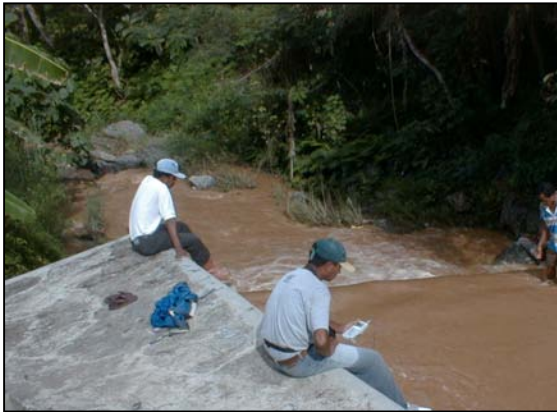
(Date: May 2000)	
Evaluation: Working but requires rehabilitation.			
Rehabilitation Plan: 1) <i>Basic Calculation</i> Silts and sands are entering into the intake chamber because of openings of the upper slab of the intake conduit 2) <i>Civil Work:</i> Excavation of upper basin of the intake weir (7m x 4m x 1.5m depth) Concrete pouring on the openings to close conduits Backfill by gravel and stones 3) <i>Piping work</i> Installation of perforated GS pipes in the upper basin 3m x 3 lines 4) <i>Mechanical work:</i> none 5) <i>Electrical work:</i> none 6) <i>Miscellaneous:</i> none			
Estimated cost: US\$2,595		Construction schedule:	Priority: A-2

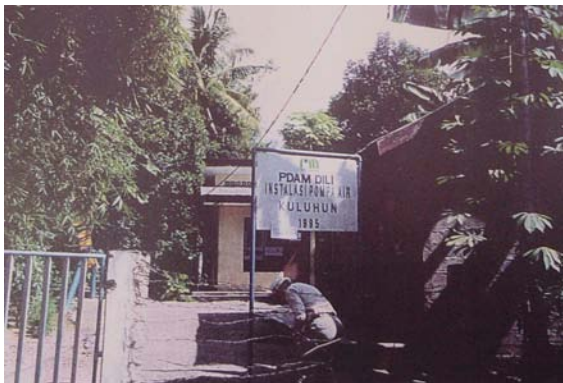
(Date: May 2000)	
Evaluation: Working but requires rehabilitation.			
Rehabilitation Plan: 1) <i>Basic Calculation</i> Rehabilitation of pump and generator sets are required. 2) <i>Civil Work:</i> none 3) <i>Piping work</i> Pipe replacement: 250mm GS x 50m 4) <i>Mechanical work:</i> Submersible pump should be replaced by new one. Type: submersible pump Capacity: 1.0m ³ /min x 10.0kg/cm ² 5) <i>Electrical work:</i> Watt-hour Meter Box x1 Fuel Tank x1 Main Power Switch Panel x1 Pump Control Board x1 Generator Set x1 6) <i>Miscellaneous:</i> none			
Estimated cost: US\$12,000		Construction schedule: 	
		Priority: A-1

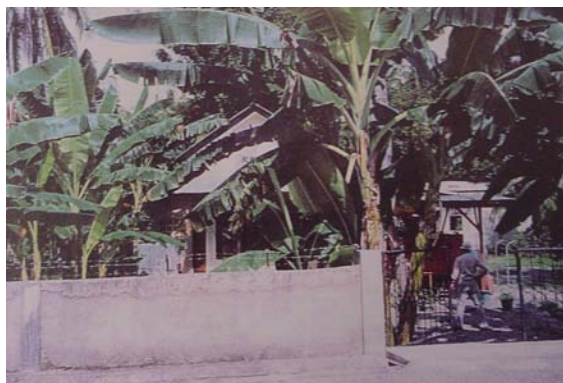
(Date: May 2000)	
Evaluation: Working normally.			
Rehabilitation Plan: 1) <i>Basic Calculation</i> No rehabilitation is required. 2) <i>Civil Work:</i> none 3) <i>Piping work</i> none 4) <i>Mechanical work:</i> none 5) <i>Electrical work:</i> none 6) <i>Miscellaneous:</i> none			
Estimated cost: None		Construction schedule:	Priority: -

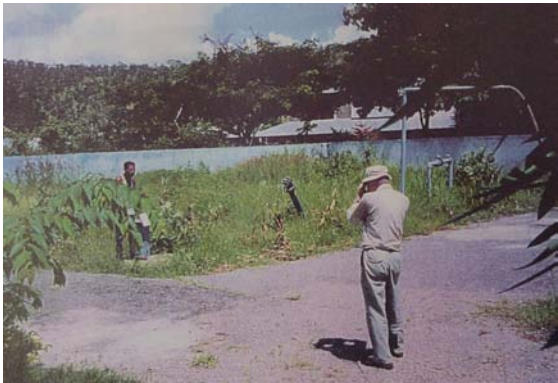
(Date: May 2000)	
Evaluation: Not presently used because of low production rate, and pumps are removed. According to the existing report, rehabilitation of old Comoro C well was carried out with the result far less than the designed production rate (20/Lsec).			
Rehabilitation Plan: 1) <i>Basic Calculation</i> As production of the Comoro wells (A, B, D, E) exceeds the water demand in the supply zone, this well will be abandoned. 2) <i>Civil Work:</i> none 3) <i>Piping work:</i> none 4) <i>Mechanical work:</i> none 5) <i>Electrical work:</i> none 6) <i>Miscellaneous:</i> none			
Estimated cost: None		Construction schedule: 	
		Priority: -

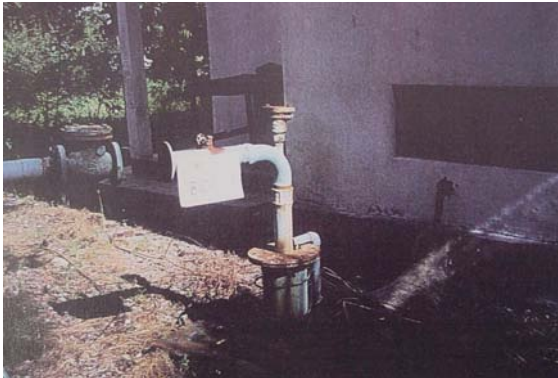
(Date: May 2000)	
Evaluation: Abandoned with the pump installation removed			
Rehabilitation Plan: 1) <i>Basic Calculation</i> Rehabilitation of this well was planned to be carried out in the 2000JICA project. Because of the problem related to land acquisition, the rehabilitation was canceled. Instead, new deep well was constructed close to the existing. It is expected to start operation on January 2001. 2) <i>Civil Work:</i> none 3) <i>Piping work:</i> none 4) <i>Mechanical work:</i> none 5) <i>Electrical work:</i> none 6) <i>Miscellaneous:</i> none			
Estimated cost: None		Construction schedule:	Priority: -

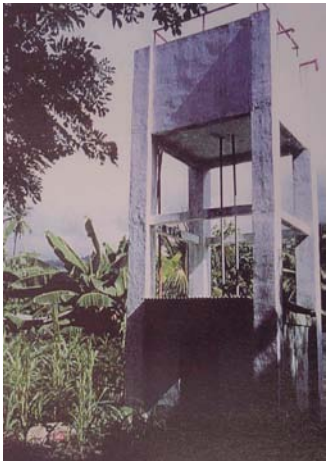
(Date: May 2000)	
Evaluation: Used exclusively for the Dili General Hospital			
Rehabilitation Plan: 1) <i>Basic Calculation</i> Rehabilitation is not required. 2) <i>Civil Work:</i> none 3) <i>Piping work:</i> none 4) <i>Mechanical work:</i> none 5) <i>Electrical work:</i> none 6) <i>Miscellaneous:</i> none			
Estimated cost: None		Construction schedule:	Priority: -

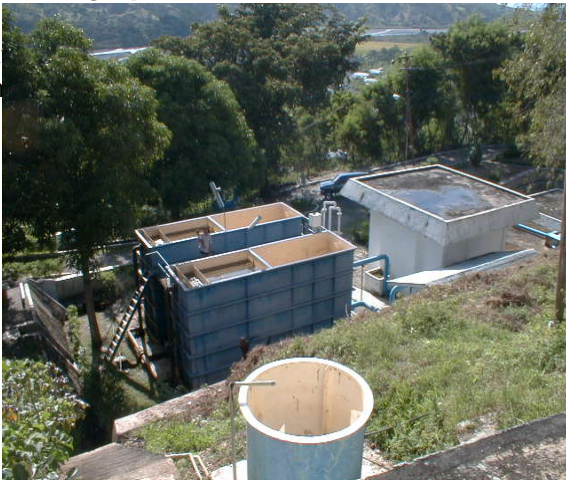
<p>(Date: May 2000)</p>	
Evaluation:			
The existing facilities are overloaded and operated at the rate, 50L/sec, resulting in poor quality of water production. Backwash pumps and chemical pumps are not working. Chemicals are fed manually at present.			
Rehabilitation Plan:

1) Basic Consideration			
Most of the problems encountered are arising from poor operation practice. Flow control should be practiced to operate at the design rate.

2) Civil Work:			
3) Piping work:			
Replacement of flow meters: 200mm - one set on the inlet, as the existing meters have decreased accuracy.			
4) Mechanical work:			
Installation of backwash pumps: 4.8m ³ /min x 8m head x 11kw - 2 sets Blower for backwash: 0.6m ³ /min x 0.55fkg/cm ² x 8.5kw - one set as standby

5) Electrical work:			
For backwash pump operation,			
Watt-hour Meter Box x1		Fuel Tank x1	
Main Power Switch Panel x1		Pump, Compressor Control Board x1	
Generator Set x1		Pump, Compressor Local Control Board x1

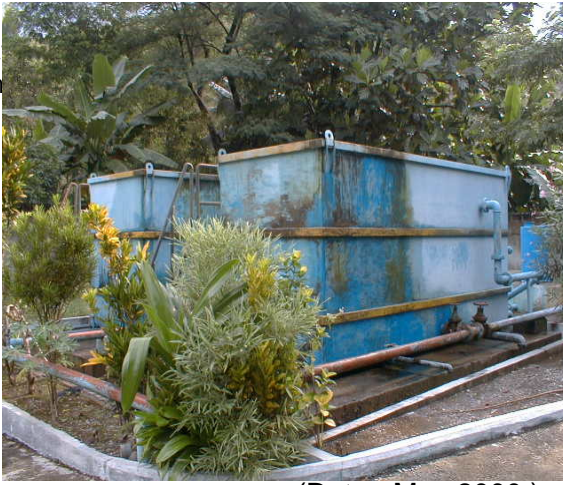
(Date: May 2000)			
Evaluation: Although working, mechanical equipment was removed during the post referendum violence. Chemicals are not being dosed on continuous basis.			
Rehabilitation Plan: 1) <i>Basic Calculation</i> As chemical facilities were completely demolished during the last violence, focus should be laid on rehabilitation of mechanical and electrical equipment for chemical dosage. 2) <i>Civil Work:</i> Protection of WTP from possible landslide due to flood at the Benamauk river Gabion and rivetment at the left bank of the river (60m length) 3) <i>Piping work:</i> none 4) <i>Mechanical work:</i> Chemical mixing tank with 0.5m ³ storage. All existing tanks, 4 in number, to be reconstructed. Feeder pumps: 6L/hr x 150w - 6 sets Motorized mixers: 0.5m ³ x0.75kw x 4 sets 5) <i>Electrical work:</i> Generator Set x2 Fuel Tank x2 Pump, Mixer Control Board x1 6) <i>Miscellaneous:</i> none

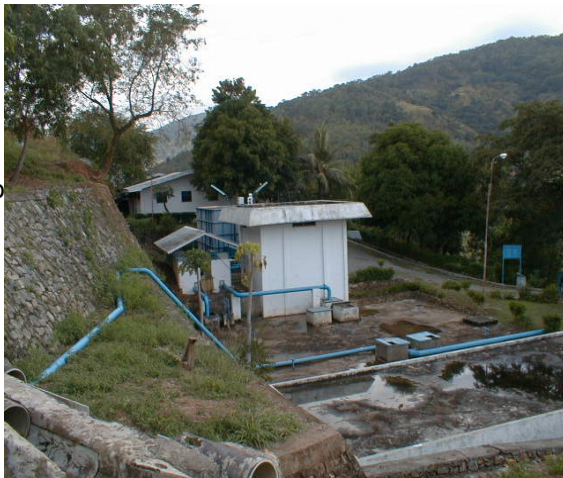
(Date: May 2000)	
Evaluation: Turbid water coming from Bemos II is mixed with clean treated water.			
Rehabilitation Plan: 1) <i>Basic Calculation:</i> Minor repair is required at the malfunctioning flow meters. 2) <i>Civil Work:</i> none 3) <i>Piping work</i> Replacement of flow meters: 150mm - two sets, referential type on the outlets 4) <i>Mechanical work:</i> none 5) <i>Electrical work:</i> none 6) <i>Miscellaneous:</i> none			
Estimated cost: US\$8,936		Construction schedule:	Priority: A-2

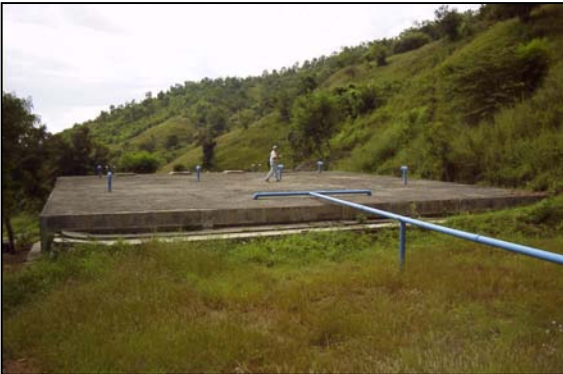
(Date: May 2000)	
Evaluation: No supply from Comoro B since water is used by UNTAET. Thick layer of deposits in the tank due to absence of maintenance since commissioned.			
Rehabilitation Plan: 1) <i>Basic Calculation</i> As the storage capacity in the supply zone exceeds the requirement, no rehabilitation is proposed. 2) <i>Civil Work:</i> none 3) <i>Piping work:</i> none 4) <i>Mechanical work:</i> none 5) <i>Electrical work:</i> none 6) <i>Miscellaneous:</i> none			
Estimated cost: None		Construction schedule:	Priority: -

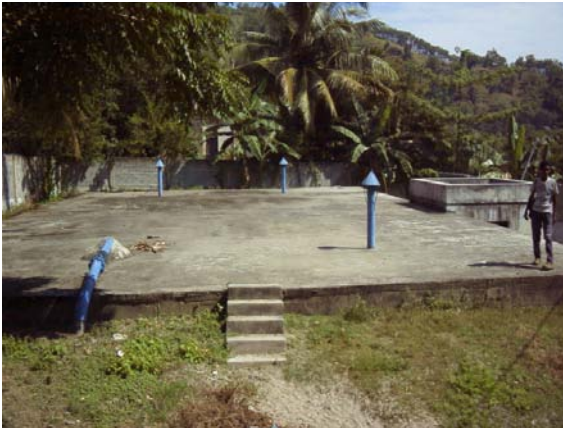
(Date: June 2000)	
Evaluation: Never cleaned since 1995. Washout (2 x 2") not adequately designed as compared to inlet 2 x 6"			
Rehabilitation Plan: 1) <i>Basic Consideration:</i> Major problem is related to low skill of operational staff assigned. On-the job training is required. 2) <i>Civil Work:</i> none 3) <i>Piping work</i> Replacement of washouts by sufficient size of GSP (6 inch x 5m - 2 lines) 4) <i>Mechanical work:</i> none 5) <i>Electrical work:</i> none 6) <i>Miscellaneous:</i> none			
Estimated cost: US\$744		Construction schedule: 	
		Priority: A-2

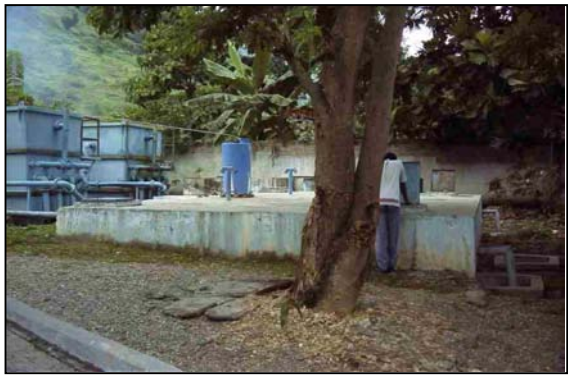
(Date: May 2000)	
Evaluation: Maintenance carried out monthly. One chlorinator is not used regularly.			
Rehabilitation Plan: 1) <i>Basic Calculation</i> Repair and rehabilitation of WTP was recently carried out but minor rehabilitation of the reservoirs will be further required. 2) <i>Civil Work:</i> none 3) <i>Piping work</i> Replacement of malfunctioning flow meters: referential type, 100mm in diameter x 2 sets to be installed on the outlets 4) <i>Mechanical work:</i> none 5) <i>Electrical work:</i> none 6) <i>Miscellaneous:</i> none			
Estimated cost: US\$4,642		Construction schedule:
