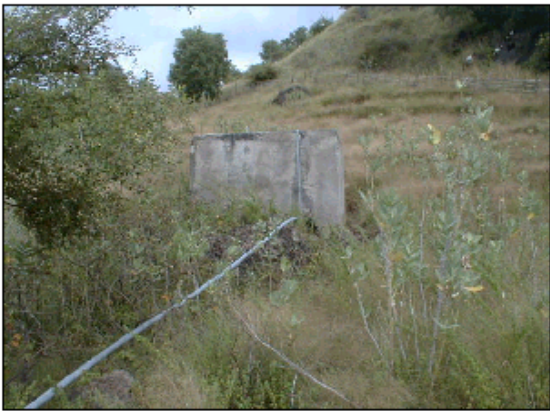
(Date: May 2000)	
<b>Evaluation:</b> In good working condition but the facility is not secured.			
<b>Rehabilitation Plan:</b> 1) <i>Basic Consideration:</i> The reservoir must be well-secured to minimize water contamination.  2) <i>Civil Work:</i> Construction of security fence around the reservoir site.  3) <i>Piping work:</i> Installation of flow meter 50mm  4) <i>Mechanical work:</i> none  5) <i>Electrical work:</i> none  6) <i>Miscellaneous:</i> none

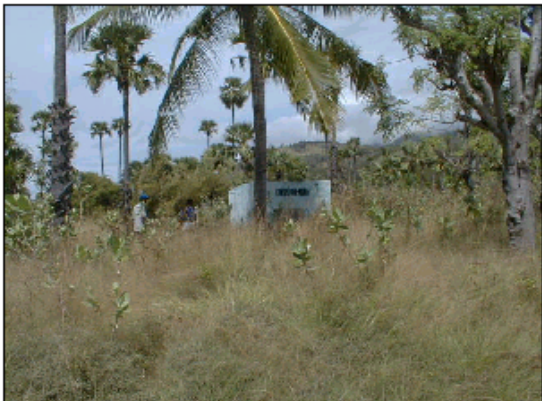
(Date: May 2000 )	
<b>Evaluation:</b> Not in operation because no supply from sources. The reservoir site is not protected.			
<b>Rehabilitation Plan:</b> 1) <i>Basic Consideration:</i> The reservoir site must be securely fenced to minimize the risk of contamination  2) <i>Civil Work:</i> Construction of security fence Installation of flow control and measuring devices  3) <i>Piping work:</i> none  4) <i>Mechanical work:</i> none  5) <i>Electrical work:</i> none  6) <i>Miscellaneous:</i> Installation of chlorine-dosing facilities

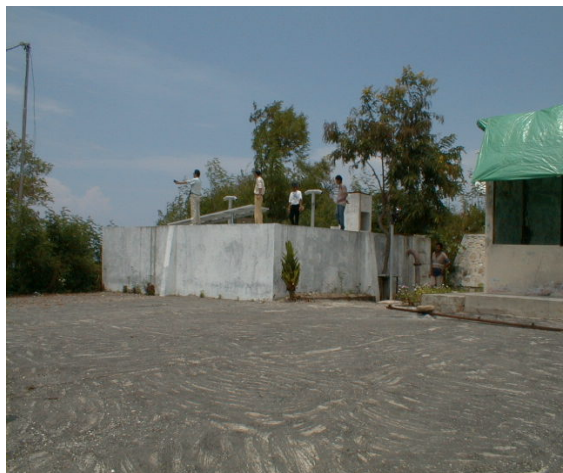
(Date: )	
<b>Evaluation:</b> Not in operation due to the damages on the transmission main			
<b>Rehabilitation Plan:</b> 1) <i>Basic Consideration</i> The expected increase in water demand will make this reservoir insufficient to store water An additional reservoir will be necessary  2) <i>Civil Work:</i> Repair of the staff house  3) <i>Piping work:</i> none  4) <i>Mechanical work:</i> none  5) <i>Electrical work:</i> none  6) <i>Miscellaneous:</i> none

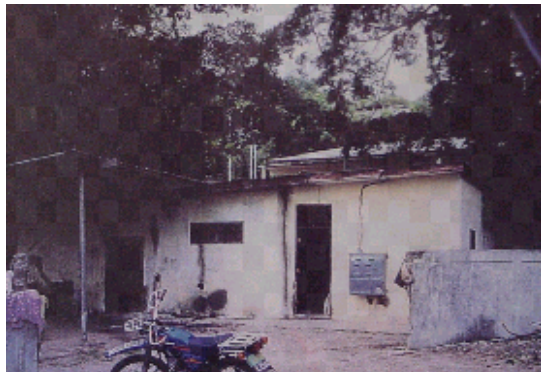
<div>(Date: October 2000)</div>	
<b>Evaluation:</b> The existing pumping facilities and generator sets appeared to had lapsed their economic life. One of the generator sets is not operational. Refurbishment of the pumping facilities is currently on-going.			
<b>Rehabilitation Plan:</b> 1) <i>Basic Consideration</i> Replacement of the existing pumping facilities and generator sets is the most viable alternative.  2) <i>Civil Work:</i> Improvement of the intake facilities including the construction of the collection chamber and intake pipe.  3) <i>Piping work:</i> none  4) <i>Mechanical work:</i> Installation of centrifugal pumps: 0.34m3/min x 84m - 15kw x 2 sets (1 duty & 1 standby) Installation of centrifugal pumps: 0.75m3/min x 100m -18.5kw x 2 sets (1 duty & 1 standby)  5) <i>Electrical work:</i> Watt-hour Meter Box x 1set                      Fuel Tank 340L x 1set Main Power Switch Panel x 1set              Pump Control Board x 1set Generator Set 75kVA x 1set  6) <i>Miscellaneous:</i> Chlorine dosage equipment: a mixing tank with mixer, dosing pumps Provision of radio transceiver sets for operation

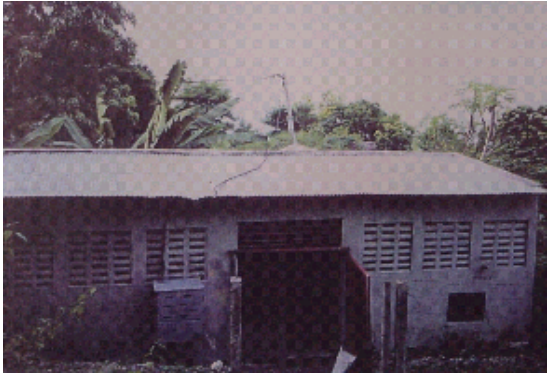
<div>(Date: October 2000)</div>	
<b>Evaluation:</b> Minor rehabilitation work is required on the intake structure. It is economically viable to replace the pumping and electrical facilities. The pumping station is newly refurbished.			
<b>Rehabilitation Plan:</b> 1) <i>Basic Consideration</i> Replacement of the existing pumping facilities and generator set is the most viable alternative.  2) <i>Civil Work:</i> Construction of the security fence.  3) <i>Piping work:</i> none  4) <i>Mechanical work:</i> Repair of leak on the delivery main Installation of centrifugal pumps: 0.75m3/min x 100m - 18.5kw x 2 sets  5) <i>Electrical work:</i> Watt-hour Meter Box x 1set Main Power Switch Panel x 1set Generator Set 75kVA x 1set Fuel Tank 340L x 1set Pump Control Board x 1set  6) <i>Miscellaneous:</i> none

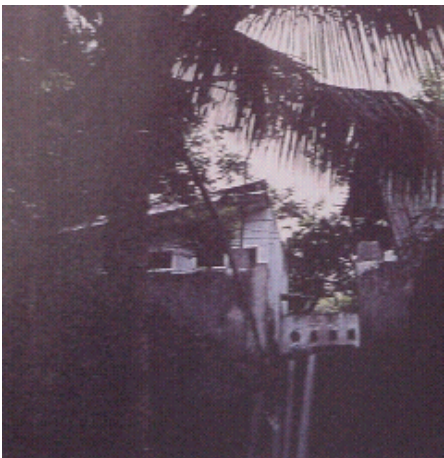
<b>Evaluation:</b> The pumping facilities were removed and the generator set heavily damaged Water pumps into the reservoir is distributed by gravity			
<b>Rehabilitation Plan:</b> 1) <i>Basic Consideration:</i> The pumping facilities and generator set need to be replaced with new ones.  2) <i>Civil Work:</i> Refurbishment of the pumping station to include doors, appropriate lighting, ventilation and security fence. Installation of water level gauge  3) <i>Piping work:</i> Installation of flow meter and control valves including appropriate pipe works.  4) <i>Mechanical work:</i> Installation of submersible pumps: 0.34m3/min x 80m - 2 sets  5) <i>Electrical work:</i> Main Power Switch Panel x 1set      Fuel Tank x 1set Generator Set x 1set      Pump Control Board x 1set  6) <i>Miscellaneous:</i> none

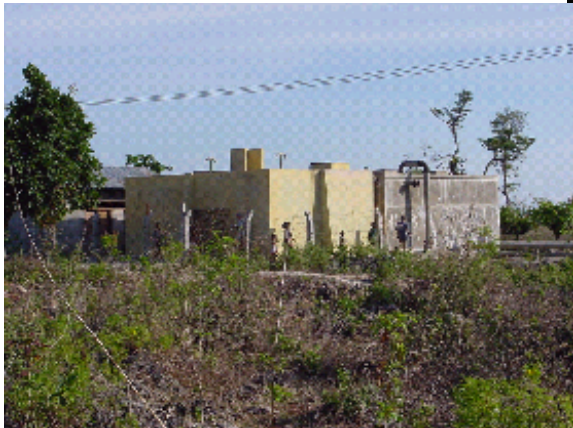
(Date: )	
<b>Evaluation:</b> In working condition Lacks routine maintenance Needs flow meter and control valves			
<b>Rehabilitation Plan:</b> 1) <i>Basic Consideration</i> Chlorination is necessary prior to distribution of water.  2) <i>Civil Work:</i> none  3) <i>Piping work:</i> Installation of flow meter and control valves dia. 6-inch  4) <i>Mechanical work:</i> none  5) <i>Electrical work:</i> none  6) <i>Miscellaneous:</i> Installation of chlorine-dosing facilities x 2 sets

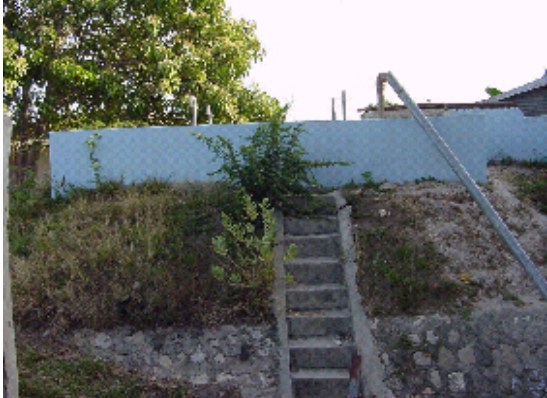
<b>Evaluation:</b> No supply of water from source Transmission main installation from Lamegua not completed			
<b>Rehabilitation Plan:</b> 1) <i>Basic Consideration:</i> To activate this reservoir requires the completion of the transmission main from Lamegua.  2) <i>Civil Work:</i> Installation of security fence  3) <i>Piping work:</i> Installation of flow meter and control valves at outlet Installation of 75mm x 1.0 km transmission main including gate valves, blow-off and air-release valves 4) <i>Mechanical work:</i> none  5) <i>Electrical work:</i> none  6) <i>Miscellaneous:</i> none

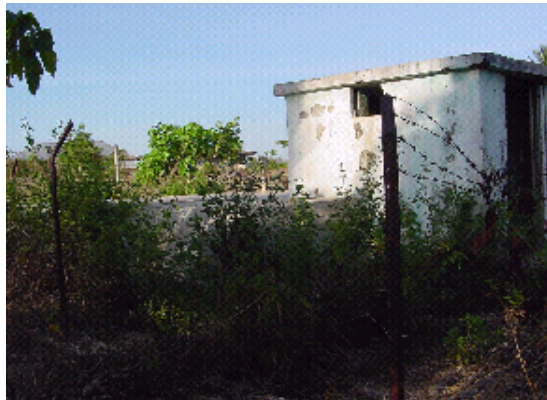
(Date: )	
<b>Evaluation:</b> Not in operation due to limited supply from source and damage of the transmission lines.			
<b>Rehabilitation Plan:</b> 1) <i>Basic Consideration:</i> To activate this reservoir requires repair of the transmission lines. The reservoir must be securely fenced.  2) <i>Civil Work:</i> Installation of security fence Installation of water level gauge  3) <i>Piping work:</i> Flow meter and controller installation  4) <i>Mechanical work:</i> none  5) <i>Electrical work:</i> none  6) <i>Miscellaneous:</i> none

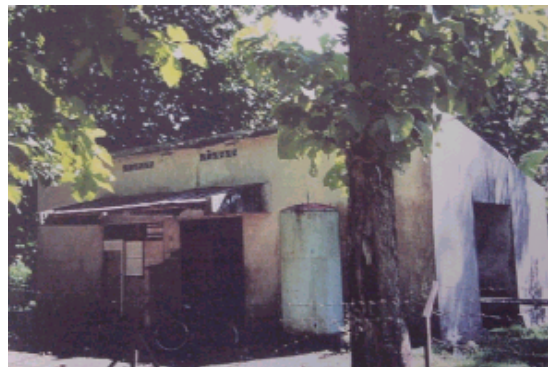
<div>(Date: May 2000)</div>	
<b>Evaluation:</b> The pumps and generator although operational had lapsed their economic life.			
<b>Rehabilitation Plan:</b> 1) <i>Basic Consideration:</i> This pumping station will serve as stand-by once the WTP and elevated water reservoir becomes operational It is economically viable to replace the existing facilities with new one.  2) <i>Civil Work:</i> none  3) <i>Piping work:</i> Installation of flow meter and control valve  4) <i>Mechanical work:</i> Pump replacement with the following specifications: Type: Centrifugal Capacity: 1.0m <sup>3</sup> /min x H40m x 16kw - 2 sets  5) <i>Electrical work:</i> Watt-hour Meter Box x1set Main Power Switch Panel x1set Generator Set 62.5kVA x1set Fuel Tank 280L x1set Pump Control Board x1set  6) <i>Miscellaneous:</i> none

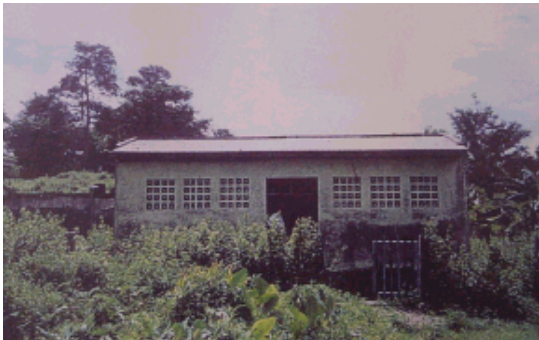
<div style="text-align: right;">(Date: Oct 2000)</div>	
<b>Evaluation:</b> This pumping station is heavily damaged. The pump motors and generator set were removed and only traces are left for other equipment. It requires total replacement of the mechanical and electrical facilities and refurbishment of the pump house.

<b>Rehabilitation Plan:</b> 1) <i>Basic Consideration:</i> It is technically and economically viable to install new pumping facilities and generator set. The pump house needs to be refurbished.  2) <i>Civil Work/Architectural:</i> Refurbishment of the pump house. Construction of the security fence  3) <i>Piping work:</i> Installation of water meter and control valves including the necessary pipeline  4) <i>Mechanical work:</i> Installation of the following pumping facilities: Raw water: 1.4 m <sup>3</sup> /min x H 4.0 m x 20 kW - 2 sets Treated water: 2.1 m <sup>3</sup> /min x H 48 m x 30 kW - 2 sets  5) <i>Electrical work:</i> Watt-hour Meter Box x1set                      Fuel Tank 650L x1set Main Power Switch Panel x1set                Pump Control Board x1set Generator Set 150kVA x1set 6) <i>Miscellaneous:</i> none			
<b>Estimated cost:</b> US\$158,049		<b>Construction schedule:</b>	
		<b>Priority:</b> A-1

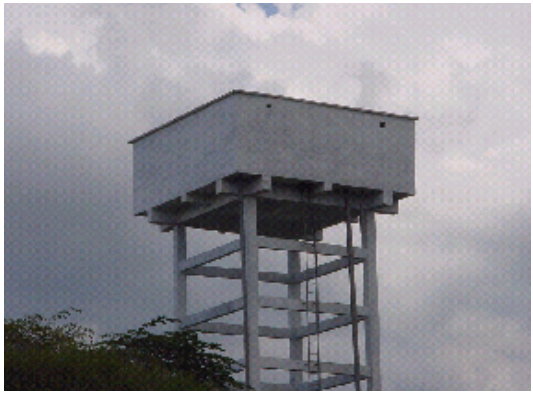
(Date: Oct 2000)	
<b>Evaluation:</b> The tank is structurally safe and could be activated once the WTP and Pumping Station No. 2 becomes operational Routine maintenance should be carried out prior to activation			
<b>Rehabilitation Plan:</b> 1) <i>Basic Consideration:</i>  2) <i>Civil Work:</i> none Installation of water level gauge  3) <i>Piping work:</i> Flow meter and controller installation  4) <i>Mechanical work:</i> none  5) <i>Electrical work:</i> none  6) <i>Miscellaneous:</i> none

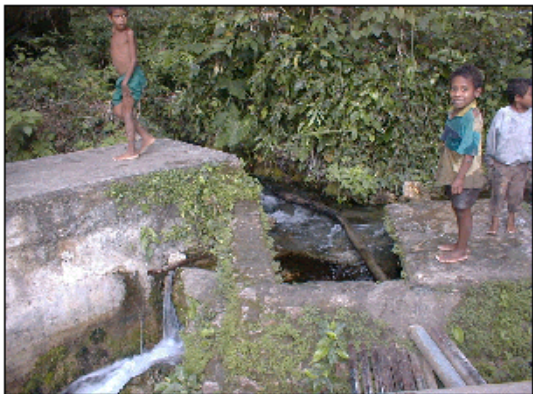
(Date: April 2000)	
<b>Evaluation:</b> Lacks routine maintenance The risk of possible water contamination is high			
<b>Rehabilitation Plan:</b> 1) <i>Basic Consideration:</i> Routine maintenance on this facility must be enhanced to maintain the water quality The entire intake area must be well protected by the construction of security fence to restrict human and animal entry.  2) <i>Civil Work:</i> Construction of security fence          3) <i>Piping work:</i> Installation of flow meters and controllers 150mm          4) <i>Mechanical work:</i> none          5) <i>Electrical work:</i> none          6) <i>Miscellaneous:</i> none
