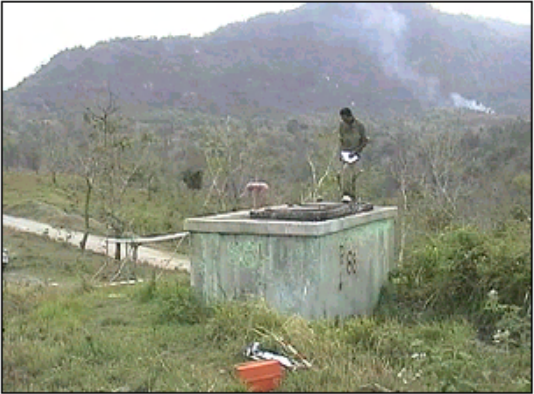
Town Viqueque	No. & Facility: 03 - Break Pressure Tank No.1	Year of Construction	Financed by:
<p>Existing Condition: <i>Structure:</i> Concrete <i>Shape:</i> Rectangular <i>Dimension:</i> L 3m x W 2.5m x H 2m (approximately) <i>Volume:</i> 15 m³ <i>Function:</i> Pressure stabilization <i>Source of Water:</i> Loihunu spring <i>Ground level (amsl):</i> <i>Accessories:</i> Ventilation Manhole Outlet valve</p>		<p>Photograph:</p>

<p>(Date: October 2000)</p>	
<p>Evaluation: In operation Requires adequate protection</p>			
<p>Rehabilitation Plan:</p> <ol style="list-style-type: none"> 1) <i>Basic Calculation</i> 2) <i>Civil Work:</i> Construction of security fence 3) <i>Piping work:</i> none 4) <i>Mechanical work:</i> none 5) <i>Electrical work:</i> none 6) <i>Miscellaneous:</i> none 			
<p>Estimated cost: US\$1,800</p>		<p>Construction schedule:</p>	<p>Priority: B-2</p>

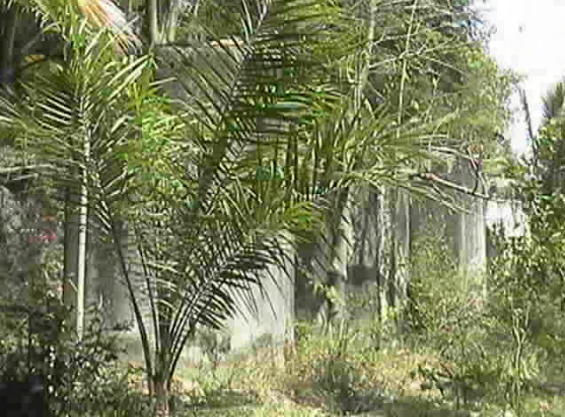
Town Viqueque	No. & Facility: 04 - Existing Reservoir	Year of Construction	Financed by:
<p>Existing Condition: <i>Facility:</i> Service reservoir <i>Structure:</i> Concrete <i>Shape:</i> Rectangular, 4 basins <i>Dimension:</i> <i>Capacity:</i> <i>Function:</i> Storage <i>Source of Water:</i> Loihunu spring (Builua) <i>Ground level (amsl):</i> <i>Accessories:</i></p>		<p>Photograph:</p>

<p style="text-align: right;">(Date:)</p>	
<p>Evaluation: Not in operation due to damaged pipes</p>			
<p>Rehabilitation Plan:</p> <p>1) <i>Basic Consideration:</i> To activate this reservoir requires repair and rehabilitation including the pipelines Requires appropriate security fence to maintain water quality and minimize the risk of contamination Chlorination of the water supply is necessary</p> <p>2) <i>Civil Work:</i> Construction of security fence Installation of water level gauge Repair of the concrete wall</p> <p>3) <i>Piping work:</i> Repair of 75mm x 500 m Installation of flow meter and control valves</p> <p>4) <i>Mechanical work:</i> none</p> <p>5) <i>Electrical work:</i> none</p> <p>6) <i>Miscellaneous:</i> Installation of chlorine dosing device</p>

<p>Estimated cost: US\$18,251</p>		<p>Construction schedule:</p> <p style="text-align: right;">Priority: B-2</p>

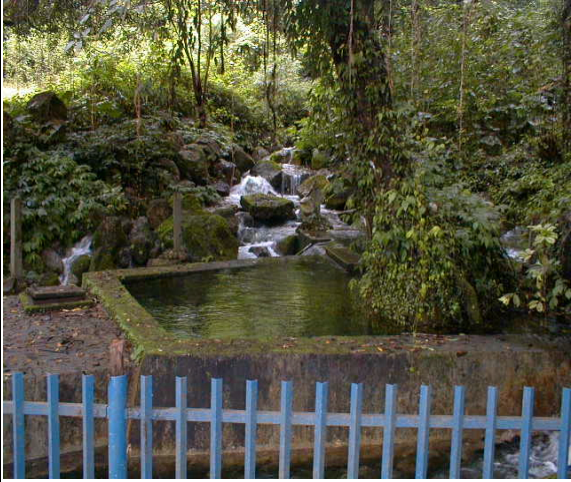
Town Same	No. & Facility: 01 - Darelau Intake	Year of Construction	Financed by:
Existing Condition: <i>Facility:</i> Intake weir, collecting chamber (concrete) <i>Dimension:</i> <i>Observed flow rate:</i> 20L/sec - 30 L/sec <i>Function:</i> Raw water intake <i>Source of Water:</i> Darelau spring <i>Ground level (amsl):</i> <i>Accessories:</i> Intake pipes: GSP 3-inch		Photograph:

(Date: April 2000)			
Evaluation: In operation Lacks routine maintenance Not securely protected nor covered			
Rehabilitation Plan: 1) <i>Basic Calculation</i> 2) <i>Civil Work:</i> Installation of appropriate cover 3) <i>Piping work:</i> Installation of flow meter and control valve 4) <i>Mechanical work:</i> none 5) <i>Electrical work:</i> none 6) <i>Miscellaneous:</i> none			
Estimated cost: US\$2,834		Construction schedule:	
		Priority: B-2

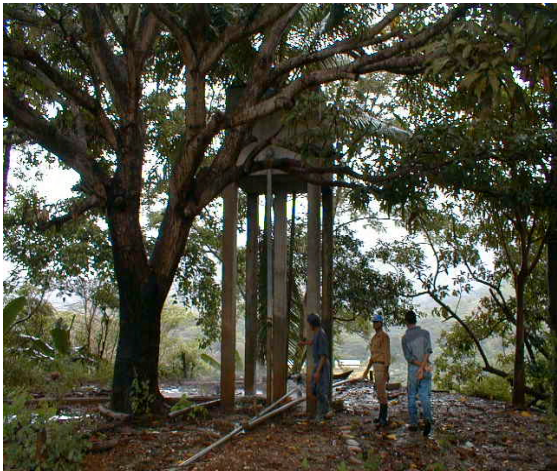
Town Same	No. & Facility: 03 - Posto Reservoir	Year of Construction	Financed by:
<p>Existing Condition: <i>Facility:</i> Elevated service reservoir <i>Structure:</i> Reinforced concrete <i>Shape:</i> Rectangular <i>Dimension:</i> 5m x 5m x 2.0m (approximately) <i>Capacity:</i> 50 m³ <i>Function:</i> Storage <i>Source of Water:</i> Kotalala Spring <i>Ground level (amsl):</i> <i>Accessories:</i> Inlet: GSP 3-inch</p>		<p>Photograph:</p>

<p>(Date:)</p>	
<p>Evaluation: Not in use due to damage caused by the violence</p>			
<p>Rehabilitation Plan:</p> <p>1) <i>Basic Calculation</i> Required storage capacity: $1554\text{m}^3 \times 15\% \times 8\text{hrs}/24\text{hrs} = 50\text{ m}^3$ Storage capacity of existing = 50 m^3 No need to expand.</p> <p>2) <i>Civil Work:</i> Installation of security fence</p> <p>3) <i>Piping work:</i> Installation of pipes 75mm x 50m, flow meter, controller and air release valve</p> <p>4) <i>Mechanical work:</i> none</p> <p>5) <i>Electrical work:</i> none</p> <p>6) <i>Miscellaneous:</i> Installation of chlorine dosage devices (pipe injection type)</p>

<p>Estimated cost: US\$8,102</p>		<p>Construction schedule:</p>	<p>Priority: B-1</p>

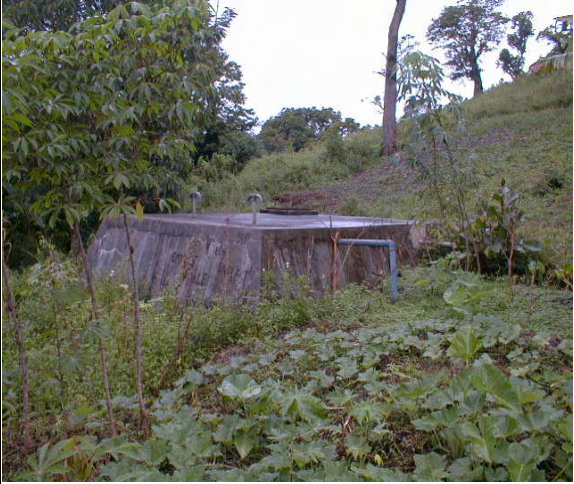
Town Same	No. & Facility: 04 - Hularua Reservoir	Year of Construction	Financed by:
<p>Existing Condition: <i>Facility:</i> Service reservoir <i>Structure:</i> Reinforced concrete <i>Shape:</i> Rectangular <i>Dimension:</i> 5.0m x 5.0m x 1.2m <i>Capacity:</i> 30m³ <i>Function:</i> Storage <i>Source of Water:</i> Darelau Spring <i>Ground level (amsl):</i> <i>Accessories:</i></p>		<p>Photograph:</p>

<p>(Date:)</p>	
<p>Evaluation: In good working condition</p>			
<p>Rehabilitation Plan:</p> <p>1) <i>Basic Calculation</i> Required storage capacity: $1554\text{m}^3 \times 25\% \times 8\text{hrs}/24\text{hrs} = 190\text{m}^3 > 30\text{m}^3$ It needs expansion of the reservoir.</p> <p>2) <i>Civil Work:</i> Construction of new storage reservoir with volume = 160 m³ including appurtenances Construction of fence and staff house.</p> <p>3) <i>Piping work:</i> Realignment of inlets and outlets including the installation of flow meter and controller</p> <p>4) <i>Mechanical work:</i> none</p> <p>5) <i>Electrical work:</i> none</p> <p>6) <i>Miscellaneous:</i> none</p>

<p>Estimated cost: US\$26,171</p>		<p>Construction schedule:</p> <p>Priority: B-2</p>

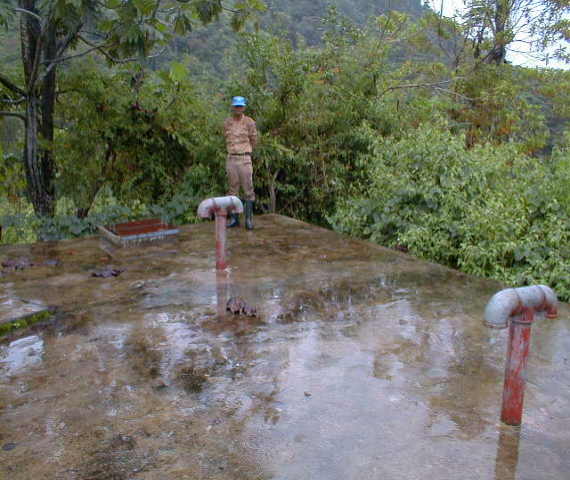
Town Same	No. & Facility: 05 - Merbati Reservoir	Year of Construction	Financed by:
<p>Existing Condition: <i>Facility:</i> Service reservoir <i>Structure:</i> Reinforced Concrete <i>Shape:</i> Rectangular <i>Dimension:</i> 8.4m x 5.7m x 3.4m <i>Capacity:</i> 150 m³ <i>Function:</i> Storage <i>Source of Water:</i> Merbati Spring <i>Ground level (amsl):</i> <i>Accessories:</i></p>		<p>Photograph:</p>

<p>(Date:)</p>	
<p>Evaluation: In good working condition</p>			
<p>Rehabilitation Plan:</p> <p>1) <i>Basic Calculation</i> Required storage: $1554 \text{ m}^3 \times 45\% \times 8\text{hrs}/24\text{hrs} = 230 \text{ m}^3 > 150 \text{ m}^3$ It needs expansion. It is assumed that 45% of the total service area is served by this reservoir.</p> <p>2) <i>Civil Work:</i> Construction of the service reservoir with volume = 80 m³ dimension: 5m x 5m x 3.4m Construction of fence and staff house</p> <p>3) <i>Piping work:</i> Installation of pipe connections including overflow, ventilation and drain.</p> <p>4) <i>Mechanical work:</i> none</p> <p>5) <i>Electrical work:</i> none</p> <p>6) <i>Miscellaneous:</i> Installation of chlorination devices</p>

<p>Estimated cost: US\$27,300</p>		<p>Construction schedule:</p>	<p>Priority: B-2</p>

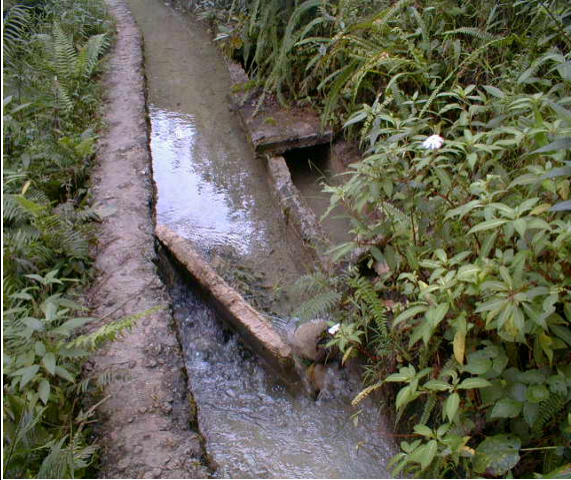
Town Ainaro	No. & Facility 01 - Raw Water Transmission Channel	Year of Construction	Financed by:
Existing Condition: Facility: Raw water concrete channel Technical Description: Concrete-made conduit consisting of 2 channels x 80 m, one closed conduit is for water supply and the open channel (25 cm wdt. x 25 cm ht.) for irrigation. Function: to transmit raw water to the WTP		Photograph:

(Date: _____)	
Evaluation: In operation but several of the spans have broken concrete covers.			
Rehabilitation Plan: 1) <i>Basic Consideration:</i> After rainfall, surface runoff normally enters into the channel through the broken covers resulting to the degradation of water quality. 2) <i>Civil Work:</i> Installation of new concrete covers at approximately 50 m span (or 50 pcs.) with the following specifications: Width = 35.0 cm Length = 1.0 m Thickness = 5.0 cm 3) <i>Piping work:</i> none 4) <i>Mechanical work:</i> none 5) <i>Electrical work:</i> none 6) <i>Miscellaneous:</i> none

Estimated cost: US\$236		Construction schedule:	Priority: A-2

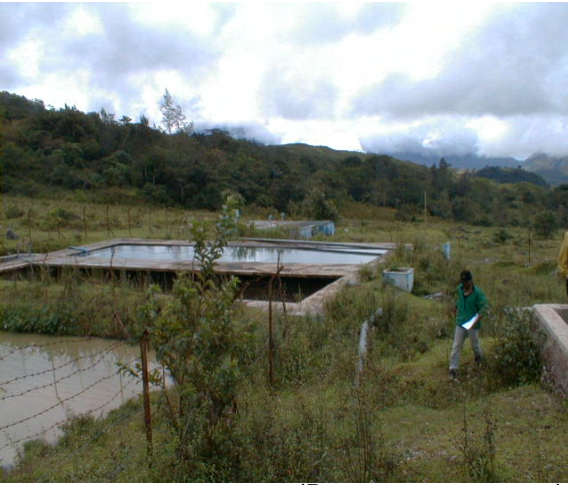
Town Ainaro	No. & Facility: 02 - Nugupo WTP	Year of Construction	Financed by:
<p>Existing Condition: <i>Function:</i> Treatment of raw water <i>Ground level (amsl):</i> <i>Production Capacity:</i> 15L/sec <i>Process:</i> grit chamber - 13 m x 3 m x 2.4 m slow sand filter x 2 basins - 7 m x 22 m <i>Design filtration rate:</i> 4.2m/day <i>Source of Water:</i> Spring water through the channel <i>Ground level:</i> <i>Accessories:</i> Storage reservoir: made of reinforced concrete, rectangular shaped (W 7m x L 10m x H 3.1m) with a storage capacity 100m³, equipped with chlorine dosage devices</p>		<p>Photograph:</p>

<p style="text-align: right;">(Date:)</p>	
<p>Evaluation: The WTP is not operational due to lack of routine maintenance. Thick layer of silt and clay had accumulated in the filter media causing operational problems such as blockages. The grit chamber is not properly designed and constructed. Water level remains always low due to the absence of flow control.</p>

<p>Rehabilitation Plan:</p> <p>1) <i>Basic Consideration:</i> Rehabilitation of the grit chamber including the installation of flow control devices to avoid the entry of floating matters into the SSF. Routine maintenance of the WTP by regular washing of the filter media.</p> <p>2) <i>Civil Work:</i> Rehabilitation of the grit chamber to include the following: Construction of overflow weir at the grit chamber. Specification of weir: width = 30 cm, height = 30 cm Construction of concrete apron for washing sand (10m x 20m x 20cm thickness)</p> <p>3) <i>Piping work:</i> Installation of flow control valves such as 150mm butterfly valves</p> <p>4) <i>Mechanical work:</i> none</p> <p>5) <i>Electrical work:</i> none</p> <p>6) <i>Miscellaneous:</i> none</p>			
<p>Estimated cost: US\$7,814</p>		<p>Construction schedule:</p>	<p>Priority: A-1</p>

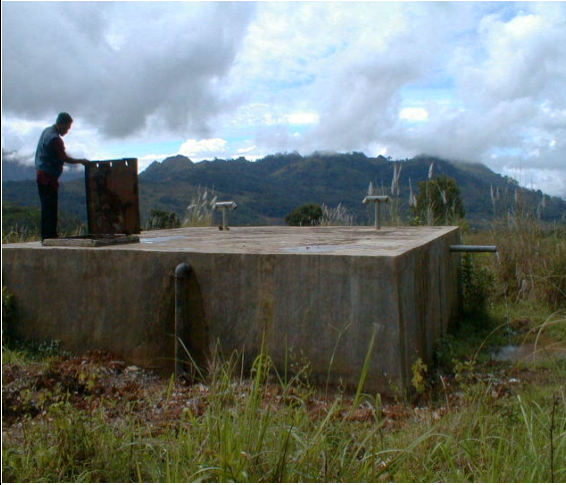
Town Ainaro	No. & Facility: 03 - Kamilaran 1 Reservoir	Year of Construction	Financed by:
<p>Existing Condition: <i>Facility:</i> Service reservoir <i>Structure:</i> Reinforced concrete <i>Shape:</i> Rectangular <i>Dimension:</i> 5.5 m x 5.5 m x 2 m <i>Capacity:</i> 50 m³ <i>Function:</i> Storage <i>Source of Water:</i> Untreated water from Irrigation Canal <i>Ground level:</i> <i>Accessories:</i></p>		<p>Photograph:</p>

<p>(Date:)</p>	
<p>Evaluation: In operation but lacks routine maintenance. Sand is deposited in the tank. Raw water stored in this reservoir is supplied to the consumers without treatment</p>			
<p>Rehabilitation Plan:</p> <p>1) <i>Basic Consideration:</i> Transmission main that connects this reservoir should be realigned to the WTP so that the raw water will be treated prior to distribution. Regular routine maintenance should be Storage required: water demand 1025m³/day x 8/24 = 342m³ Existing reservoir: 200m³, therefore, 342 - 200 = 142m³ storage required.</p> <p>2) <i>Civil Work:</i> Construction of new service reservoir (8m x 8m x 2.5m) with necessary appurtenances beside the existing Construction of security fence</p> <p>3) <i>Piping work:</i> Pipe realignment of 150mm x 20m including installation of flow meter and control</p> <p>4) <i>Mechanical work:</i> none</p> <p>5) <i>Electrical work:</i> none</p> <p>6) <i>Miscellaneous:</i> none</p>

<p>Estimated cost: US\$21,842</p>		<p>Construction schedule:</p>	<p>Priority: A-2</p>

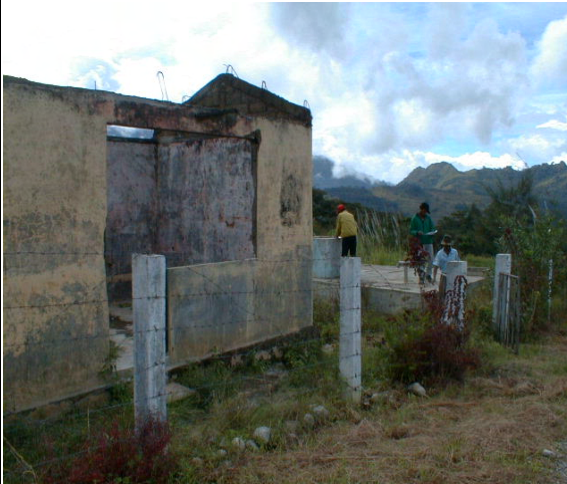
Town Ainaro	No. & Facility: 04 - Kamilaran 2 Reservoir	Year of Construction	Financed by:
Existing Condition: Facility: Service reservoir Structure: Reinforced concrete Shape: Rectangular Dimension: 6.0m x 4.0m x 2.1m Capacity: 50m ³ Function: Storage Source of Water: Nugupo WTP Ground level (amsl): Accessories:		Photograph:

(Date: _____)	
Evaluation: In operation but the staff house was damaged			
Rehabilitation Plan: 1) <i>Basic Consideration:</i> Requires protection such as security fence 2) <i>Civil Work:</i> Repair of staff house including re-installation of the roofing system (Area = approximately 3m x 6m) Construction of security fence. 3) <i>Piping work:</i> Installation of flow control and measuring devices. 4) <i>Mechanical work:</i> none 5) <i>Electrical work:</i> none 6) <i>Miscellaneous:</i> none			
Estimated cost: US\$9,622		Construction schedule:	Priority: A-2

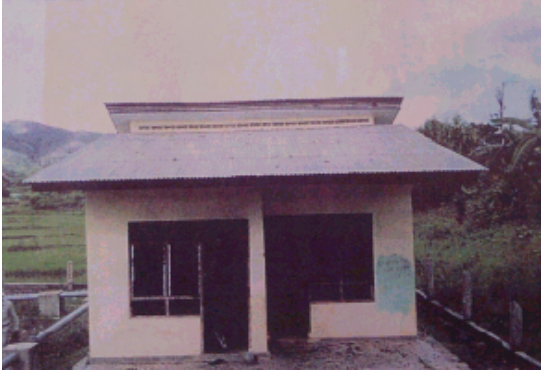
Town Aileu	No. & Facility: 01 - Mantane River Infiltration Gallery	Year of Construction	Financed by:
<p>Existing Condition: <i>Source of Water:</i> Mantane River <i>Function:</i> Draws water and pumps to Gov't. Housing Reservoir <i>Major facilities:</i> water collection pipe & 7 chamber, pump pit & booster pumping station <i>Water collection pipe specification:</i> 2 sets GSP 3-inch x 50 m laid 100 cm below the river bed. <i>Pump type:</i> Centrifugal pump <i>Pump capacity:</i> 2 sets of 1m³/min (or 16 L/sec) x 83 m head x 22 kW (1 duty & 1 standby) <i>Generator:</i> damaged <i>Accessories:</i> Pump panel - heavily damaged <i>Ground level (amsl):</i></p>		<p>Photograph:</p>

<p>(Date:)</p>	
<p>Evaluation: The infiltration gallery is not properly designed and constructed resulting to low quantity and quality of water. The pumping facilities are in good condition, however the generator set and other electrical equipment were heavily damaged during the violence.</p>

<p>Rehabilitation Plan:</p> <p>1) <i>Basic Consideration</i> Reconstruction of the infiltration gallery to an acceptable standard will improve water production from this source.</p> <p>2) <i>Civil Work:</i> Construction of the infiltration gallery with the following specifications: Pump pit: 2.0m dia x height 5.0m - one basin Pumping house: 6.0m x 8.0m with two rooms Construction of the security fence.</p> <p>3) <i>Piping work:</i> Diameter and length: 200mm x 200m Depth: 2.5m below the groundwater level</p> <p>4) <i>Mechanical work:</i> none</p> <p>5) <i>Electrical work:</i> Watt-hour Meter Box x1set Fuel Tank 450L x1set Main Power Switch Panel x1set Pump Control Board x1set Generator Set 100kVA x1set</p> <p>6) <i>Miscellaneous:</i> none</p>			
<p>Estimated cost: US\$82,710</p>		<p>Construction schedule:</p>	<p>Priority: B-1</p>

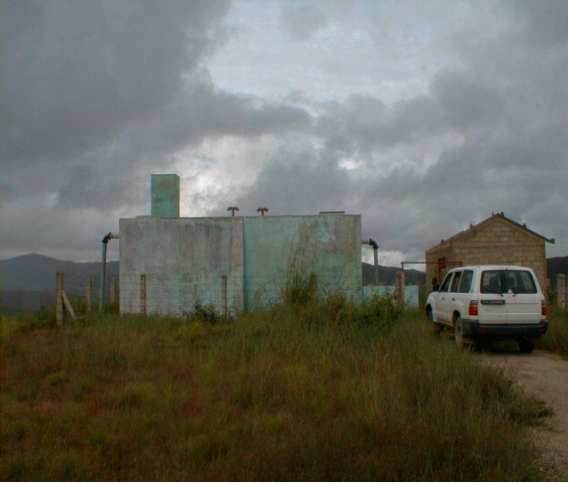
Town Aileu	No. & Facility: 02 - Govt. Housing Reservoir	Year of Construction	Financed by:
<p>Existing Condition: <i>Future:</i> Service reservoir <i>Structure:</i> Reinforced concrete <i>Shape:</i> Rectangular <i>Dimension:</i> 8.0 m x 8.5 m x 3.5 m <i>Capacity:</i> 175m³ <i>Function:</i> Storage <i>Source of Water:</i> Mantane River Infiltration Gallery <i>Ground level (amsl):</i> <i>Accessories:</i> Chlorine dosing equipment</p>		<p>Photograph:</p>

<p>(Date: _____)</p>	
<p>Evaluation: Not in use due to non-operation of the infiltration gallery which is the water source.</p>			
<p>Rehabilitation Plan:</p> <ol style="list-style-type: none"> 1) <i>Basic Calculation</i> 2) <i>Civil Work:</i> Installation of water level gauge. 3) <i>Piping work:</i> Installation of 150mm flow meter and control valve 4) <i>Mechanical work:</i> none 5) <i>Electrical work:</i> none 6) <i>Miscellaneous:</i> none

<p>Estimated cost: US\$6,122</p>		<p>Construction schedule:</p> <p style="text-align: right;">Priority: B-2</p>

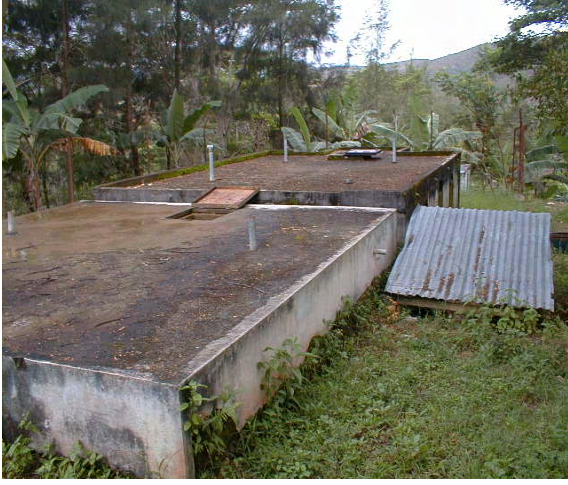
Town Aileu	No. & Facility: 03 - Marele Reservoir 1	Year of Construction	Financed by:
<p>Existing Condition: <i>Facility:</i> Service reservoir <i>Structure:</i> Reinforced Concrete <i>Shape:</i> Rectangular <i>Dimension:</i> <i>Capacity:</i> 50m³ <i>Function:</i> Storage <i>Source of Water:</i> Naufaizaram Spring <i>Ground level:</i> <i>Accessories:</i></p>		<p>Photograph:</p>

<p>(Date:)</p>	
<p>Evaluation: In use</p>			
<p>Rehabilitation Plan:</p> <ol style="list-style-type: none"> 1) <i>Basic Calculation</i> 2) <i>Civil Work:</i> Installation of water level gauge. 3) <i>Piping Work:</i> Installation of 75mm flow meter and control valve 4) <i>Mechanical work:</i> none 5) <i>Electrical work:</i> none 6) <i>Miscellaneous:</i> none 			
<p>Estimated cost: US\$3,451</p>		<p>Construction schedule:</p>	<p>Priority: B-2</p>
