Town Aileu	No. & Facility: 06 - Sloi Kraik Intake	Year of Construction	Financed by:
Existing Condition: <i>Facility:</i> Spring intake <i>Source of Water:</i> Sloi Kraik spring <i>Supplies to:</i> Sloi Kraik reservoir <i>Function:</i> raw water intake <i>Major facilities:</i> Intake weir Raw water transmission main GSP 3-inch <i>Elevation (amsl):</i>		Photograph:

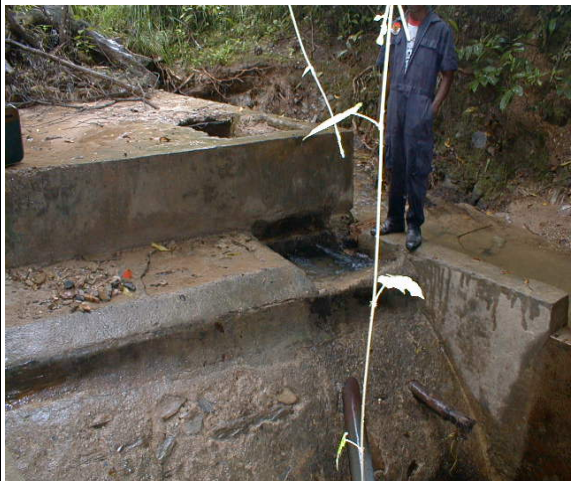
(Date:)	
Evaluation: During dry season the flow substantially drops to almost nil. During rainy season the turbidity is high.			
Rehabilitation Plan: 1) <i>Basic Consideration</i> This source will serve a community based water supply system and will be disconnected by valve from the town's water supply. To improve the water quantity and quality, rehabilitation of the intake facilities such as installation of perforated pipes under a graded filter bed should be carried out. 2) <i>Civil Work:</i> Excavation: 6.0m length x 2.0m width x 2.0m depth upstream of the intake weir. Installation of perforated pipes: perforated pipe 150mm diameter GSP (20 mm dia x 20 holes) Backfilling: gravel (80 cm thick), sand (1.2m thick) 3) <i>Piping work:</i> Installation of water collector with the following specification Diameter and length: 150mm x 6m Depth: 1.8m below the riverbed 4) <i>Mechanical work:</i> none 5) <i>Electrical work:</i> none 6) <i>Miscellaneous:</i> none

Estimated cost: US\$4,917		Construction schedule: 	
		Priority: B-2

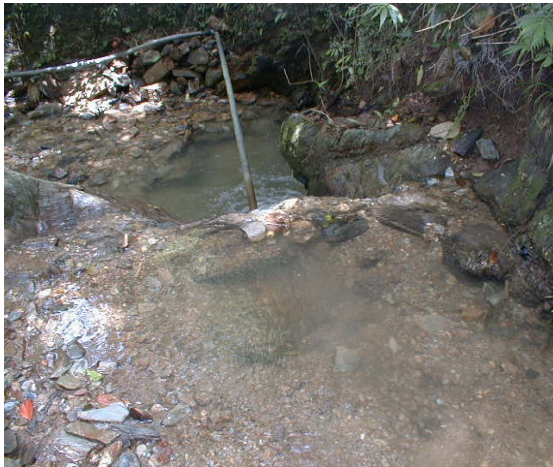
Town Aileu	No. & Facility: 07 - Hularema Intake	Year of Construction	Financed by:
Existing Condition: <i>Facility:</i> Spring intake <i>Source of Water:</i> Hularema spring <i>Supplies to:</i> Hularema reservoir <i>Function:</i> raw water intake <i>Major facilities:</i> Intake weir Raw water transmission main GSP 2-inch <i>Elevation (amsl):</i>		Photograph:

(Date:)	
Evaluation: During dry season the flow substantially drops to almost nil. During rainy season the turbidity is high.			
Rehabilitation Plan: 1) <i>Basic Consideration</i> This source will serve a community based water supply system and will be disconnected by valve from the town's water supply. To improve the water quantity and quality, rehabilitation of the intake facilities such as installation of perforated pipes under a graded filter bed should be carried out. 2) <i>Civil Work:</i> Excavation: 6.0m length x 2.0m width x 2.0m depth upstream of the intake weir. Installation of perforated pipes: perforate pipe 150mm (20 mm dia x 20 holes) Backfilling: gravel (80 cm thick), sand (1.2m thick) 3) <i>Piping work:</i> Installation of water collector with the following specification Diameter and length: GSP 6-inch x 6m Depth: 1.8m below the riverbed 4) <i>Mechanical work:</i> none 5) <i>Electrical work:</i> none 6) <i>Miscellaneous:</i> none

Estimated cost: US\$4,848		Construction schedule: 	
		Priority: B-2

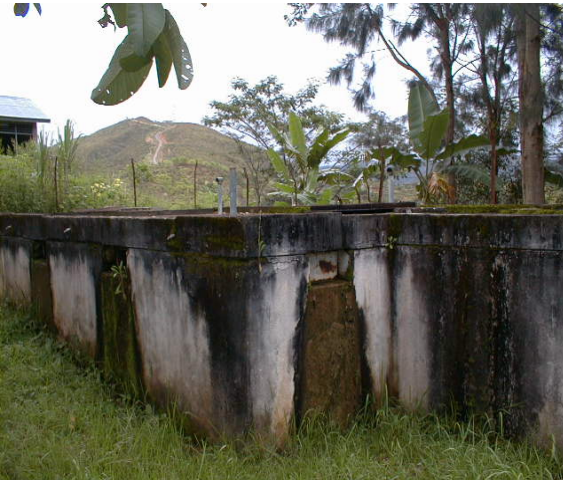
Town Aileu	No. & Facility: 08 - Marele Reservoir 2	Year of Construction	Financed by:
Existing Condition: Facility: Sevice reservoir Structure: Reinforced concrete Shape: Rectangular Dimension: Capacity: 30m ³ Function: Storage Source of Water: Sloi Kraik River Elevation (amsl): Accessories:		Photograph:

(Date:)	
Evaluation: In use			
Rehabilitation Plan: 1) Basic Calculation 2) Civil Work: Installation of water level gauge 3) Piping work: Installation of 75mm flow meter and control valve Interconnections of 75mm diameter with a length Of 30m between No.1 and No.2 reservoirs 4) Mechanical work: none 5) Electrical work: none 6) Miscellaneous: none			
Estimated cost: US\$3,991		Construction schedule:	Priority: B-2

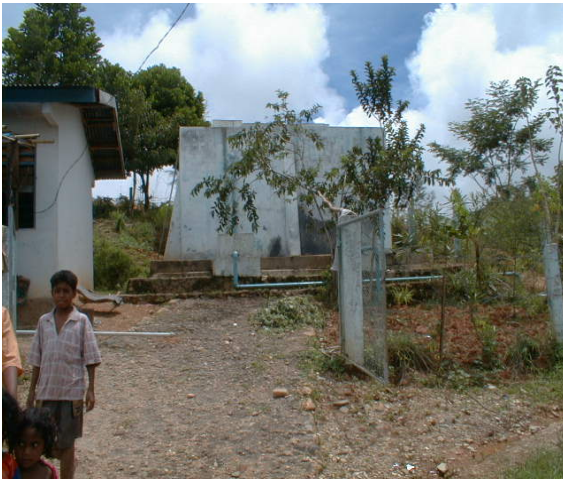
Town Aileu	No & Facility: 09 - Hularema Reservoir	Year of Construction	Financed by:
Existing Condition: <i>Facility:</i> Service reservoir <i>Structure:</i> Reinforced concrete <i>Shape:</i> Rectangular <i>Dimension:</i> 5.2m x 8.2m x 3.0m <i>Capacity:</i> 120m ³ <i>Function:</i> Storage <i>Source of Water:</i> Hularema River <i>Elevation (amsl):</i> <i>Accessories:</i>		Photograph:

(Date:)	
Evaluation: In use but with some leaks at the base			
Rehabilitation Plan: 1) <i>Basic Consideration</i> 2) <i>Civil Work:</i> Installation of water level gauge 3) <i>Piping work:</i> Leak repair work and installation of 50mm flow meter and control valve. 4) <i>Mechanical work:</i> none 5) <i>Electrical work:</i> none 6) <i>Miscellaneous:</i> none			
Estimated cost: US\$3,057		Construction schedule:	Priority: B-2

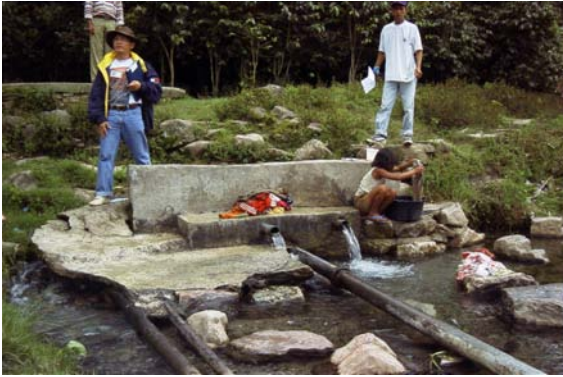
Town Maubisse	No. & Facility: 01 - Erulu Spring	Year of Construction	Financed by: Portuguese
Existing Condition: <i>Facility:</i> Collection chamber, storage reservoir <i>Dimension:</i> <i>Storage capacity:</i> 56m ³ <i>Function:</i> Intake and storage <i>Source of Water:</i> Erulu Spring <i>Elevation (amsl):</i> <i>Accessories:</i>		Photograph:

(Date:)	
Evaluation: <p>The reservoir, which is a few hundred meters away from the source is not in use due to damaged section of the transmission main.</p>			
Rehabilitation Plan: <p>1) <i>Basic Calculation:</i> Storage requirement = 356 m³/day * 33% * 8/24 = 40 m³ (Assumed 33% of the total) Capacity of the existing reservoir = 56 m³ Therefore, no need for reservoir expansion</p> <p>2) <i>Civil Work:</i> Construction of the drainage facilities. Construction of security fence.</p> <p>3) <i>Piping work:</i> Installation of flow meter, control valves Repair/replacement of the damaged section of the transmission main (75mm x 30 m) Installation of 1 public tap</p> <p>4) <i>Mechanical work:</i> none</p> <p>5) <i>Electrical work:</i> none</p> <p>6) <i>Miscellaneous:</i> Installation of chlorine-dosing device</p>

Estimated cost: US\$7,891		Construction schedule: 	
		Priority: C-2

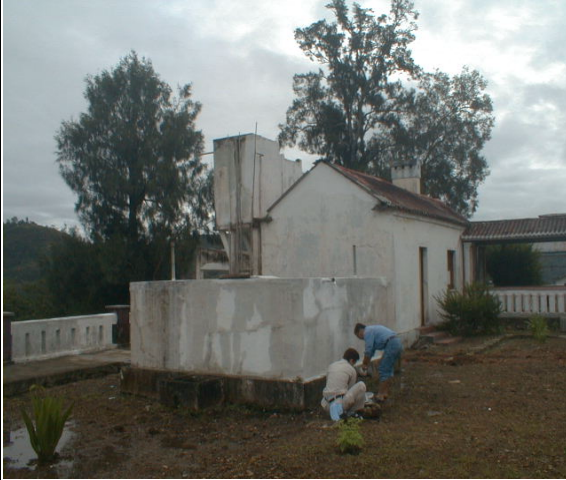
Town Maubisse	No. & Facility: 03 - Pousada Reservoir	Year of Construction	Financed by: Portuguese
Existing Condition: Structure: Reinforced Concrete Shape: Rectangular Dimension: Capacity: 23m ³ Function: Storage Source of Water: Bucana Spring Ground level: Accessories:		Photograph:

(Date:)	
Evaluation: In operation but limited supply is coming due to service connections made on the transmission main. The capacity of the existing reservoir will be sufficient to store water supplied from the source estimated @ 0.7 L/s.			
Rehabilitation Plan: 1) <i>Basic Calculation</i> Storage requirement = $0.70 \text{ L/s} \times 86,400 \times 8/24 = 20 \text{ m}^3$ Capacity of the existing reservoir = 23 m^3 Therefore, reservoir expansion is not required. 2) <i>Civil Work:</i> Installation of water level gauge. 3) <i>Piping work:</i> Installation of flow meter and control valve. 4) <i>Mechanical work:</i> none 5) <i>Electrical work:</i> none 6) <i>Miscellaneous:</i> Installation of chlorine-dosing facilities.

Estimated cost: US\$6,451		Construction schedule: 	
		Priority: C-2

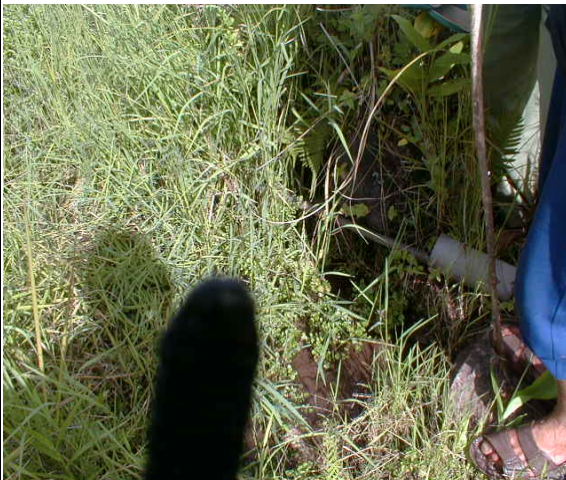
Town Maubisse	No. & Facility: 05 - Raikuak Ulun Spring	Year of Construction	Financed by:
Existing Condition: <i>Facility:</i> Spring Intake <i>Dimension:</i> <i>Function:</i> Intake for raw water <i>Source of Water:</i> Raikuak Ulun Spring <i>Ground level (amsl):</i> <i>Accessories:</i> Weir: made of earth Transmission main: GSP 1-inch		Photograph:

(Date:)	
Evaluation: The intake facility is not properly designed and constructed It requires rehabilitation including the construction of the concrete weir, collection chamber			
Rehabilitation Plan: 1) <i>Basic Consideration:</i> Rehabilitation of the existing facilities including the construction of the concrete weir, collection chamber 2) <i>Civil Work:</i> Weir: 5m width x 2.5 m height, made of concrete Collection chamber: 2m x 3m x 1.5m height Construction of the security fence. 3) <i>Piping work:</i> Installation of 75mm x 15 m inlet pipe including 150mm perforated pipe for water collection. 4) <i>Mechanical work:</i> none 5) <i>Electrical work:</i> none 6) <i>Miscellaneous:</i> none

Estimated cost: US\$9,295		Construction schedule:	Priority: C-1

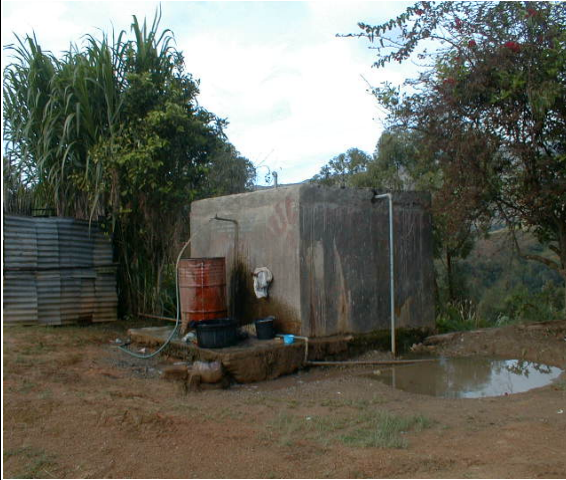
Town Maubisse	No. & Facility: 07 - Leputo Reservoir	Year of Construction	Financed by:
Existing Condition: Facility: Service reservoir Structure: Reinforced Concrete Shape: Rectangular Dimension: Capacity: 20m ³ Function: Storage Source of Water: Raikuak Ulun Ground level (amsl): Accessories:		Photograph:

(Date:)	
Evaluation: Currently in use but requires rehabilitation and expansion. The raikuak ulun water source supplies about 1.7 L/s or 146.9 m ³ /day to this reservoir.			
Rehabilitation Plan: 1) <i>Basic Calculation:</i> Required storage capacity = 146.9 m ³ /day * 8/24 = 49 m ³ Capacity of the existing reservoir = 20 m ³ Storage deficit = 49 - 20 = 29 m ³ 2) <i>Civil Work:</i> Construction of a new reservoir with a capacity of 30 m ³ including the necessary appurtenances Construction of the security fence. 3) <i>Piping work:</i> Installation of flow meter and control valves for the existing reservoir Pipe interconnection. 4) <i>Mechanical work:</i> none 5) <i>Electrical work:</i> none 6) <i>Miscellaneous:</i> Installation of chlorine-dosing device

Estimated cost: US\$15,651		Construction schedule: 	
		Priority: C-2

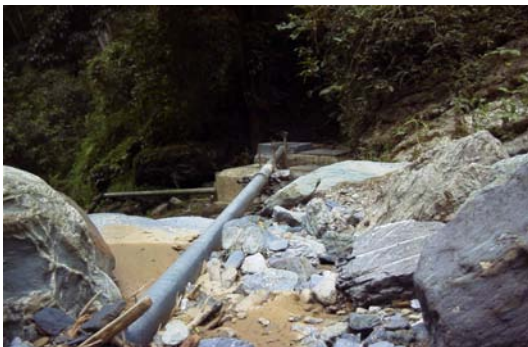
Town Gleno	No. & Facility: 01 - Mota Boot Intake	Year of Construction	Financed by:
Existing Condition: Facility: Intake pipe and collection chamber appeared to be seriously damaged. Only traces are left. Dimension: Capacity: Function: Raw water collection Source of Water: Mota Boot River Ground level (amsl): Accessories:		Photograph:

(Date:)	
Evaluation: The intake facilities including transmission main are seriously damaged resulting to the non-operation of this facility and substantial decrease in water supply.			
Rehabilitation Plan: 1) <i>Basic Consideration:</i> Require construction of new intake facilities including transmission main. The facilities must be constructed in safe place with adequate protection. 2) <i>Civil Work:</i> Construction of collection chamber: 5.0 m x 3.0 m x 1.5 m Construction of concrete weir: 7.0 m width x 1.5 m height (approximate) Construction of security fence 3) <i>Piping work:</i> Installation of new intake pipe 150mm x 10 m with perforation. Installation of new transmission main 150mm x 100 m. 4) <i>Mechanical work:</i> none 5) <i>Electrical work:</i> none 6) <i>Miscellaneous:</i> none

Estimated cost: US\$23,692		Construction schedule:	Priority: B-1

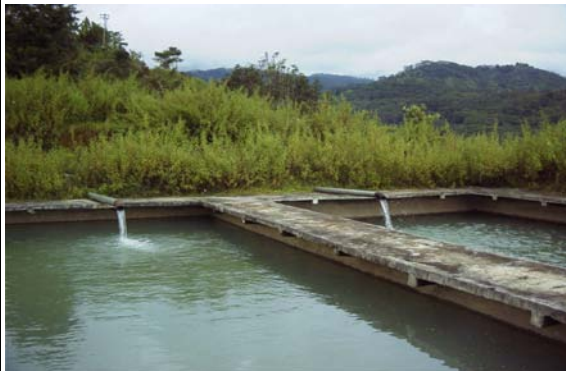
Town Gleno	No. & Facility: 02 - Riheu Water Treatment Plant	Year of Construction	Financed by:
Existing Condition: Process: Slow sand filtration Dimension: 10m x 18m - 2 basins Filtration rate: 4m/day Capacity: 15 L/s Function: Water Treatment Source of Water: Mota Boot and Mota Kiik Ground level (amsl): Accessories:		Photograph:

(Date:)	
Evaluation: In constant breakdown due to lack of resources and absence of regular maintenance. Limited supply for treatment due to breakdown of main source at Mota Boot. Capacity is enough to supply the water demand.			
Rehabilitation Plan: 1) <i>Basic Consideration:</i> No expansion is needed. Requires routine maintenance and skilled operators Requires adequate protection of water production and chlorination prior to distribution. 2) <i>Civil Work:</i> Construction of concrete apron for washing the filter media (sand) Apron: 10m width x 15m length x 30cm height Construction of security fence to include the WTP site and reservoir facilities. Construction of staff house. 3) <i>Piping work:</i> Installation of flow meter and control valve (150mm x 2 sets) 4) <i>Mechanical work:</i> none 5) <i>Electrical work:</i> none 6) <i>Miscellaneous:</i> none

Estimated cost: US\$24,456		Construction schedule:	Priority: B-2

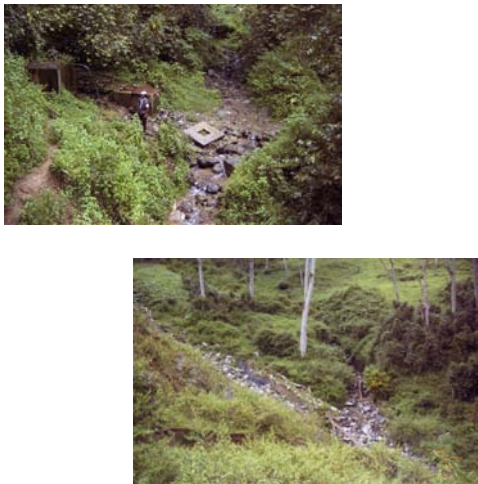
Town Ermera	No. & Facility: 01 - Ersoi and Lubulala Intake	Year of Construction	Financed by:
Existing Condition: <i>Facility:</i> Intake structures <i>Function:</i> Collection of spring water <i>Sources:</i> Ersoi and Lubulala springs <i>Observed flow of sources:</i> <i>Elevation (amsl):</i> <i>Accessories:</i>		Photograph:

(Date:)	
Evaluation: The flow from these water sources normally drops substantially during dry season. The existing intake structures are vulnerable to damage and require rehabilitation.			
Rehabilitation Plan: 1) <i>Basic Consideration:</i> As immediate remedial measures, rehabilitation of the existing intake structures will be required. 2) <i>Civil Work:</i> Construction of new intake facilities for Ersoi and Lubulala with the following specifications: 2 sets of Collection chamber: 1.5m x 2m x 2m Construction of security fence. 3) <i>Piping work:</i> Repair of 50mm x 50 m transmission main Installation of 2 sets intake pipes 50mm x 10 m 4) <i>Mechanical work:</i> none 5) <i>Electrical work:</i> none 6) <i>Miscellaneous:</i> none

Estimated cost: US\$9,200		Construction schedule:	Priority: C-1
