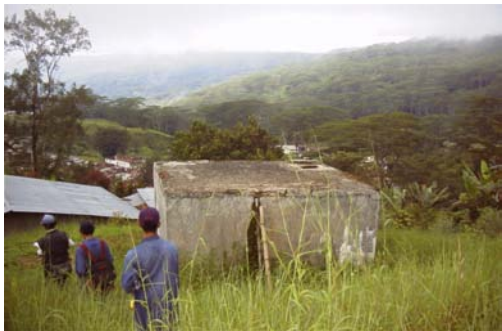
Poetete Reservoir No.2 (Date: )	
<b>Evaluation:</b> Working but require rehabilitation and expansion. The existing 2 reservoirs will be insufficient to provide the required storage requirement. Both tanks are not equipped with flow meters and control valves.			
<b>Rehabilitation Plan:</b> 1) <i>Basic Calculation:</i> Storage requirement = Water demand * 8 hrs storage/day where: water demand = 428 m <sup>3</sup> /day Storage requirement = 428 * 8/24 = 143 m <sup>3</sup> /day Storage deficit = 143 - 63 = 80 m <sup>3</sup> /day  2) <i>Civil Work:</i> Construction of service reservoir with the capacity of 80 m3 including the necessary appurtenances Construction of security fence and staff house  3) <i>Piping work:</i> Installation of 100mm including flow meter and control valves for the proposed reservoir Installation of 50mm x 50 m including 2 sets of control valves for existing reservoirs  4) <i>Mechanical work:</i> none          5) <i>Electrical work:</i> none          6) <i>Miscellaneous:</i> none

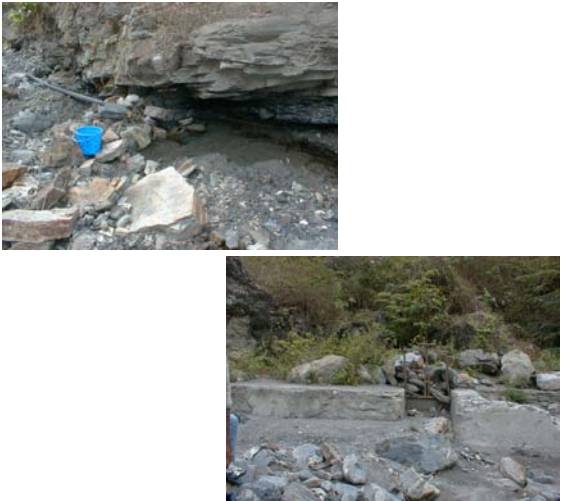
(Date:                      )	
<b>Evaluation:</b> The existing facilities are oftentimes subjected to natural damage because they were constructed below standard.			
<b>Rehabilitation Plan:</b> 1) <i>Basic Consideration</i> To improve water collection, new intake will be constructed with a design intake rate, 5L/sec for each.

2) <i>Civil Work:</i> Construction of the intake facilities to include the following: Perforated pipes: 150mm GSP protected by concrete Gabion: 50cm x 50cm x 150cm x 17 Security fence, flow controller, grit chamber (2m x 4m x 2mH)

3) <i>Piping work</i> Design intake rate: 5 L/sec (Daulo), 5 L/sec (Enalua) Intake pipes: 100mm x 50 m (for Enalua) and 100mm x 100 m (for Daulo) Raw water transmission: 150mm (Daulo) x 4km

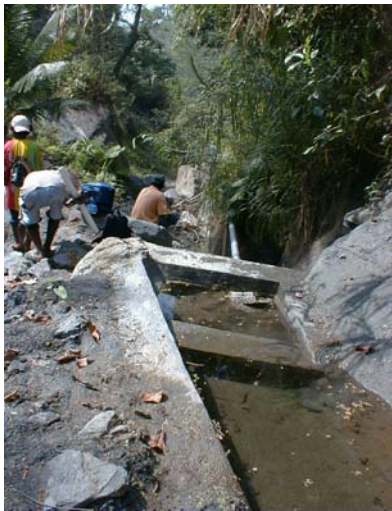
(Date: )	
<b>Evaluation:</b> Oxfam carried rehabilitation works on this source particularly on the intake structures.			
<b>Rehabilitation Plan:</b> 1) <i>Basic Consideration</i> The existing facilities are not sufficient to abstract the design intake rate, 5L/sec. Construction of new intake facilities is necessary to upgrade water collection. Rehabilitation work is necessary on the transmission main.  2) <i>Civil Work:</i> Construction of intake facilities safe from natural damages Installation of perforated pipes protected by concrete, 1.5m underneath the river bed together with gabion. Construction of a grit chamber (2m x 4m x 2mH) Construction of river crossings. 3) <i>Piping work:</i> Installation of transmission main 75mm x 7 km and 100mm x 2.5km (from intake to Maumeta reservoir) including necessary appurtenances such as air release valves, blow-off  4) <i>Mechanical work:</i> none          5) <i>Electrical work:</i> none          6) <i>Miscellaneous:</i> none

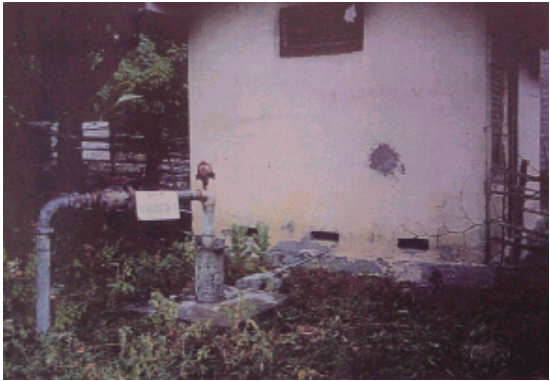
(Date: )	
<b>Evaluation:</b> Not in operation due to damage of the pumping facilities and electro-mechanical equipment			
<b>Rehabilitation Plan:</b> 1) <i>Basic Consideration:</i> In the course of the study, this deepwell will be abandoned.  2) <i>Civil Work:</i>          3) <i>Piping work:</i> none          4) <i>Mechanical work:</i> none          5) <i>Electrical work:</i>          6) <i>Miscellaneous:</i> none

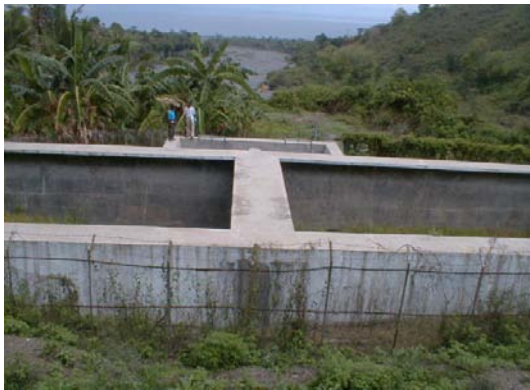
(Date: )	
<b>Evaluation:</b> In operation but requires repair and rehabilitation			
<b>Rehabilitation Plan:</b> 1) Basic Consideration  2) Civil Work: Repair of concrete base and walls after removal of filter media. Provide concrete apron for sand washing with drain. Wash and seive filter sands and gravel for reuse Installation of ladders for maintenance  3) Piping work: Installation of flow meter and control valves on the inlets  4) Mechanical work: none  5) Electrical work: none  6) Miscellaneous: none

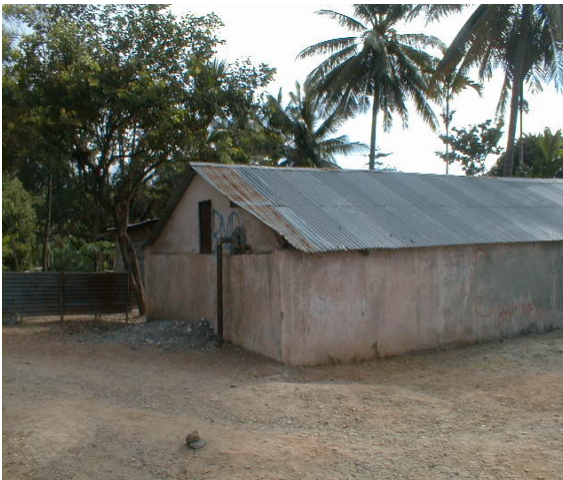
(Date: )	
<b>Evaluation:</b> In use but requires minor rehabilitation.			
<b>Rehabilitation Plan:</b> 1) <i>Basic Consideration</i>  2) <i>Civil Work:</i> Construction of security fence.  3) <i>Piping work:</i> Installation of pipes to interconnect to the existing.  4) <i>Mechanical work:</i> none  5) <i>Electrical work:</i> none  6) <i>Miscellaneous:</i> Installation of chlorine dosing device			
<b>Estimated cost:</b> US\$5,300		<b>Construction schedule:</b> Priority: A-2

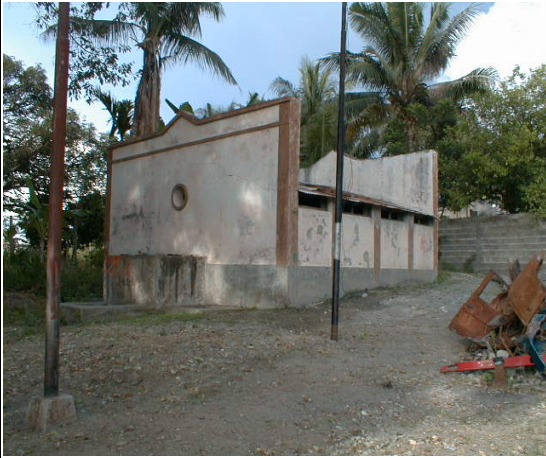
(Date: )	
<b>Evaluation:</b> In use but requires minor rehabilitation.			
<b>Rehabilitation Plan:</b> 1) Basic Consideration  2) Civil Work: Construction of security fence  3) Piping work: none  4) Mechanical work: none  5) Electrical work: none  6) Miscellaneous: none			
<b>Estimated cost:</b>  US\$2,400		<b>Construction schedule:</b>	<b>Priority:</b>  A-2

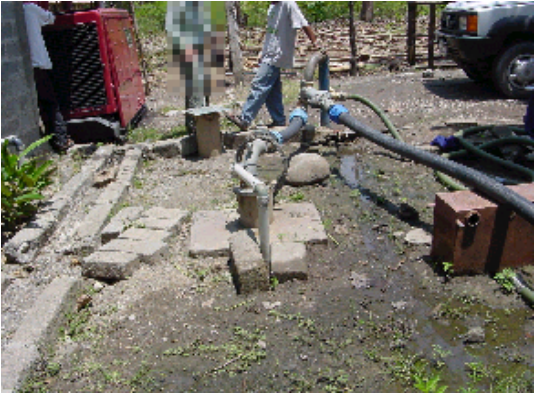
(Date: _____ )	
<b>Evaluation:</b> 1. In operation. 2. Pumps, generator set and electro-mechanical facilities had lapsed their economic life. Need replacement.			
<b>Rehabilitation Plan:</b> 1) <i>Basic Consideration :</i> For an efficient operation, the existing pumping facilities and generator set to be replaced with new one. The pumping station needs to be refurbished.  2) <i>Civil Architectural:</i> a) Pumping station : Installation at doors with locks, windows and accessories. Ceiling to be repaired. b) Security fence : New security fence to be installed.  3) <i>Piping work:</i> none  4) <i>Mechanical work:</i> Pumps: 0.45m <sup>3</sup> /min x 46m head x 7kw Delivery: 2 inch 1/2 Type : submersible pump  5) <i>Electrical work:</i> Watt-hour Meter Box x1set      Fuel Tank x1set Main Power Switch Panel x1set      Pump Control Board x1set Generator Set x1set 6) <i>Miscellaneous:</i> none

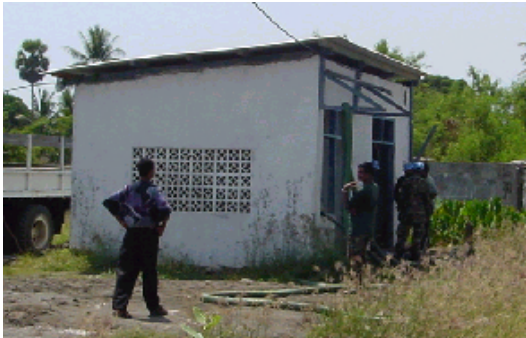
(Date: )							
<b>Evaluation:</b> <ol style="list-style-type: none"> <li>1. Pumps, generator set and electro-mechanical facilities heavily damaged.</li> <li>2. Put back into operation by PKF on temporary basis.</li> <li>3. Installed with mobile pumping equipment and generator set.</li> <li>4. Pumps water into PKF water trucks on routine basis.</li> </ol>									
<b>Rehabilitation Plan:</b> <ol style="list-style-type: none"> <li>1) <i>Basic Consideration :</i> New set of pumps and electron-mechanical facilities need to be installed on this well in order to operate normally. The pumping station needs to be refurbished.</li> <li>2) <i>Civil Architectural:</i> <ol style="list-style-type: none"> <li>a) Pumping station : Installation at doors with locks, windows and accessories. Ceiling to be repaired.</li> <li>b) Security fence : New security fence to be installed.</li> </ol> </li> <li>3) <i>Piping work:</i> Replacement and realignment of the discharge pipe.</li> <li>4) <i>Mechanical work:</i> Pumps: 0.45m<sup>3</sup>/min x 70m head x 7kw Delivery: 1/2 inch Type : submersible pump</li> <li>5) <i>Electrical work:</i>

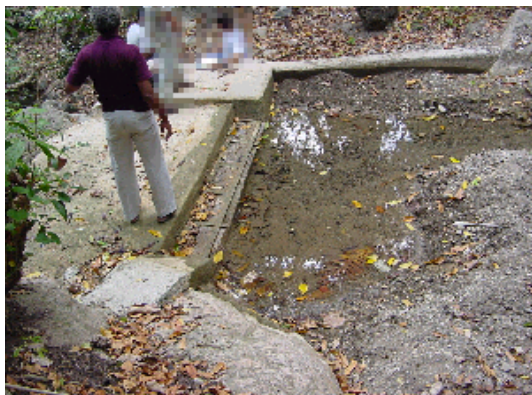
(Date: )	
<b>Evaluation:</b> 1. In operation. 2. Yield decreases in dry season. 3. Lacks routine maintenance.			
<b>Rehabilitation Plan:</b> 1) <i>Basic Consideration :</i>  2) <i>Civil Architectural:</i> Installation of security fence.  3) <i>Piping work:</i> none  4) <i>Mechanical work:</i> none  5) <i>Electrical work:</i> none  6) <i>Miscellaneous:</i> none			
<b>Estimated cost:</b> US\$1,800		<b>Construction schedule:</b>
