## Inventory Survey of Major Hillside Slope Failures in the Intensive Area

The Study on Critical Land and Protection Forest  
Rehabilitation at Tondano Watershed  
in the Republic of Indonesia

Japan International Cooperation Agency

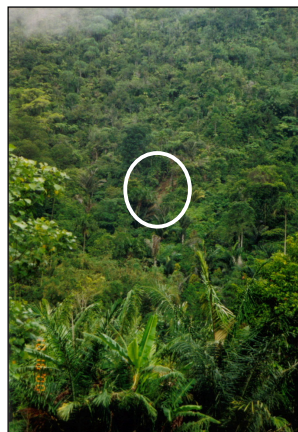
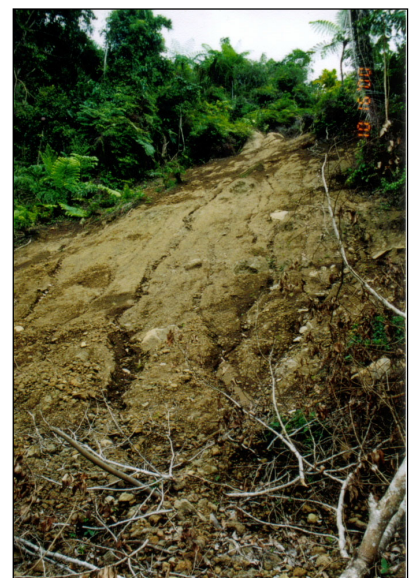
Figure H.3.10

Weathered Tuff Breccia

Low

High

Condition of Slope Failure on Hillside  
(Kaayuran Atas)

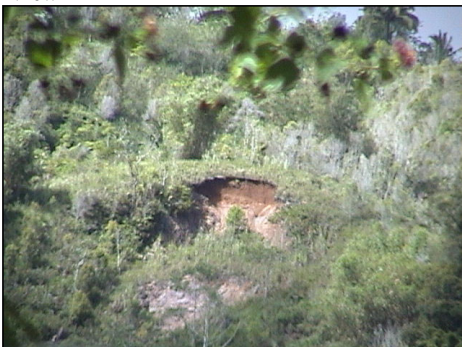
Figure H.3.12

Weatherd Tuff Breccia

Unsuitable Land Use

Low

Condition of Slope Failure on Hillside  
(Touliang Oki)
