## Inventory Survey of Major Hillside Slope Failures in the Intensive Area

The Study on Critical Land and Protection Forest  
Rehabilitation at Tondano Watershed  
in the Republic of Indonesia

Figure H.3.13

Condition of Slope Failure on Hillside  
(Makalonsouw)

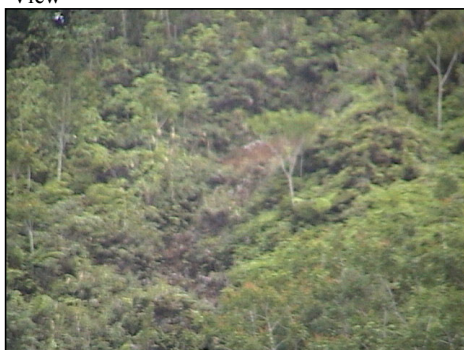
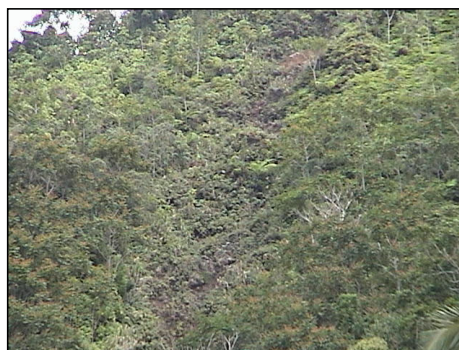
View

Possible cause of the failure

Natural Failure

Possibility of slope failure expansion

Low

Possibility of natural rehabilitation

High

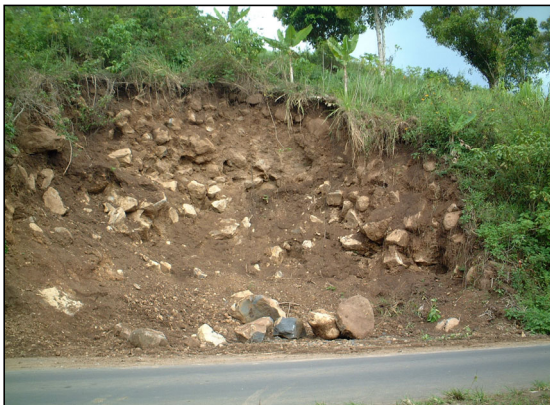
View

Possibility of slope failure expansion

High

Possibility of natural rehabilitation

Low
