## Inventory Survey of Major Road Cut Slope Failures in the Intensive Area

Eris-1

The Study on Critical Land and Protection Forest Rehabilitation at Tondano Watershed in the Republic of Indonesia

**Figure H.3.18**  
**Condition of Slope Failure along the Road (Eris-1)**

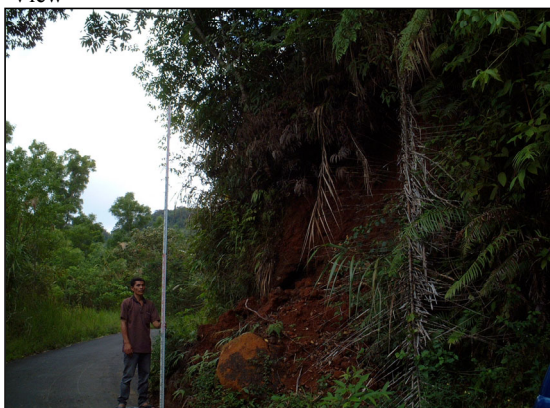
View

4.0 m

5.0 m

0.7 m

10 m<sup>3</sup>

70°

Low

Middle

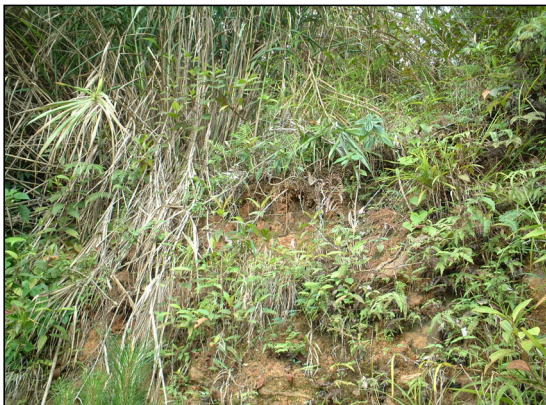
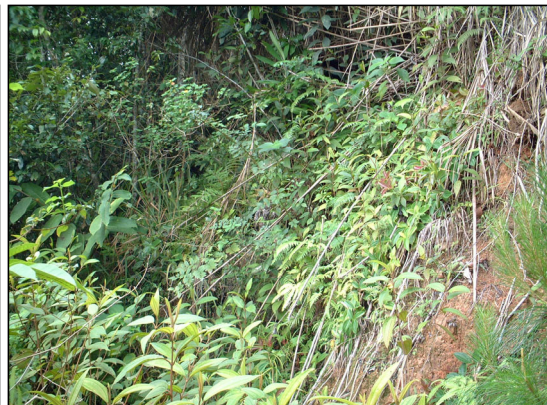
View

8.0 m

1.5 m

100 m<sup>3</sup>

60 °

Low

High
