Inventory Survey of Major Road Cut Slope Failures in the Intensive Area

The Study on Critical Land and Protection Forest Rehabilitation at Tondano Watershed in the Republic of Indonesia

Figure H.3.20

Condition of Slope Failure along the Road (Eris-3)

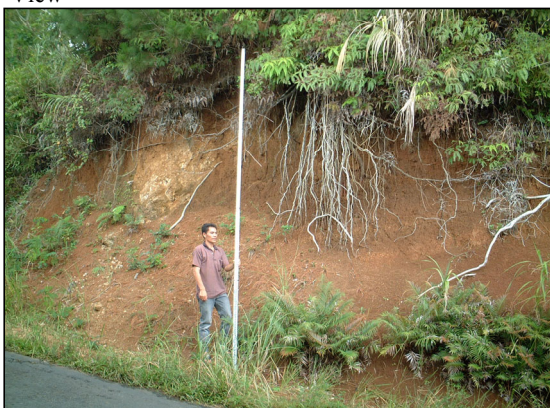
2)Slope Failure Condition

Possibility of slope failure expansion

Middle

Possibility of natural rehabilitation

Low
