## ***Inventory Survey of Existing Check Dams***

**The Study on Critical Land and Protection Forest  
Rehabilitation at Tondano Watershed  
in the Republic of Indonesia**

**Figure HAT3.2**

**Inventory Survey of Existing Check Dam  
(CD-1) (1/2)**

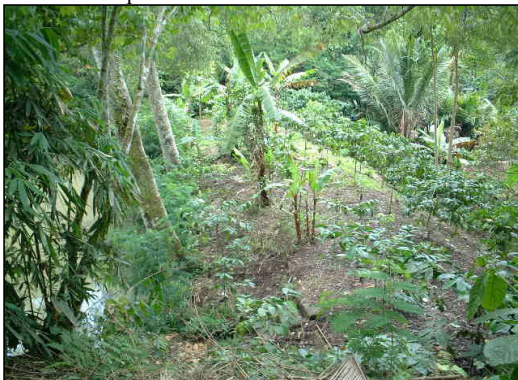
View from upstream

Good.

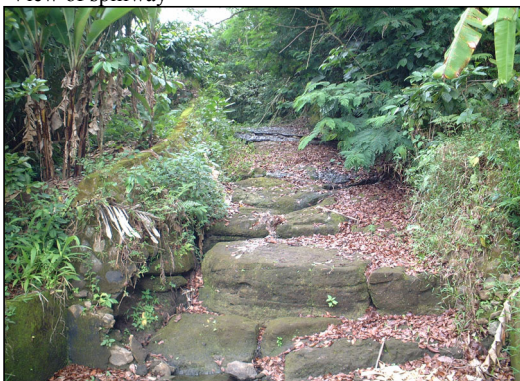
View of spillway

Good.

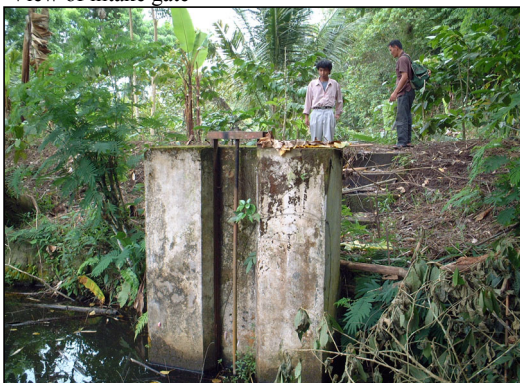
View of intake gate

Unknown.
