Inventory Survey of Check Dams in the Intensive Area

CD - 5

**The Study on Critical Land and Protection Forest
Rehabilitation at Tondano Watershed
in the Republic of Indonesia**

**Inventory Survey of Existing Check Dam
(CD-5) (1/2)**

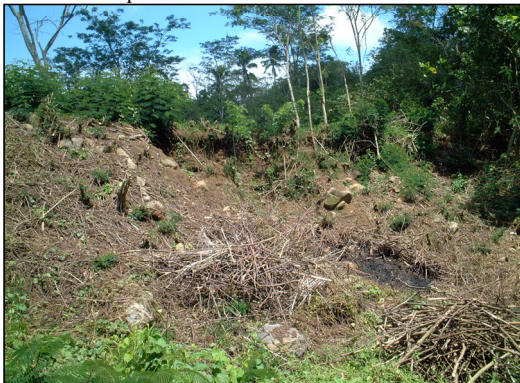
View from upstream

Downstream slope is partially failed.
(about 30m³)

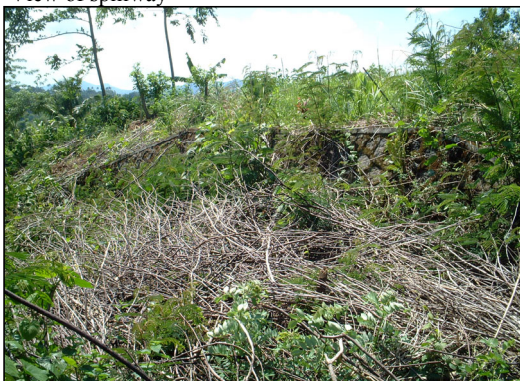
View of spillway

Brushwoods are disturbing spillway flow section.
