## Inventory Survey of Check Dams in the Intensive Area

CD - 6

The Study on Critical Land and Protection Forest  
Rehabilitation at Tondano Watershed  
in the Republic of Indonesia

Inventory Survey of Existing Check Dam  
(CD-6) (1/2)

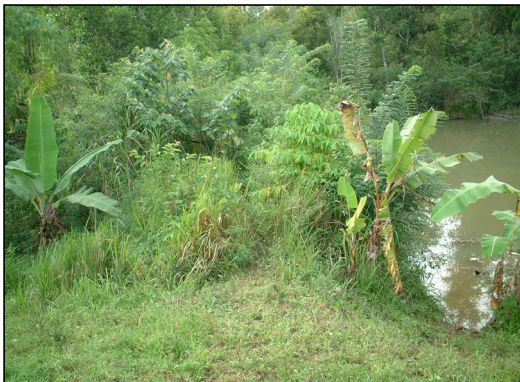
General view

Downstream portion has damaged.  
Seepage from toe of slope is observed.

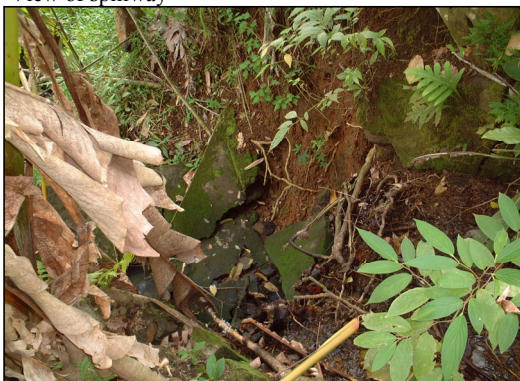
View of spillway

Downstream part is brokendown.
