Inventory Survey of Check Dams in the Intensive Area

CD - 8

The Study on Critical Land and Protection Forest Rehabilitation at Tondano Watershed in the Republic of Indonesia

Inventory Survey of Existing Check Dam (CD-8) (1/2)

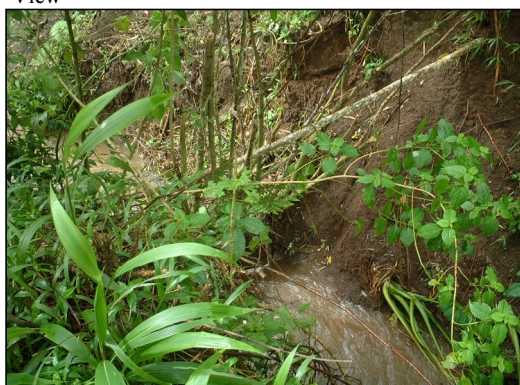
View

Dam body has collapsed.

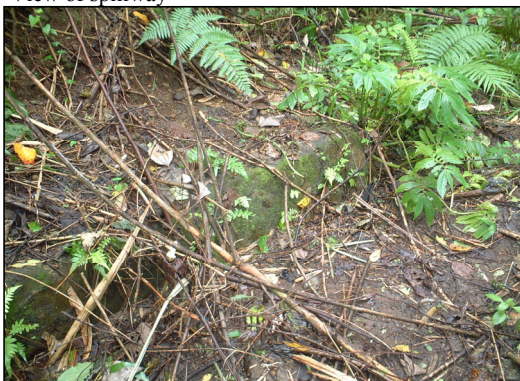
View of spillway

Slope failure has blocked the spillway section.
This might be the reason of dam body collapse.
