Inventory Survey of Check Dams in the Intensive Area

CD - 9

**The Study on Critical Land and Protection Forest
Rehabilitation at Tondano Watershed
in the Republic of Indonesia**

**Inventory Survey of Existing Check Dam
(CD-9) (1/2)**

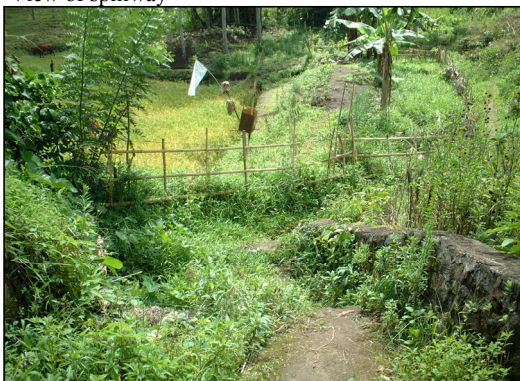
View of spillway

Spillway dimension is different from its original design.
