Inventory Survey of Check Dams in the Intensive Area

CD - 10

**The Study on Critical Land and Protection Forest
 Rehabilitation at Tondano Watershed
 in the Republic of Indonesia**

**Inventory Survey of Existing Check Dam
 (CD-10) (1/2)**

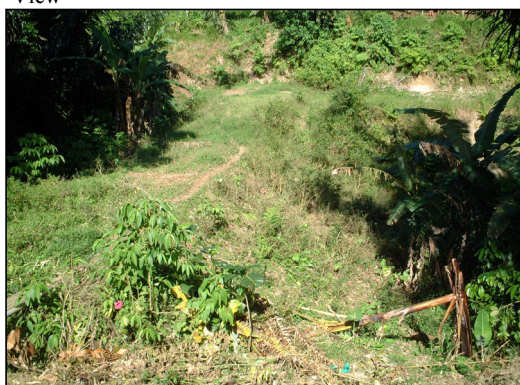
View

Dam Type **Earth Fill Dam** Crest Length **40.0** m
Dam Pengendali Crest Width **3.5** m
 D/S Slope **1:1.75** - Dam Height **4.5** m

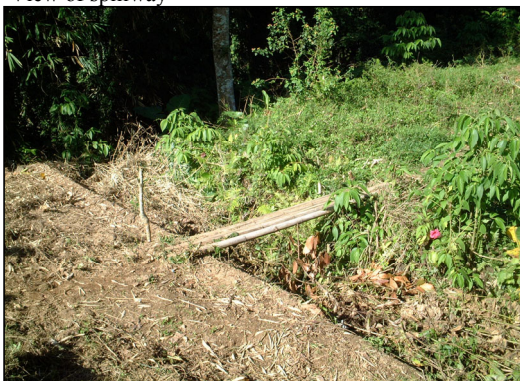
View of spillway

Spillway Bed Width **1.2** m
Spillway Height **0.6** m

Material **Wet Masonry**

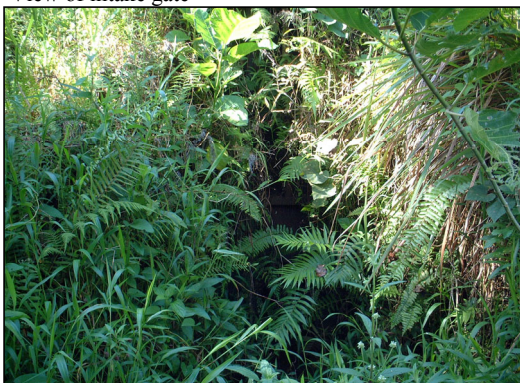
View of intake gate

Type **Sluice Gate**
