## Inventory Survey of Check Dams in the Intensive Area

CD - 13

The Study on Critical Land and Protection Forest  
Rehabilitation at Tondano Watershed  
in the Republic of Indonesia

Inventory Survey of Existing Check Dam  
(CD-13) (1/2)

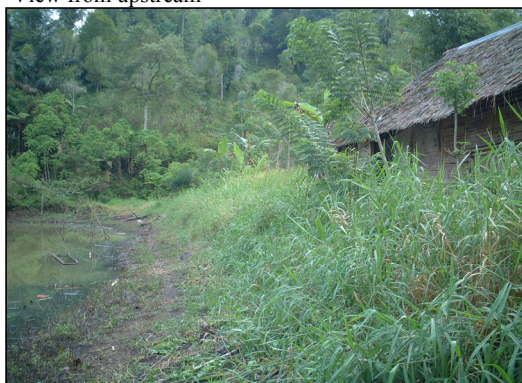
View from upstream

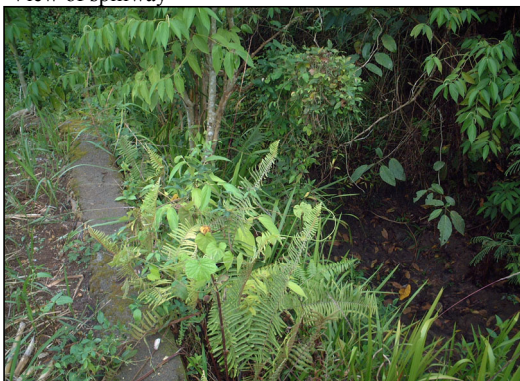
View of spillway

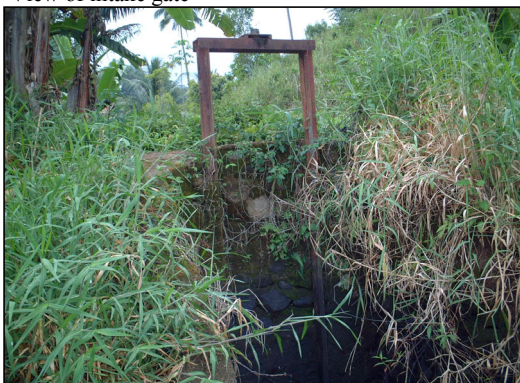
View of intake gate

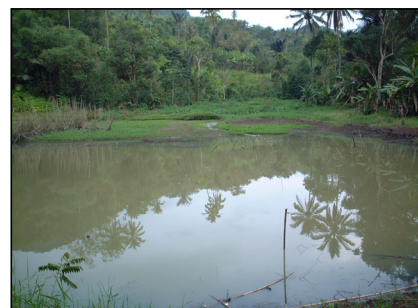
General View of Dam Lake
