CD - 14

**The Study on Critical Land and Protection Forest
Rehabilitation at Tondano Watershed
in the Republic of Indonesia**

Figure HAT3.15

**Inventory Survey of Existing Check Dam
(CD-14) (1/2)**

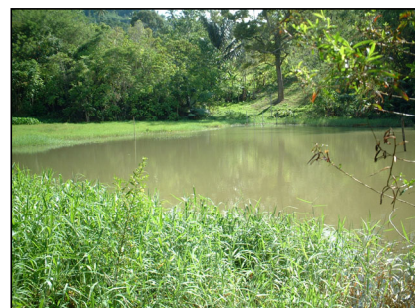
General View of Dam Lake

Status of Sediment Control	Functioning
Deposition Gradient	N/A %
Sedimentation Yield	N/A m ³
	N/A ton/ha/year
