Inventory Survey of Check Dams in the Intensive Area

CD - 15

**The Study on Critical Land and Protection Forest
Rehabilitation at Tondano Watershed
in the Republic of Indonesia**

**Inventory Survey of Existing Check Dam
(CD-15) (1/2)**

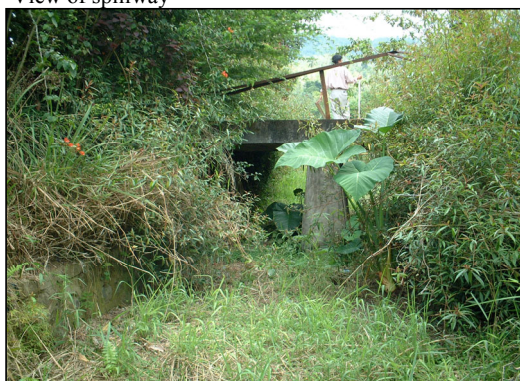
View of spillway

Spillway Bed Width **3.5** m
Spillway Height **1.0** m

Material **Wet Masonry**

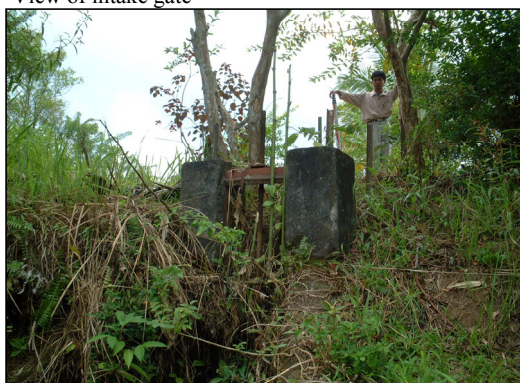
View of intake gate

Type **Sluice Gate**
