## Inventory Survey of Check Dams in the Intensive Area

CD - 16

Touliang Oki

Inventory Survey of Existing Check Dam (CD-16) (1/2)

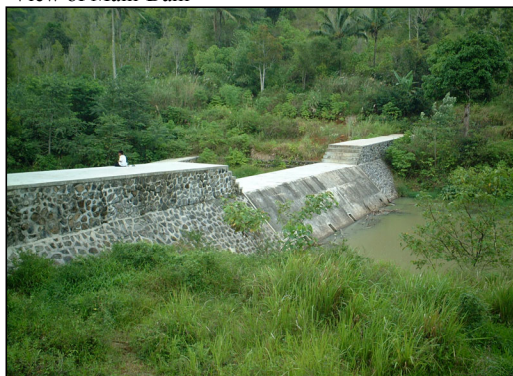
View of Main-Dam

Condition

Good.

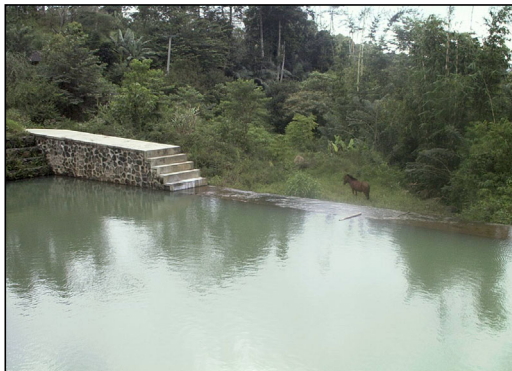
View of Sub-Dam

Condition

Good.

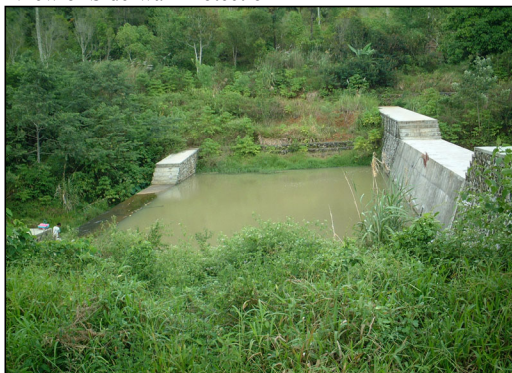
View of Side-wall Protection

Condition

Good.
