2.4 Reconnaissance Survey of Six (6) Routes

2.4.1 Item of Study

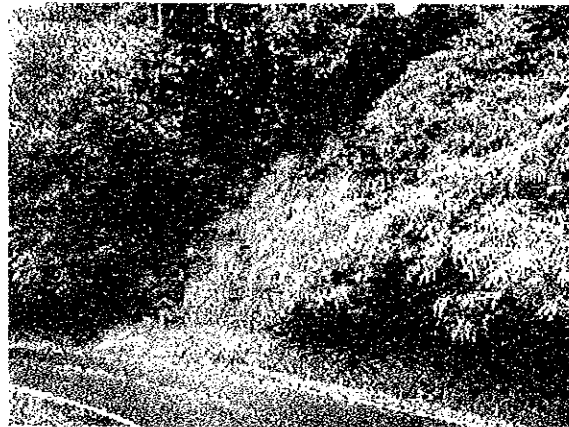
Figure 2.4.3 Surface Failure (Cameron Rd. 30 km)

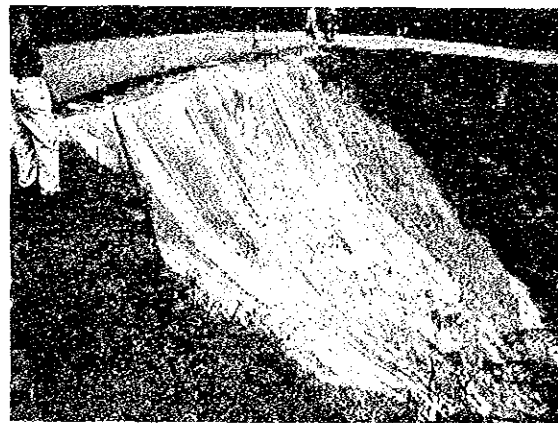
Figure 2.4.4 Surface Failure below Road Shoulder (Cameron Rd. 23.8 km)

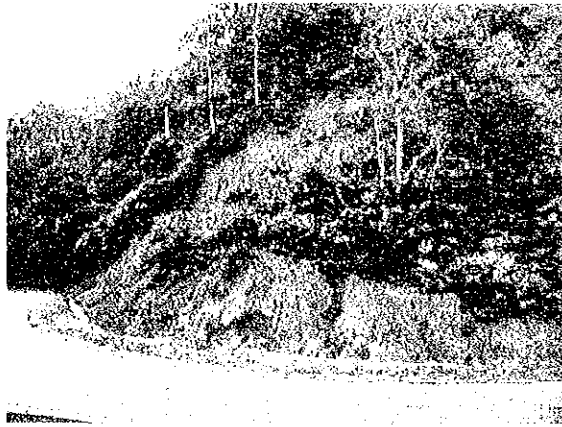
Figure 2.4.5 Landslide (Cameron Rd. 33 km)

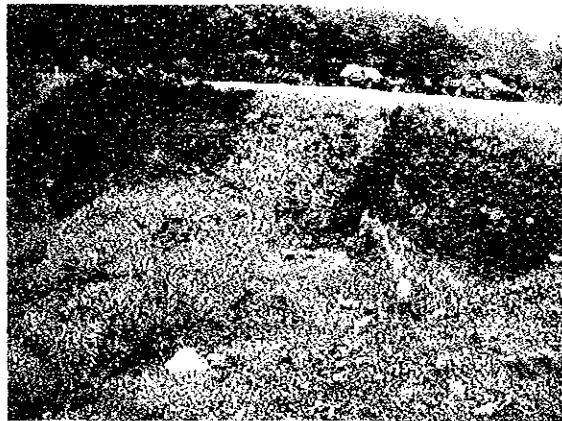
Figure 2.4.6 Embankment Failure (Sabah Rd. 94.5 km)

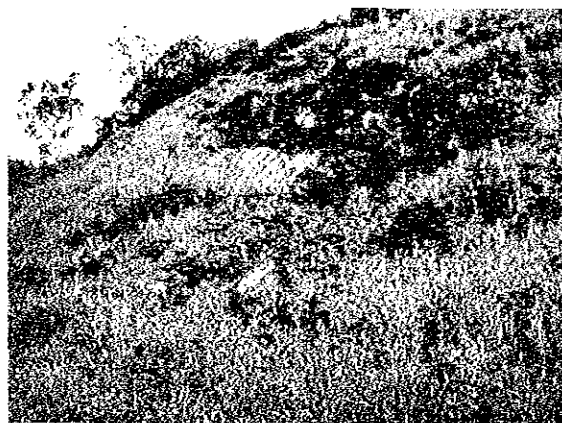
Figure 2.4.7 Wedge Slip (E-W Highway, 15.1 km)

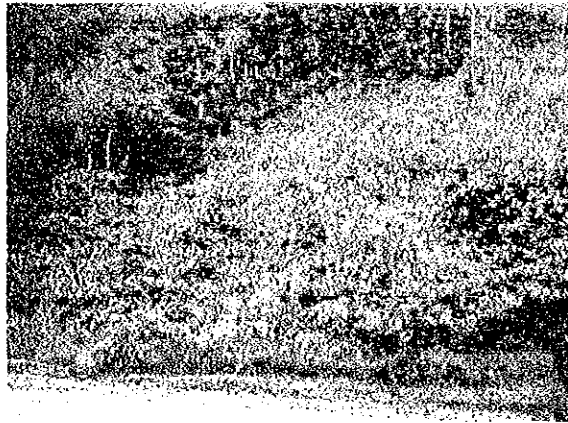
Figure 2.4.8 Rock Fall (Sabah Rd. 78.6 km)

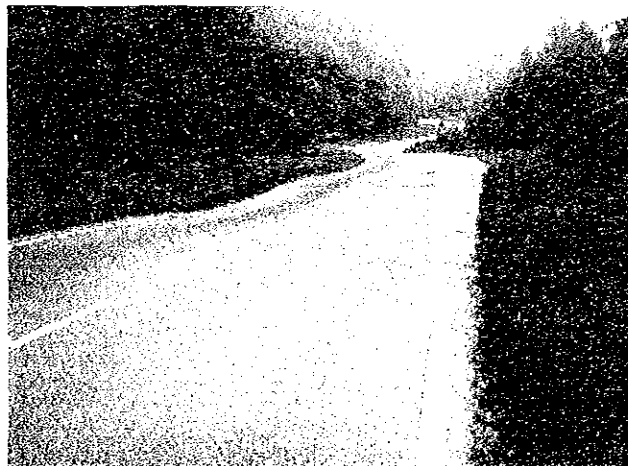
Figure 2.4.10 Settlement of Road (Sabah Rd. 74.5 km)

Various types of slope disasters can be seen along this road. The remarkable point of this road is that there are many road settlements and traces of debris flow. The road settlement concentrate from 68 km to 75 km.

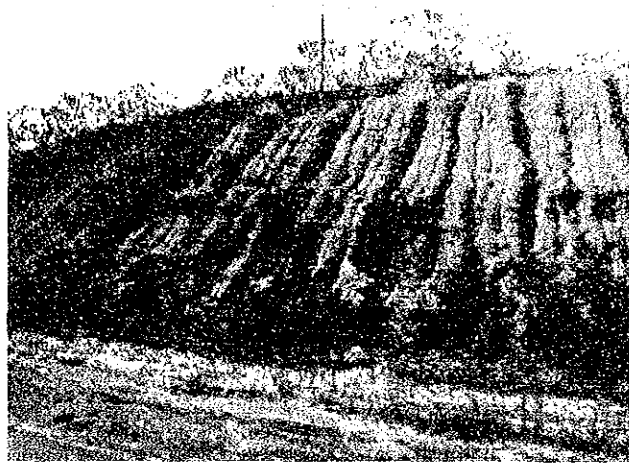
Figure 2.4.11 Gully (Sabah Rd. out of project area)

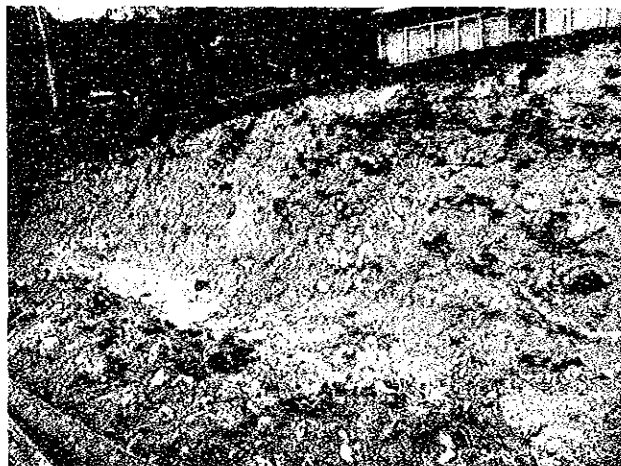
Non-cemented gravel, sand and silt are found at 64 km in Berincang. We think that these gravel, sand and silt are sedimentary layers deposited in an old lake at Cameron Highlands.

Figure 2.4.13 Gravel Layer at Berincang
