2.6 Current Status of Countermeasure Works

2.6.1 Present Condition of Countermeasure Against Slope Failure

2.6.2 Present Condition of River Crossing Drainage in Malaysia

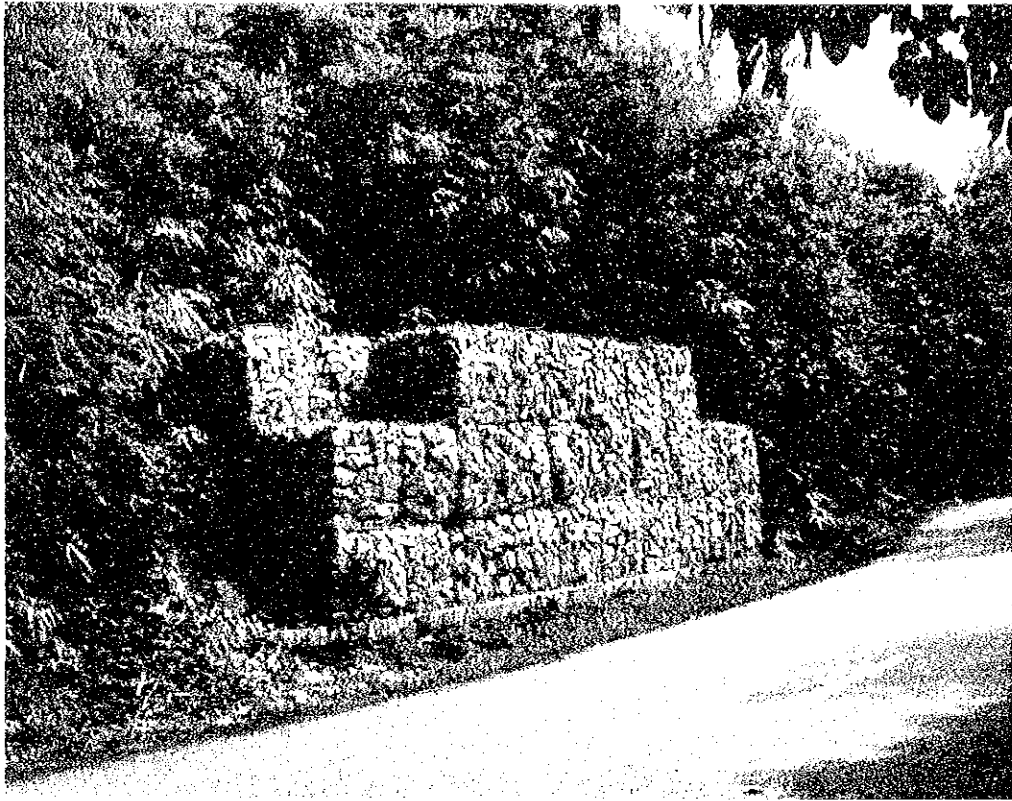
- 2) Gabion wall is the temporary works, so it should not be used the permanent structures against earth pressure, but it has high permeability, so it is useful to use the counterweight of toe of collapse or counterweight embankment of toe against landslide.

Figure 2.6.12 Gabion Wall

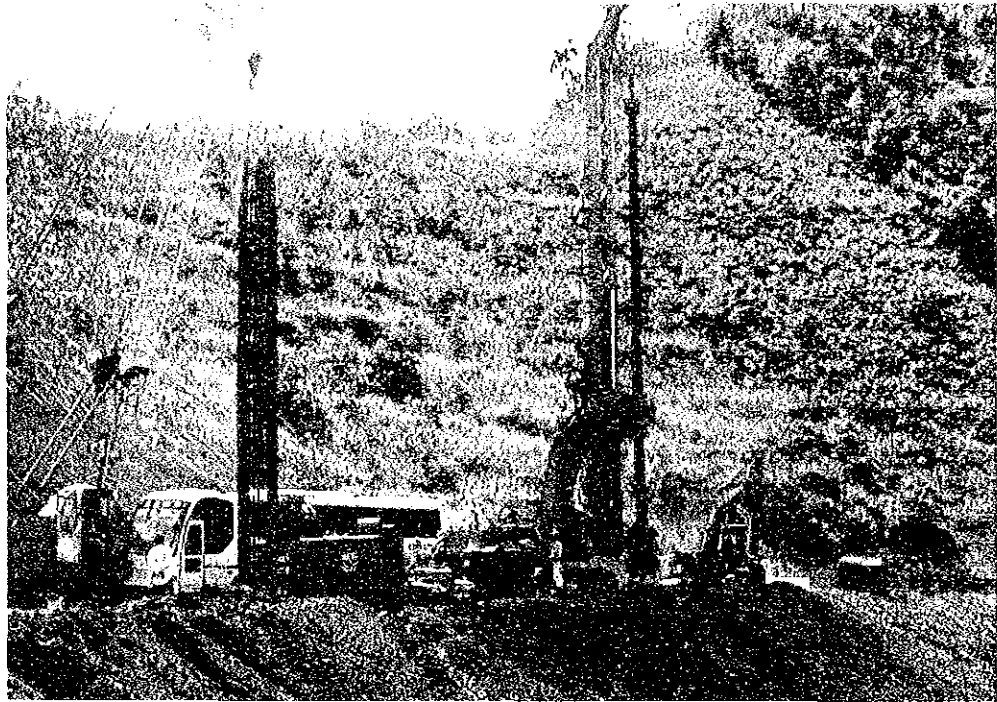
- 3) Reinforced concrete pile is used for countermeasure against landslide, but against landslide, reinforced concrete pile is not effective to protect landslide because the prevention work of landslide is need the strength of shearing strength of slip surface of landslide.

Figure 2.6.20 Cast-in-Place Reinforced Concrete Pile

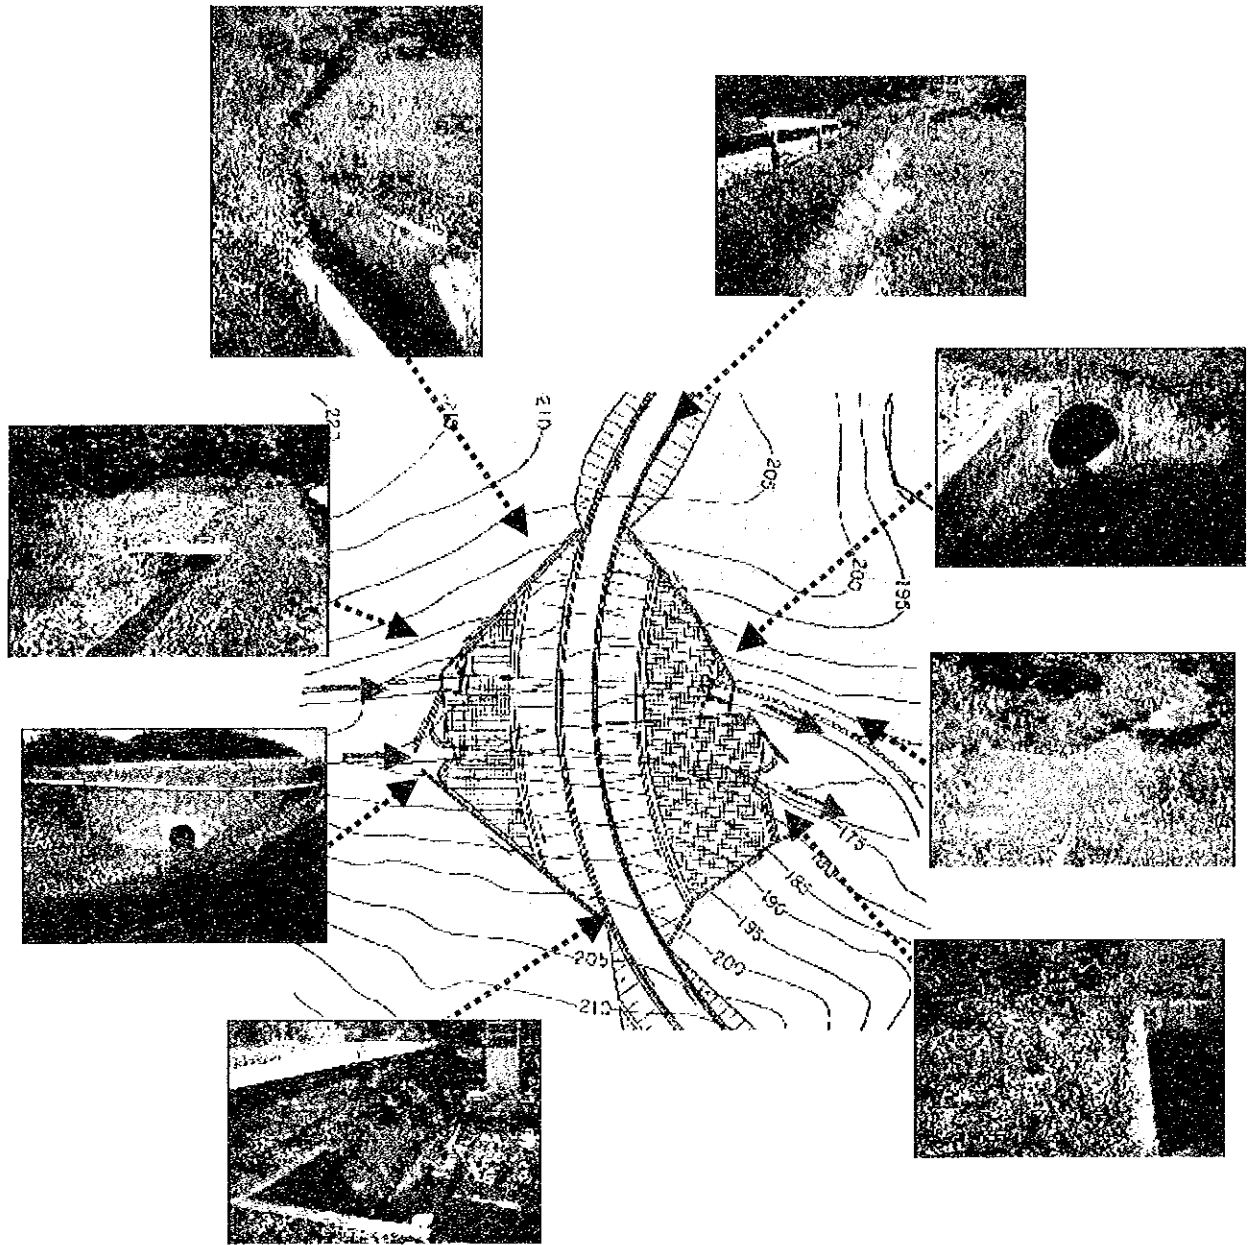
A general drainage system of mountainous road and existing drainage facilities in East-West Highway are shown in Figure 2.6.22. At East-West Highway, many improvement works have been carried out since it had been constructed about 20 years ago. It could be commented that most of the facilities are allowable and good condition beyond our expectations in point of a drainage capacity of the culvert and a structure of the inlet and outlet at present.

Figure 2.6.22 Drainage System of Mountainous Road and Existing
Drainage Facilities in East-West Highway

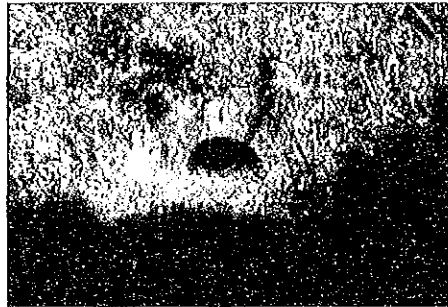
- Due to a shortage of the drainage capacity, pools might be formed at the inlet after rainfall.

Figure 2.6.23 Condition of Inlet at Chainage 38.4 km

Because the problems mentioned above might have much influence on a foundation of the embankment, prompt improvement and constant maintenance are required.

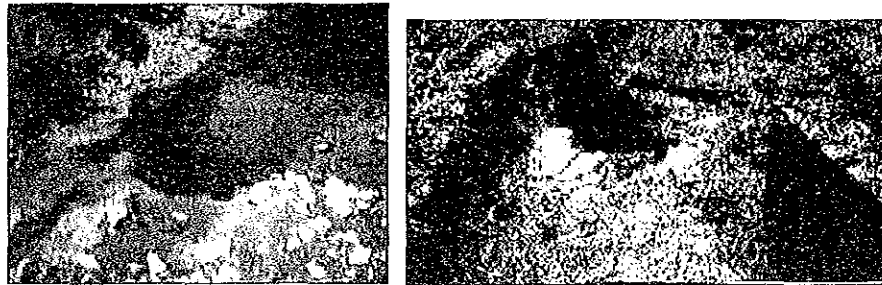
- Due to a lack of proper prevention works, there might be scoured caused by erosion at the outlet.

Figure 2.6.24 Erosion at the Outlet of Culvert (chainage 106.6km)

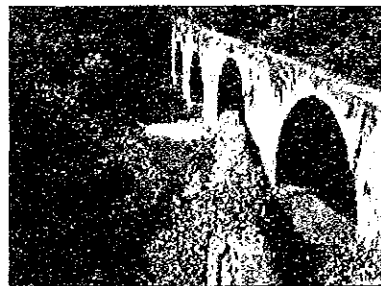
Deposit of sediments and/or drift plant might disturb an adequate water flow at the inlet and inner part

Figure 2.6.25 Sedimentation of Big Tree at chainage 28.4 km
