3.4 Geological Investigation

Suitable methods and procedures were used onsite for the geological investigation and instrumentation of the road slope in Malaysia. The study team selected three representative sites to study the stability of the EW highway. The objectives of the study are as follows.

The EW Highway is about 117km long and crosses mountainous terrain with difference of elevation (relief) exceeding 1000m. Most of the routes lie adjacent to rock slopes.

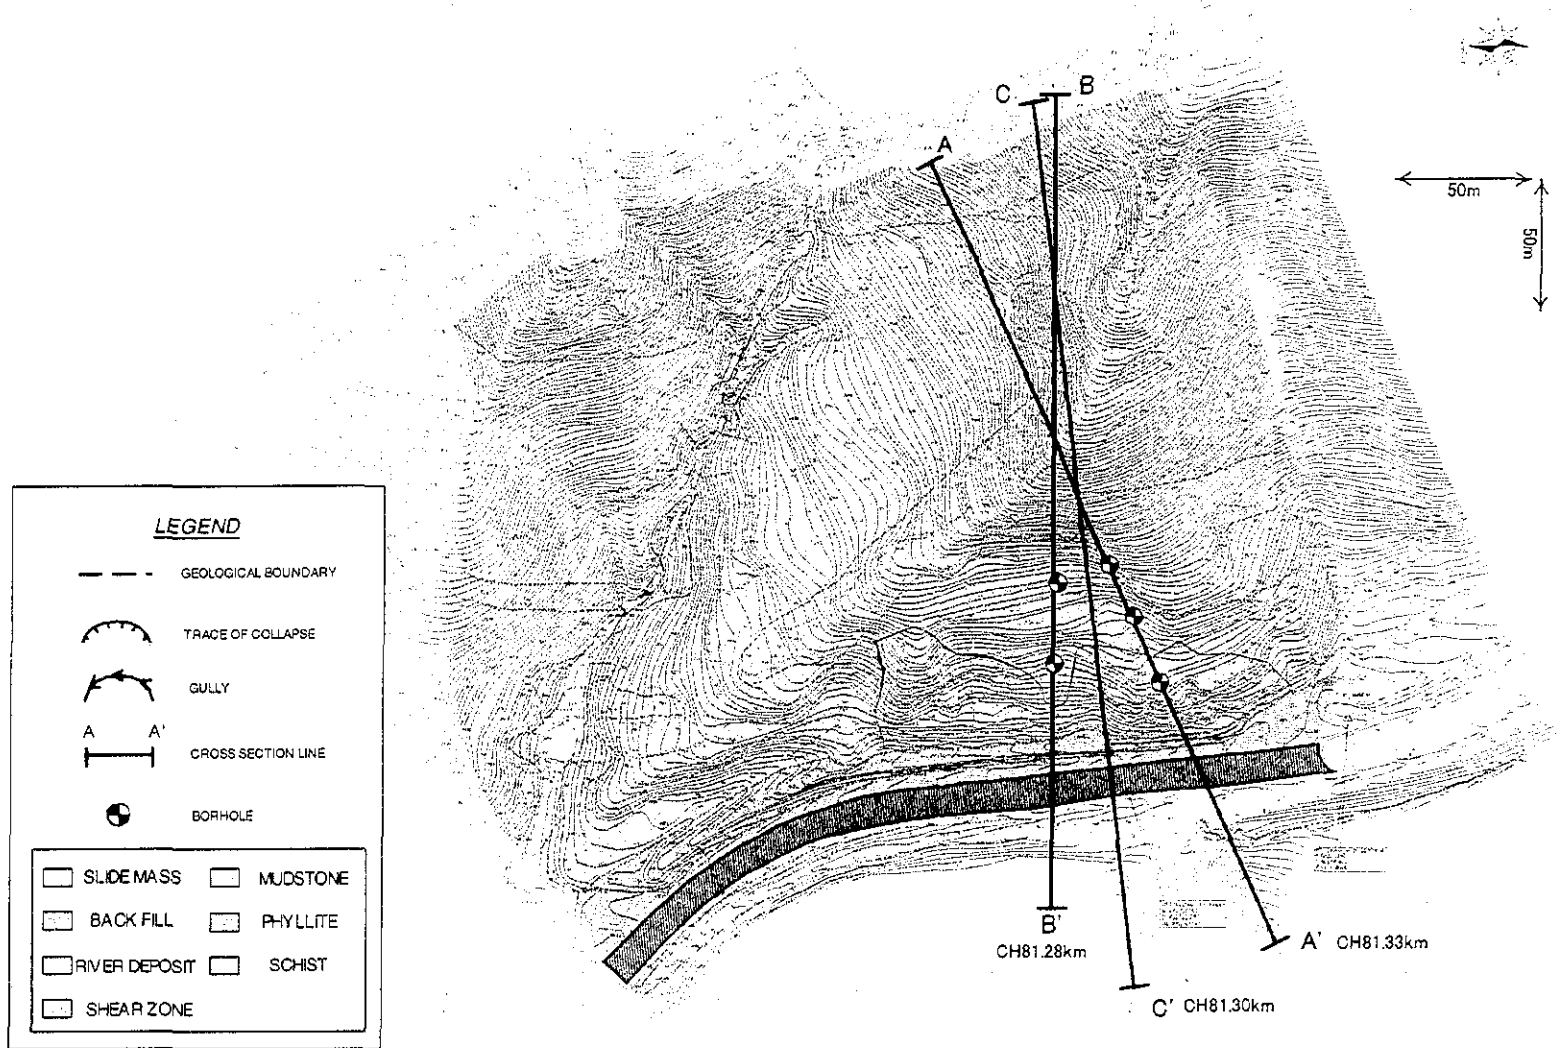
Figure 3.4.3 Geological Map at CH81.33km

- 1) Landslide mass consist of several active small blocks as shown in Figure 3.4.2. When the slope inspection was carried out, block-A movement was considered more important to the road, so the study program was planned along main section A-A'. As the study progressed, the behavior of main landslide mass is also considered important, so the program of boring investigation was modified to do additional borings BH-4 and BH-5 in section B-B' (CH81.28km). The geophysical survey was executed in section A-A' (CH 81.33km) and section C-C' (CH 81.30km).

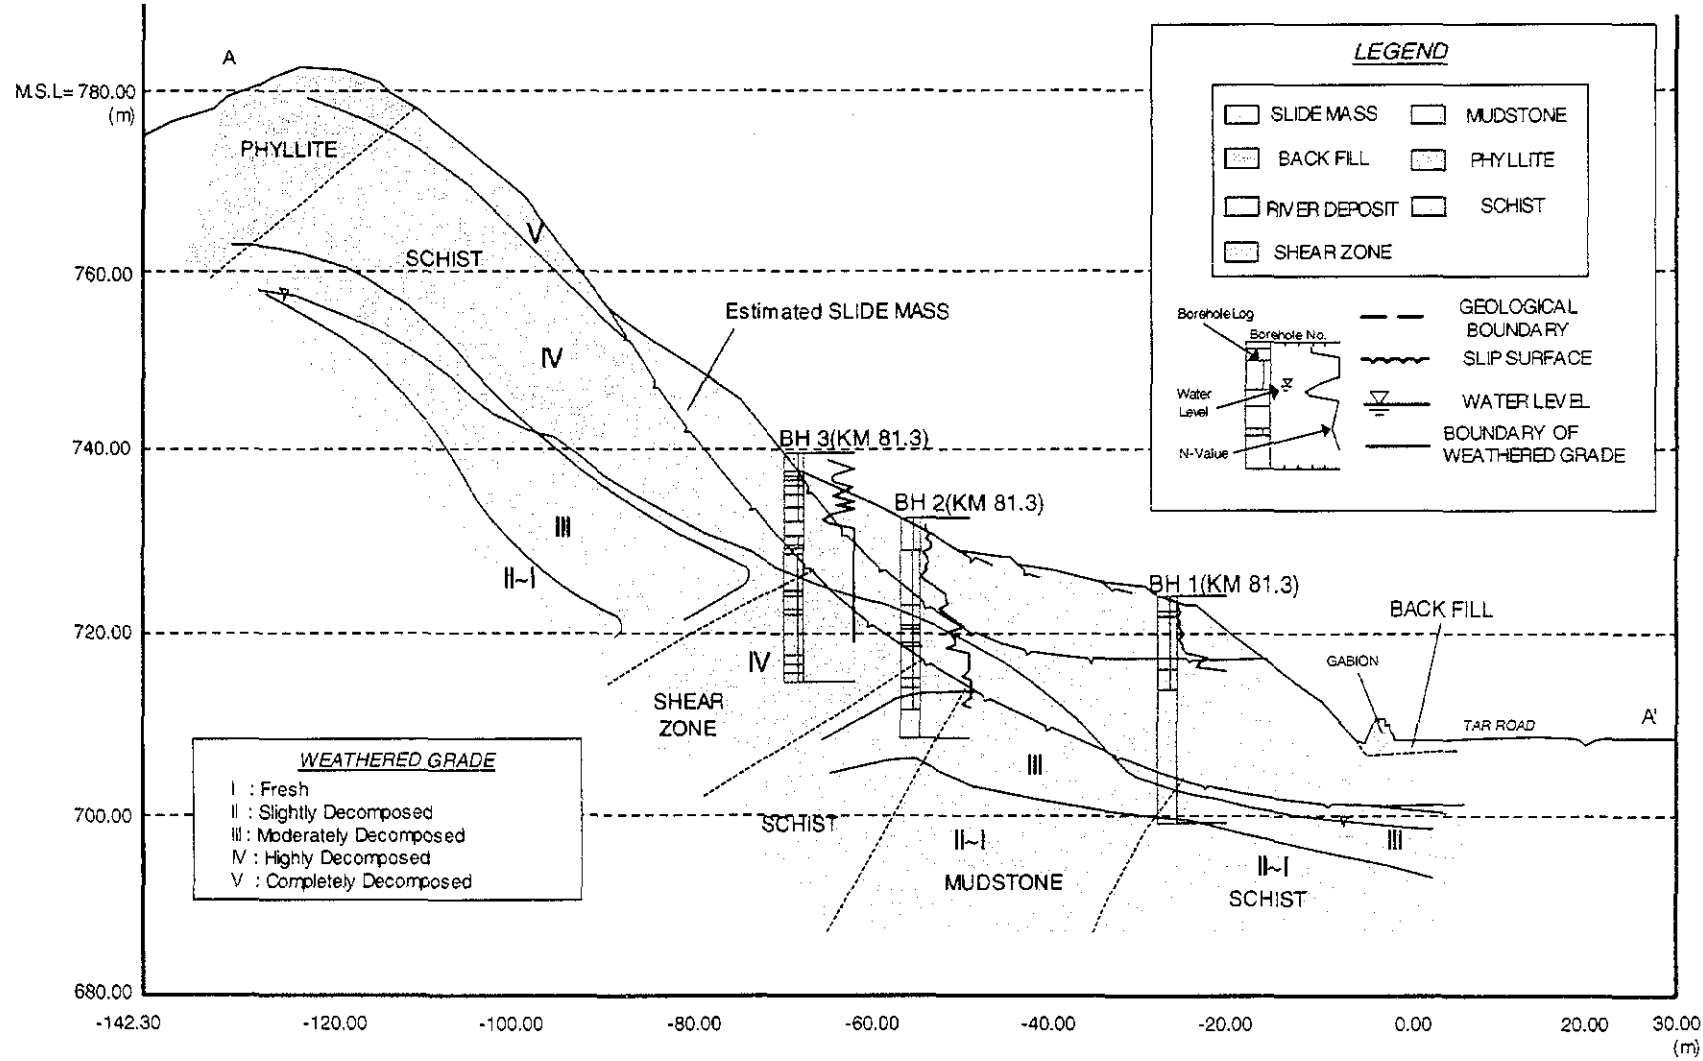
Figure 3.4.4 Geological Cross Section A-A': CH81.33km

- 2) The landslide surface is estimated as line A-A' in Figure 3.4.4 and as line B-B' in Figure 3.4.5. Estimated sliding surface A-A' and b-e-b' is occurring the zone of shearing failure in the rock, that zone is classified highly weathered class-V, the movement and velocity is small, since lowering of the groundwater level now.

- 3) A line A-A' in Figure 3.4.4 and a line B-B' in Figure 3.4.5, are estimated talus deposits surface that SPT N-value is relatively low (less than 10blows/450mm), from ground level to depths of about 6.0m for the following boreholes: BH-1, BH-2, BH-4, and BH-5. The materials generally consist of silty CLAY and clayey SILT with some gravel including completely weathered rocks.

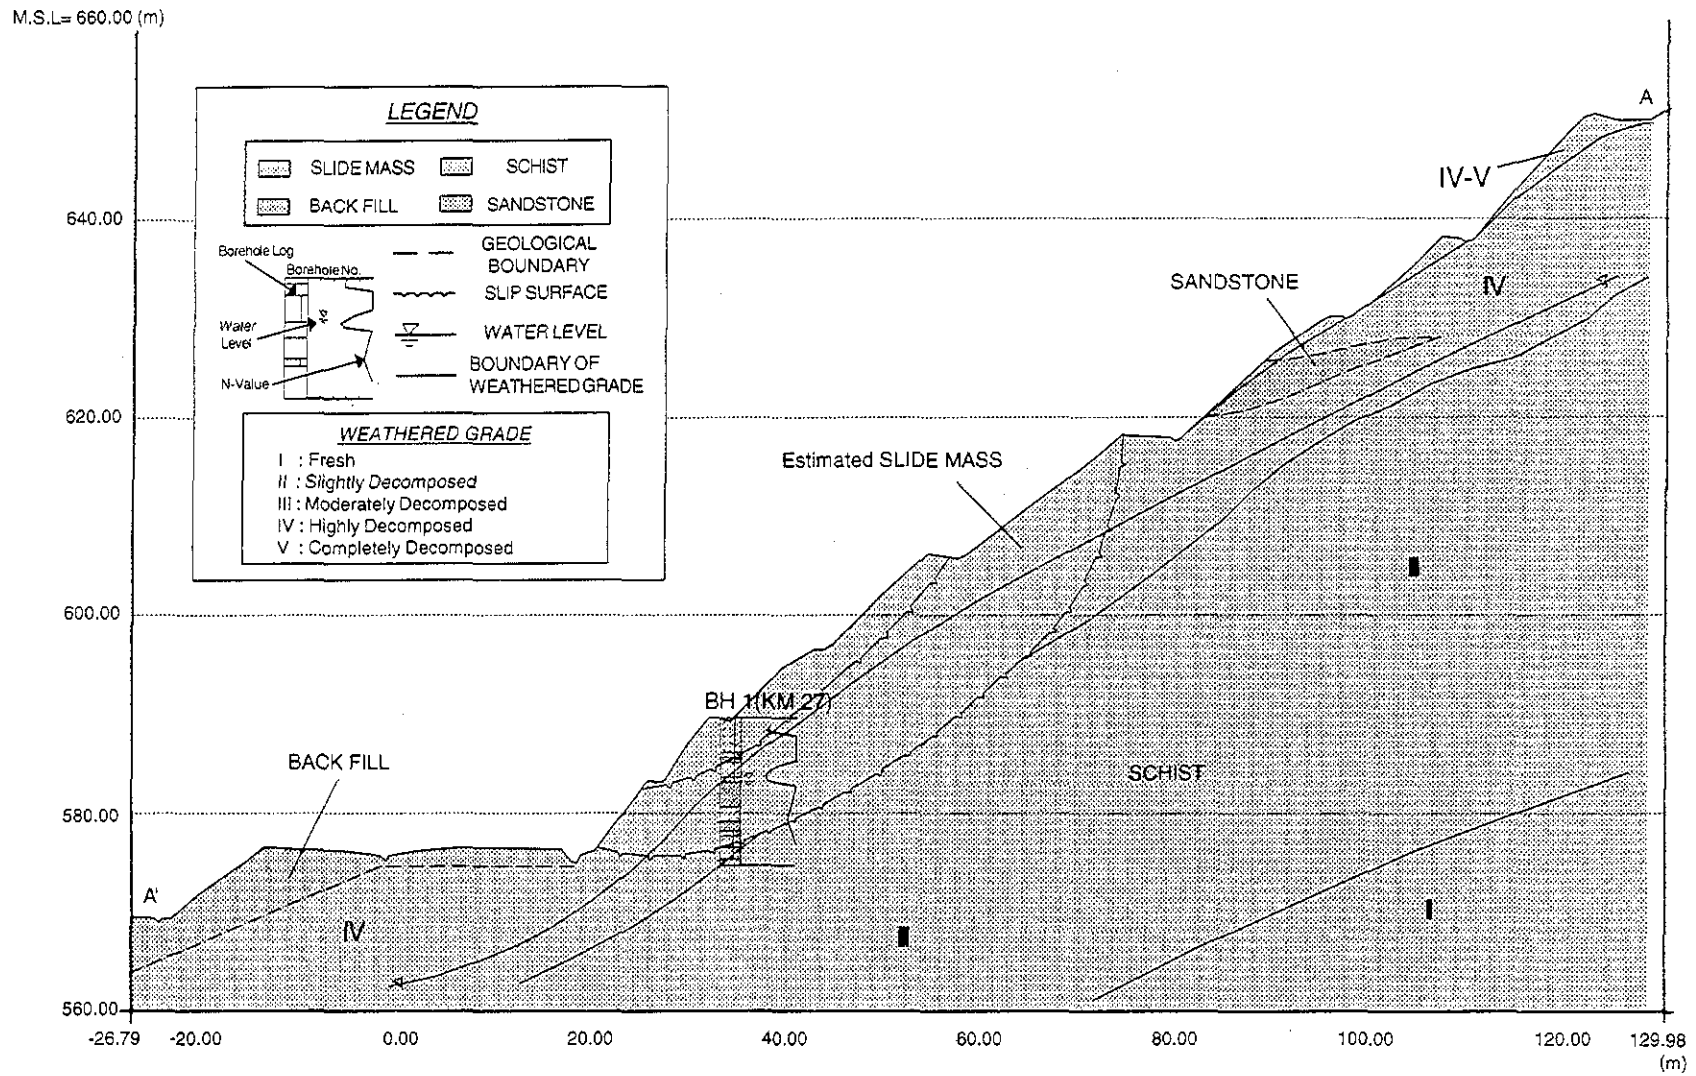
Figure 3.4.11 Geological Cross Section A-A': CH27.00km

- (5) The site feature around CH 26km to CH 27km is suspected to be the topography of a natural landslide by the photographic interpretation. The road and cut slope is crossing on the top of the landslide topography. The construction of the road by cutting on the natural slope is made to increase the stability of the natural landslide.
- (6) A drastic countermeasure should be taken for the slope since the risk of collapse is the same as neighbouring collapse area. The estimated volume of collapse is around 5m deep at boring location on the study section shown in Figure 3.4.11.

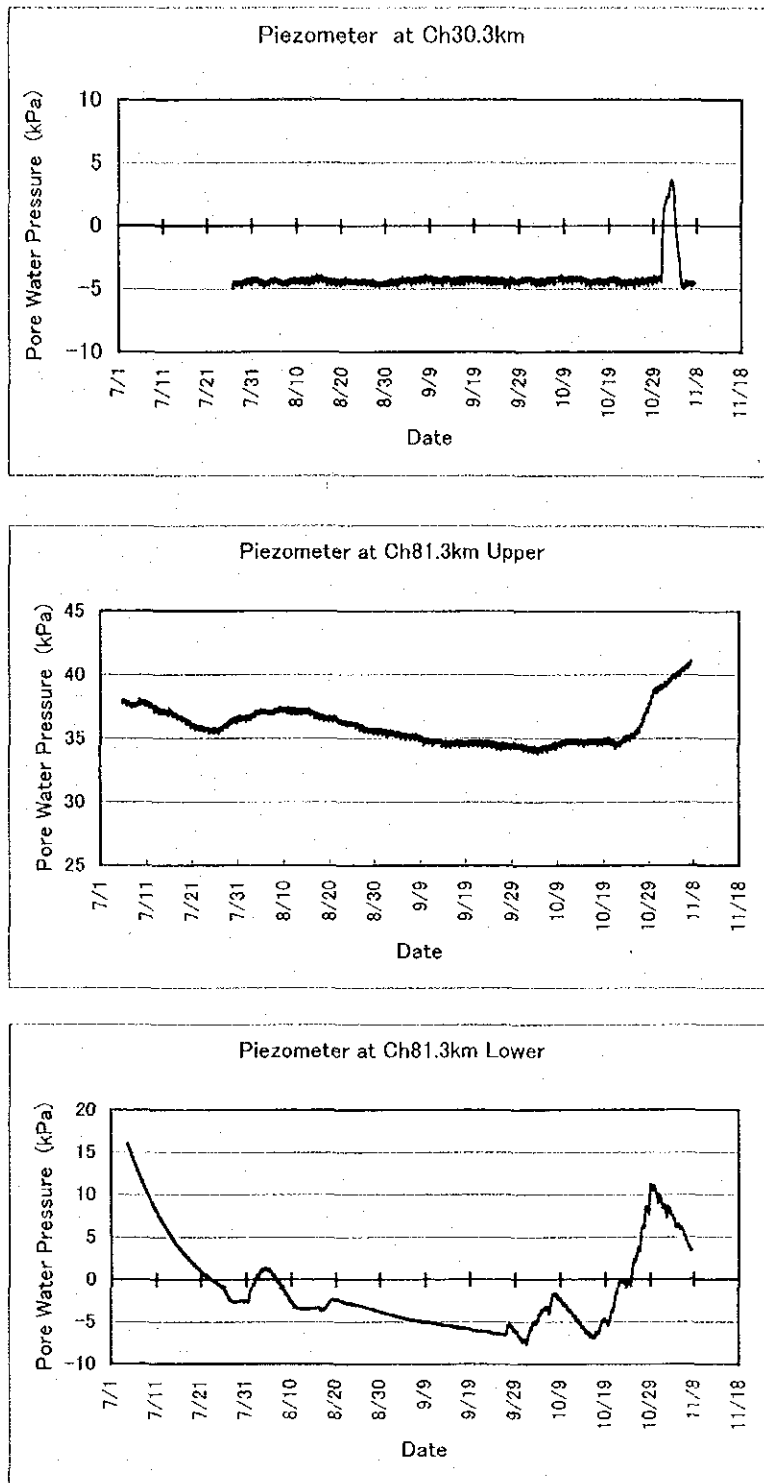
Figure 3.5.5 Piezometer Monitoring Result

- i) *Three Surface Wire Extensometers were installed at Ch27.0km and Ch81.3km and no clear movement has been seen at three extensometers*
- ii) *Three Piezometers are installed at Ch27.0km and Ch81.3km. They shows high pore pressure in late October to November and low pore pressure in September.*
- iii) *Very stable ground temperatures were monitored by thermometers in piezometers as shown on Figure 3.5.6.*
- iv) *Inclinometers show no clear movement.*

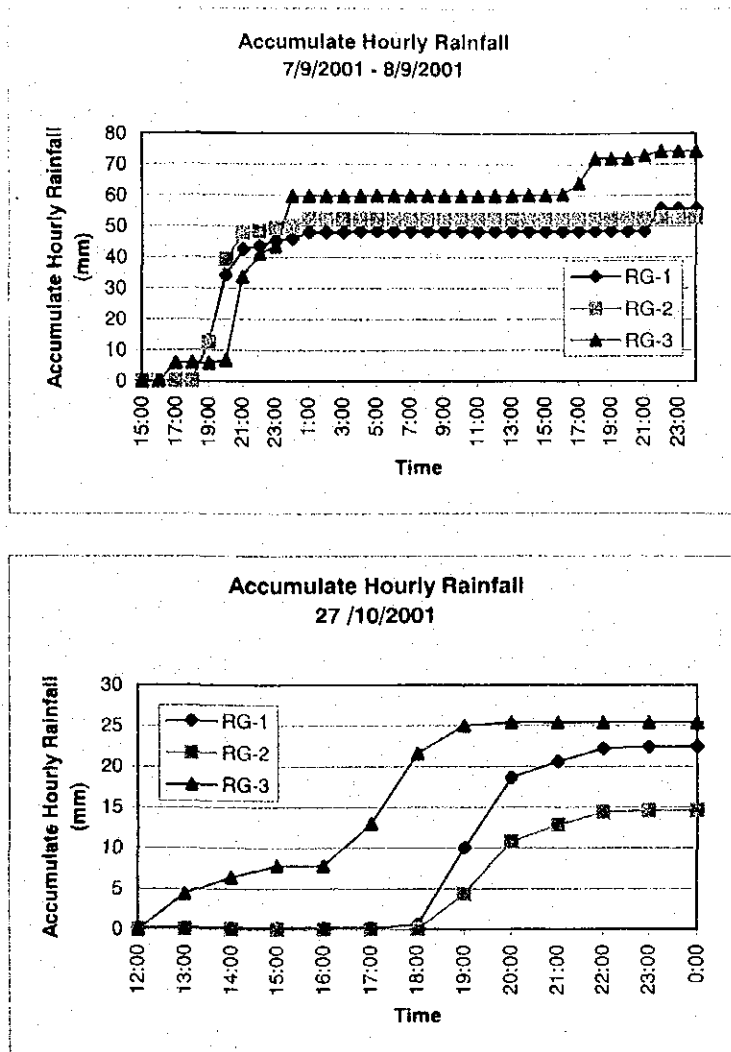
Figure 3.5.15 Comparison of Accumulate Hourly Rainfall at Rain Gauge

- i) Three rain gauges were installed at Ch27.0km, Ch30.3km and Ch81.3km. Monitoring has been done for five months from 6th July 2001 to 6th November 2001.
- ii) The amount of Rainfall at three location are different even between Ch27.0km and Ch30.3km which are close by each other as shown on Figures 3.5.8 and 3.5.10.
- iii) Maximum hourly rainfall was,
Ch27.0km 33.2 mm/hour on 29th Oct. 23:00-24:00
Ch30.3km 34.4 mm/hour on 24th Jul. 18:00-19:00
Ch81.3km 36.4 mm/hour on 10th Jul. 21:00-22:00.
- iv) Figure 3.5.14 shows the accumulate hourly rainfall at above time. It shows rainfall patterns at only two locations, Ch27.0km and Ch30.3km are similar. Sometimes the rainfall patterns at all locations are similar as on 7th September, 27th October as shown on Figure 3.5.15.

As mentioned above, the rainfall are deferent at location by location even if the locations are close each other.

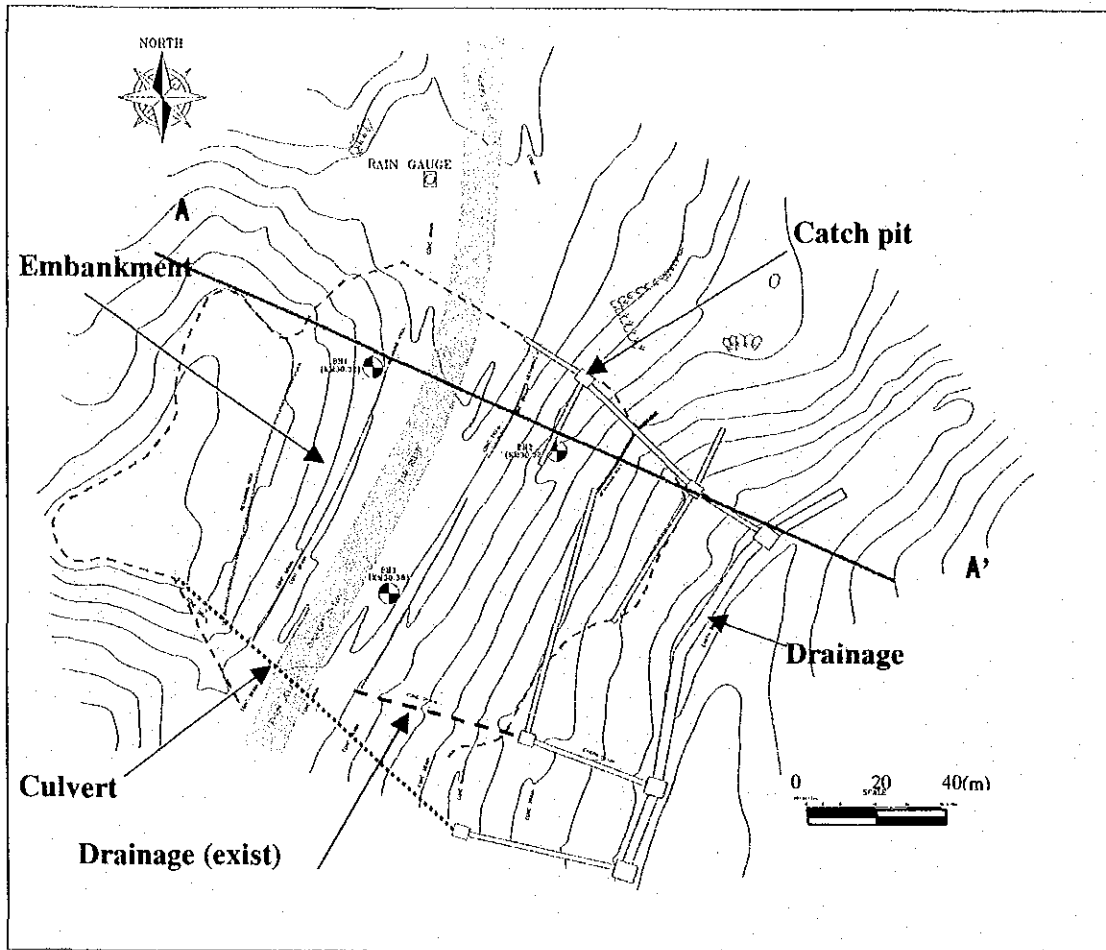
Figure 3.6.5 Plan of CH 30.30 km

The results of slope investigation show that maximum height of fill is 35 m and the groundwater level stayed almost original ground surface. Materials of fill are mainly silt and contain small amount of sand and gravel. Most part of fill was compacted more than 20 N-Value. The estimated collapse pattern is a progressive failure from lower erosion to upper part. So countermeasure of this site is complete drainage of berm and boundary of ground and fill.

Drain ditch and cascade : 180m

Surface drainage : 330m
