No. 1 Nam Khe (Tanh Hoa Prov.)

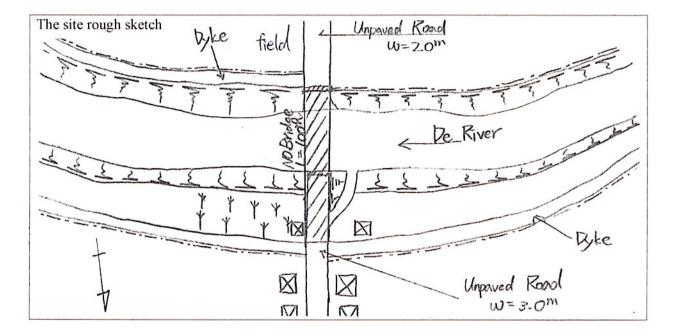
Pic. 1: The present bridge

Othe	er Information	
1)	War breaks and only left-bank abutments of a bridge remain.	
2)	Now, a ferryboat is not functioning, either. No crossing trace of people.	
2)	200m of the upstream, shore protection of both banks are repaird. 300m of the downstream, shore protection of the left bank are constructing.

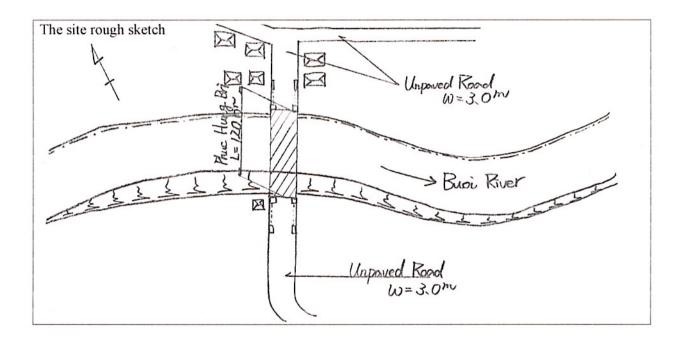
Pic. 1: The present bridge

- 1) Especially damage of the slab is remarkable.
- 2) A school and a hospital, is situated in the left bank. Right-bank residents' life road
- 3) In the case of the yard reservation for left-bank construction, lot purchase is needed.
- 4) Navigation restrictions are not required.
- 5) The water level of a flood is a left-bank attachment road side.

from the right bank of downstream

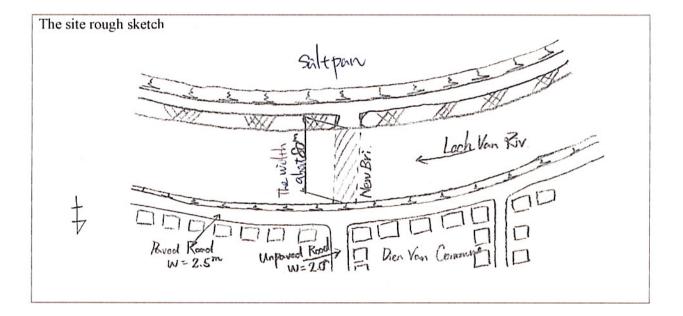
Pic. 1: The present bridge

- The access road from national highway No. 1 is narrow, and it is bad. Penetration of a track is impossible. It can be passed only through a small vehicle. There is a bridge (10t limit)on an access road.
- 2) It is a ferryboat (10 person) For 800 persons, a child and 200 persons are a laborer.
- 3) The clearance of a bridge is required more than MWL 5.0m.
- 4) It is flooded 0.5m from an attachment road side in flood.
- 5) It is difficult to purchase a lot, because a residential section is in the near left-bank side. (being parallel with a river)
 It is thought that a footbridge is suitable with judging from the number of users.

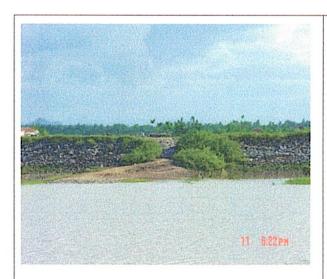
Pic. 2: The present bridge

downstream from the left bank
