No.10 Hoi (Ha Tinh Prov.)

No.13 Truc (Ha Tinh Prov.)

No.14 Ha Rong (Ha Tinh Prov.)

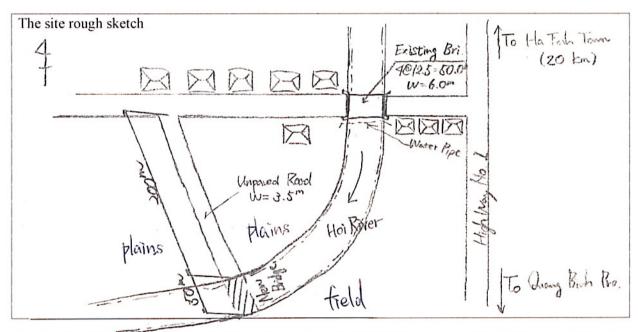
Pic. 2: The present bridge

- It is alternative bridge (metal I girder 60m) in 150m of the upstream. The bridge is situated in a 100m place from national highway No. 1.
- 2) It is flooded on dyke in flood. Therefore, they want right-bank residents to move to the left bank.
- 3) According to DOT, it is the bridge which requires emergency most. But there is no bridge now.
- 4) A left-bank access road (about 2km to national highway No. 1) is due to upgrade around March, 2002.

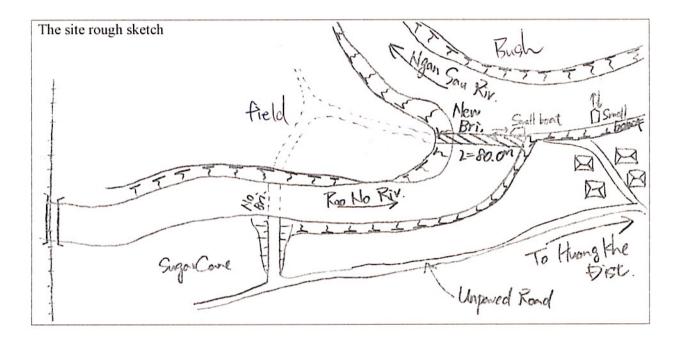
Pic. 1: The present bridge

- The old bridge was built over the branch. (1978 outflow)
 The proposed position is a downstream of a river side.
- 2) It is a railroad bridge to the branch upstream. (w=0.8m footbridge juxtaposition)
- 3) Plan to upgrade road by WB fund from around May, 2002.
- 4) There is a ferry boat.

from the right bank

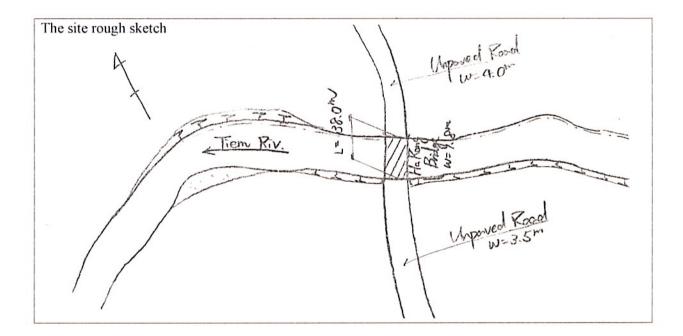
Pic. 2: The present bridge

- 1) the amount of flowing water in flood: $5000\sim7000 \text{m}3/\text{sec}$ the amount of flowing water in dry season: about 10 m3/sec, Driftwood
- 2) There is a gate to an access road left-bank side. The residents have managed.
- 3) There is no water in the dry season and passing waterway by vehicle is possible.
- 4) Submerged bridge is better.

from the left bank
