No. 33 Binh Dao Bridge

(Quang Nam Province)

No. 39 Song Dinh

No. 40 Lang Quang

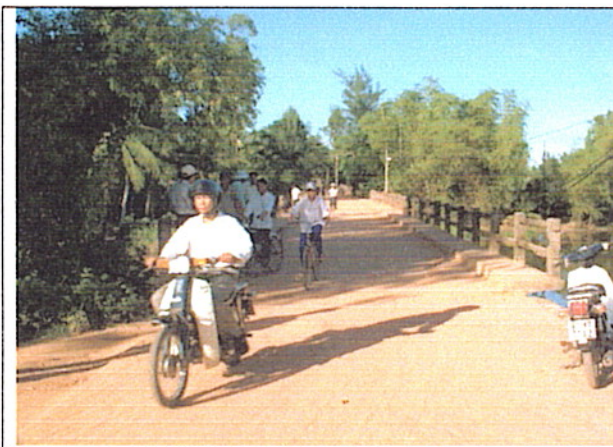
- 1) Constructed in 1977. Designed with 10ton load. Irrigation channel (1m wide x 1.5m high) is contained between the PC girders.
- 2) Existing navigation channel is 10mx2m. 18m x 4 will be required for the proposed bridge due to bigger size of ships and increased ship passage.
- 3) Still the bridge structure is in reasonable condition.
- 4) The highest flood level in 1999 = Bridge surface, the flood level of every year = girder bottom.
- 5) There is no reason for urgent replacement at present. There is a big problem to raise up the irrigation channel, in case the proposed bridge is constructed to meet the highest flood level (= bridge surface) and required navigation channel.

Picture 1: On bridge center line

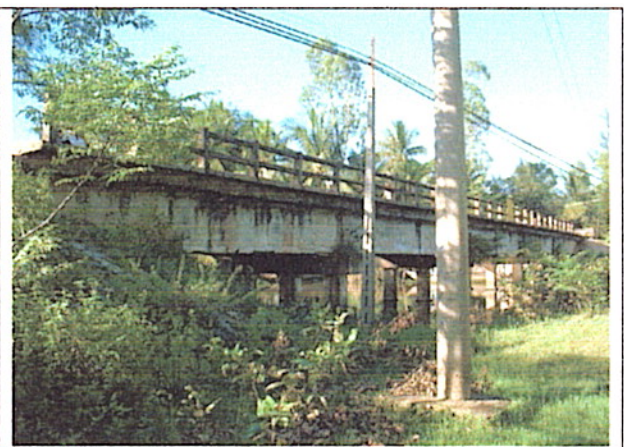
Picture 2: From the side

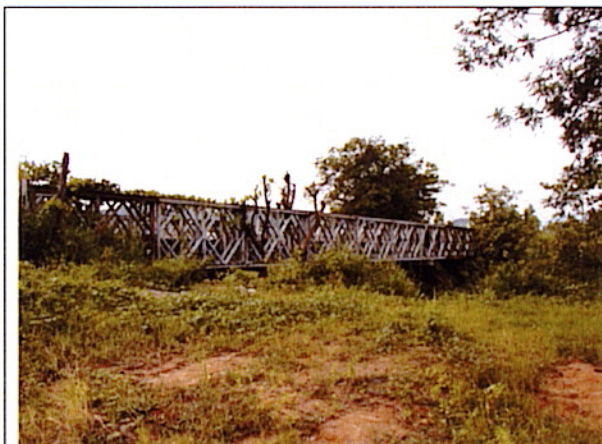
2) The existing bridge is a bailey-type and its wooden deck was replaced to the steel-meshed type in 1999 due to flood damages. Since all substructures are built on the bed-rock and are observed to be stable. The load of vehicles is limited to 13 ton.

Photo 1 : Existing Bridge

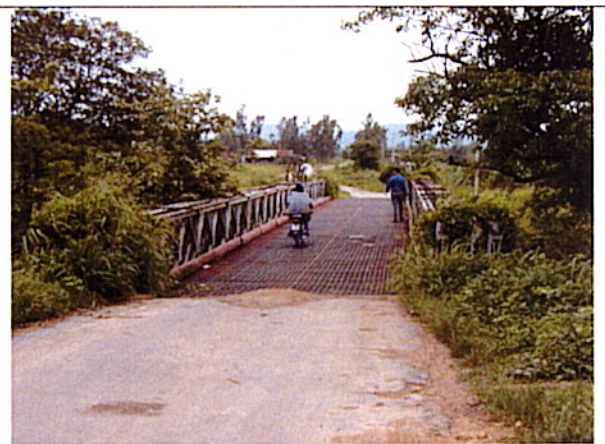
Photo 2 : Existing Bridge

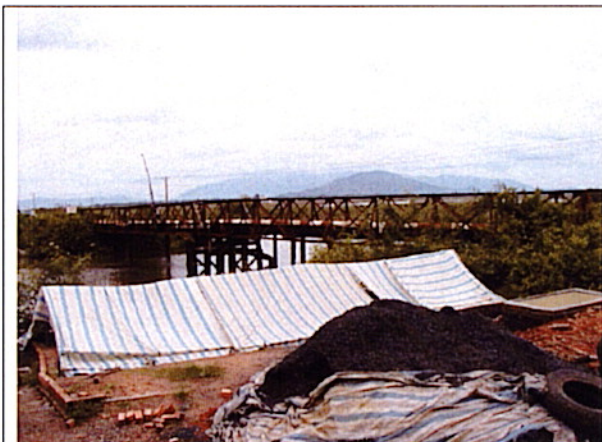
2) The existing bridge is an effel-type built in the 1960s. The damage level of it is observed as medium. The connecting points between the bridge and its access roads are seriously deteriorated.

Photo 1: Existing Bridge

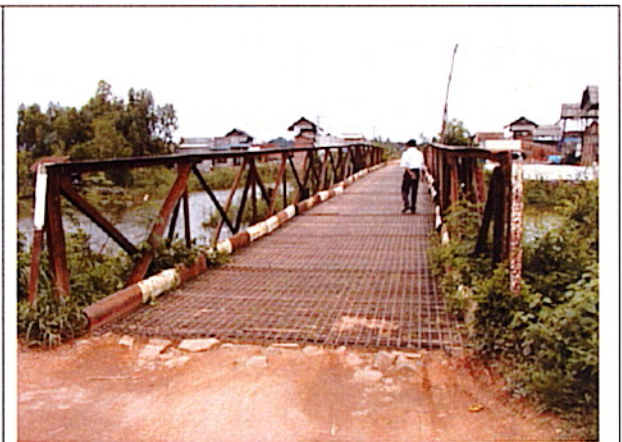
Photo 2: Existing Bridge
