**No.57 A Yun Ha Bridge**

**(Gia Lai Province)**

**No. 60 Suoi Boi Bridge**

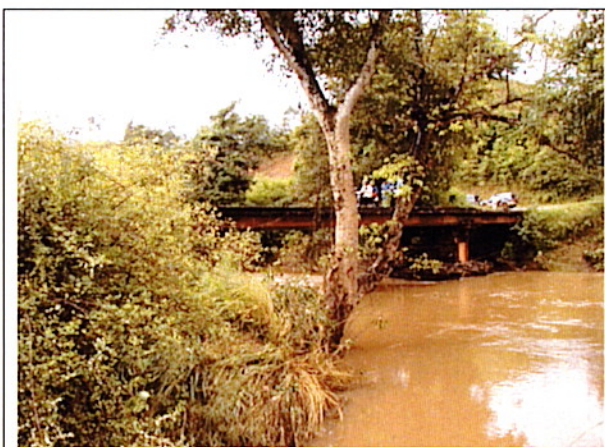
Photo 1: Existing Bridge

2) The existing bridge is a H-beam type and the progress of corrosion was observed. Protection work built by gabion matts around piers looks unstable. Although souring around the abutments were observed but not looks to reach serious damages
