No. 84 Chay

No. 85 Song Goc

No. 87 Be

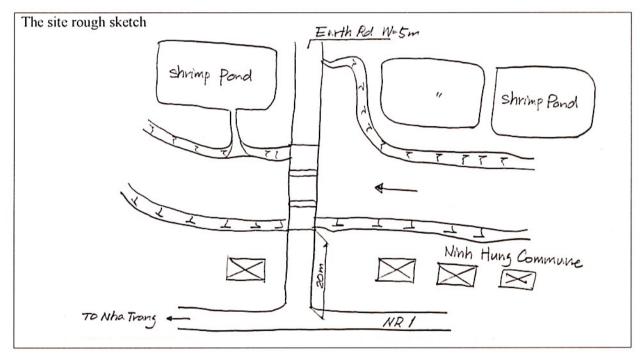
Photo 2: Existing Bridge

- 1) The access road to the bridge is an access route from 5 communes to NR1 bound for Nha Trang. However, there is another access route to NR1. There is transportation demand to carry agricultural productions such as sugarcane, banana, coconuts and mango.
- 2) The existing bridge is a H-beam type constructed in 1976. Corrosion on outer beams have been making progress but the inner beams still looks sound.
- 3) The existing access road is an earth road with 4-6m in width. The upgrade plan will be completed with 6.5m in width by 2002.
- 4) The bridge has suffered minor damages by flooding but overflow on the bride surface occurred in 1986, 1998 and 1999. HWL is assumed to be 0.4 m over the bridge surface according to the interview result
- 5) The centerline of the proposed bridge should be paid attention in order to avoid some houses on the left bank.

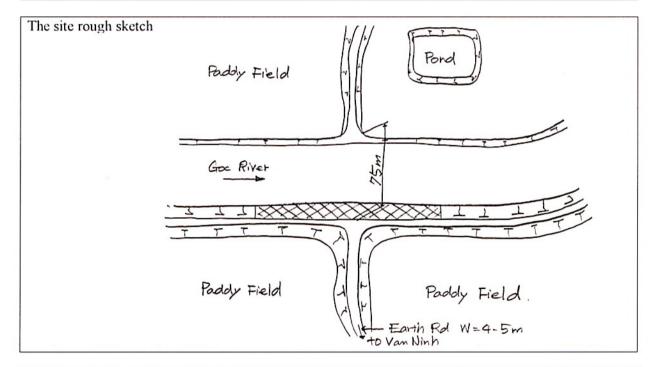
Photo 2: Approach road to the proposed bridge

- 1) This bridge is located on DR No.5, Hgyuen Hue Road, same as No83 Ngoi Ngan is. There was a bridge crossing over the Goc River 20 years ago. There will be transportation demand to carry fishery production from shrimp farms to access the district center.
- 2) There is no bridge crossing the river. This river has 75 m in width with slow flow and is affected by tide. There is one meter of tidal difference. The dike was strengthened by stone masonry after 1999 flood. There has been no flood passing over the dike.
- 3) The local government has been looking for the fund for a 500m approach road to the bridge on the left bank. The alternative route to the district center has poor condition at the moment. The access road on the right bank was not upgraded but has a plan to improve by 2001.

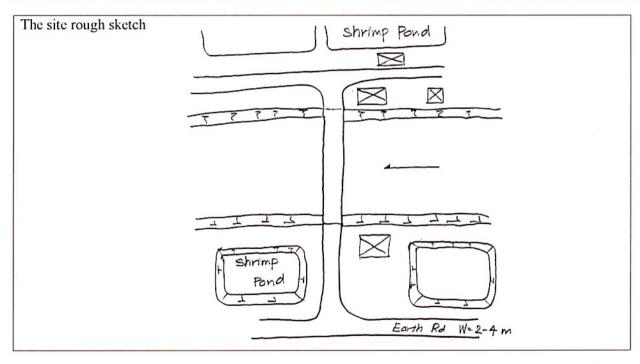
Photo 1: Existing Bridge

- 1) There is little traffic demand on the bridge because Vinh Thai Bridge was constructed in 1996 at the downstream side of the bridge. The bridge is used for only access to shrimp ponds. Traffic volume is only 100 motorcycles and people per day.
- 2) The existing bridge is a wooden type constructed in 1994. Nha Trang city constructed it and entrusted management of it to the commune.
- 3) There is little damage on the bridge by flooding. HWL is assumed to be 0.1m over the bridge surface. There is one meter difference in the water level by tide.
- 4) Access roads have poor conditions such as narrow width, inundation part at high tide and bad alignment. It is no plan to be upgraded.
