**No. 43 Tam Ngan Bridge – Component A -**

**( Ninh Thuan Province)**

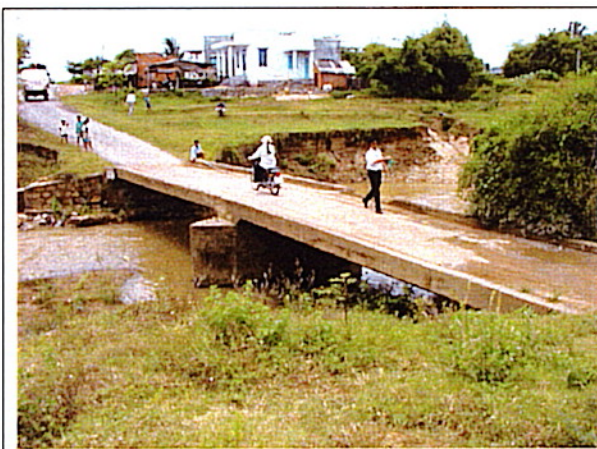
- 2) The existing bridge was built before 1975. The damage level of H-beams is observed to be low at the moment although corrosion of the beams has been making progress. In addition, scouring around a pier and abutment was observed. The load of vehicles is limited to 5 ton.

Photo 1: Existing Bridge

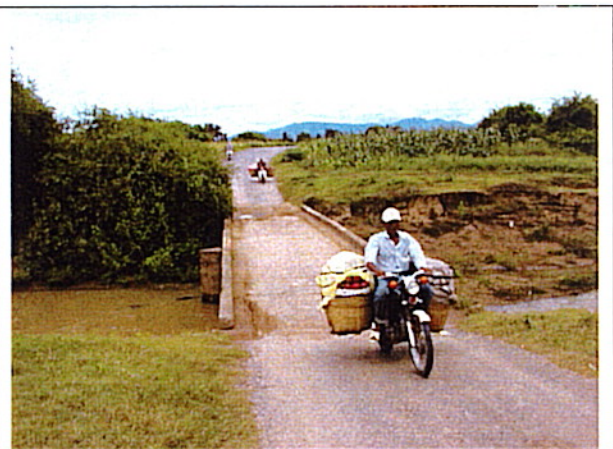
Photo 2: Existing Bridge

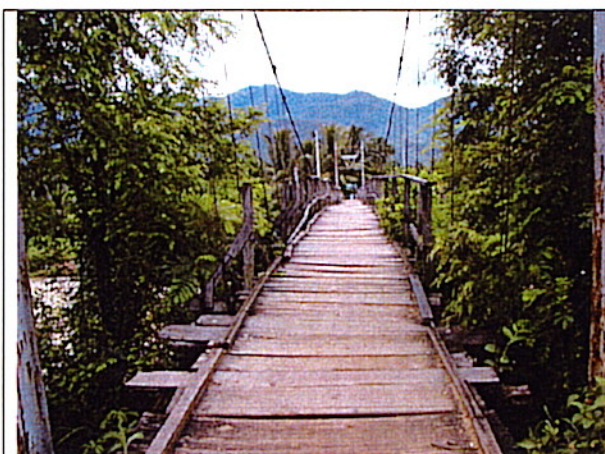
- 2) The existing bridge is a suspension type for pedestrian constructed in 1992. The heavy vehicles cross the river only in dry season. Damages are observed on the deck of the bridge

Photo 1: Existing Bridge

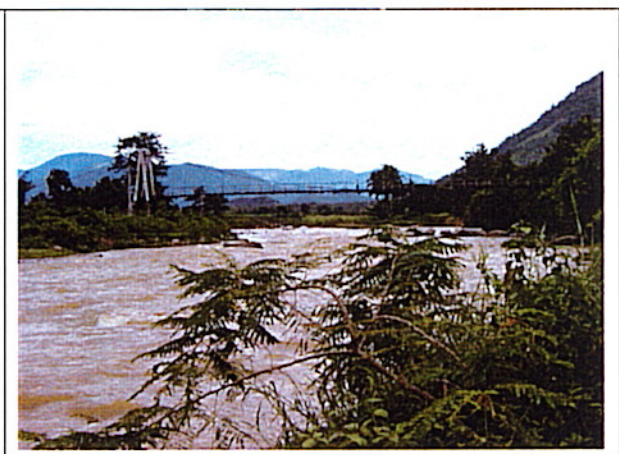
Photo 2: Side view

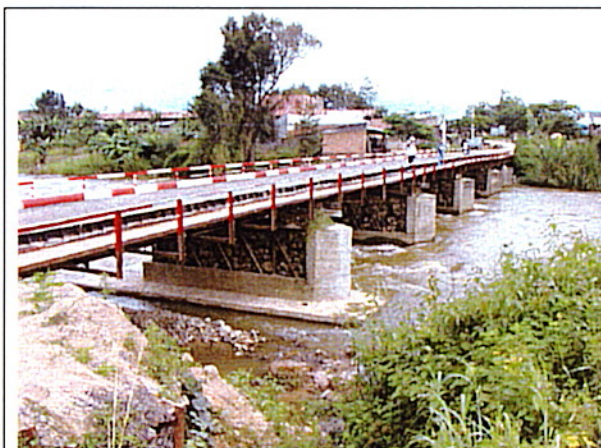
2) The existing bridge is a H-beam type and its substructure is composed of RC and gabion mattresses constructed in 1978. The flood in 2000 swept A1 abutment away and cause the collapse of the first span. It took three weeks to repair it and the steel-meshed slab was applied instead of the wooden one. Although corrosion on the H-beams is making progress, serious damages are not observed. The load of a vehicle is limited to 13 ton.

Photo 1: Existing Bridge

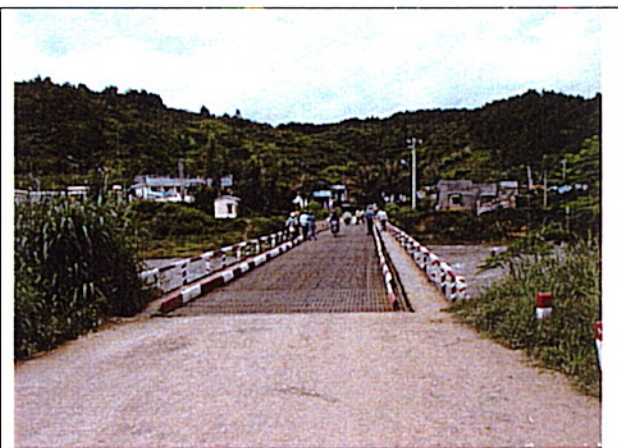
Photo 2: Existing Bridge
