No. 1 Nam Khe (Tanh Hoa Prov.)

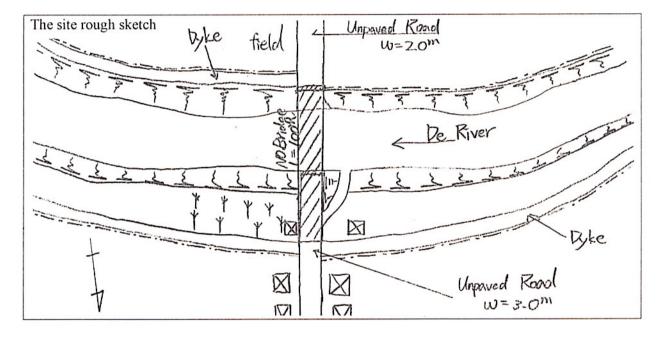
Pic. 1: The present bridge

Other	Information
1)	War breaks and only left-bank abutments of a bridge remain.
2)	Now, a ferryboat is not functioning, either.
,	No crossing trace of people.
2)	200m of the upstream, shore protection of both banks are repaird.
	300m of the downstream, shore protection of the left bank are constructing.

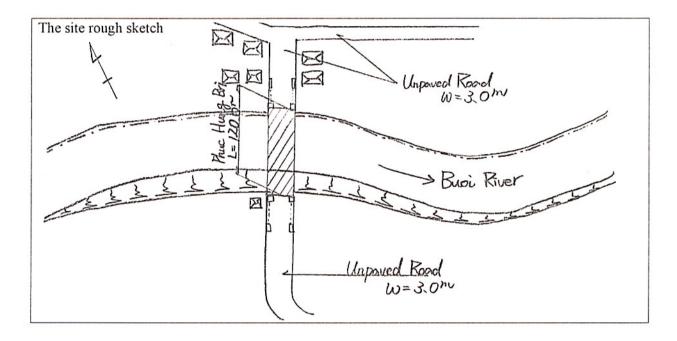
Pic. 1: The present bridge

- 1) Especially damage of the slab is remarkable.
- 2) A school and a hospital, is situated in the left bank. Right-bank residents' life road
- 3) In the case of the yard reservation for left-bank construction, lot purchase is needed.
- 4) Navigation restrictions are not required.
- 5) The water level of a flood is a left-bank attachment road side.

axis direction from the right bank

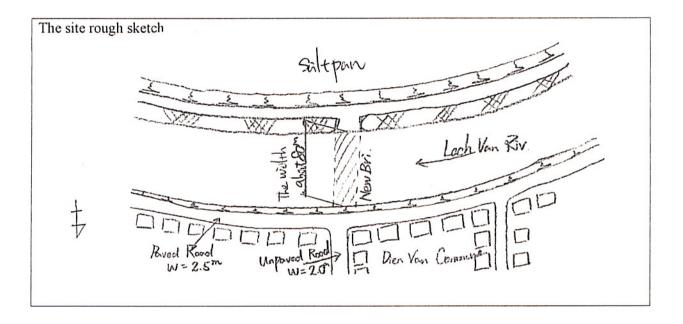
Pic. 1: The present bridge

- The access road from national highway No. 1 is narrow, and it is bad. Penetration of a track is impossible. It can be passed only through a small vehicle. There is a bridge (10t limit)on an access road.
- 2) It is a ferryboat (10 person) For 800 persons, a child and 200 persons are a laborer.
- 3) The clearance of a bridge is required more than MWL 5.0m.
- 4) It is flooded 0.5m from an attachment road side in flood.
- 5) It is difficult to purchase a lot, because a residential section is in the near left-bank side. (being parallel with a river)
 - It is thought that a footbridge is suitable with judging from the number of users.

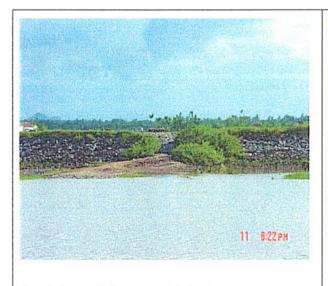
Pic. 2: The present bridge

downstream from the left bank
