No. 33 Binh Dao Bridge

(Quang Nam Province)

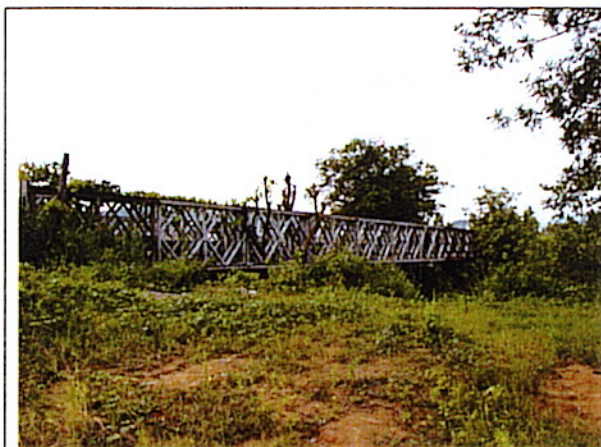
Photo 1 : Existing Bridge

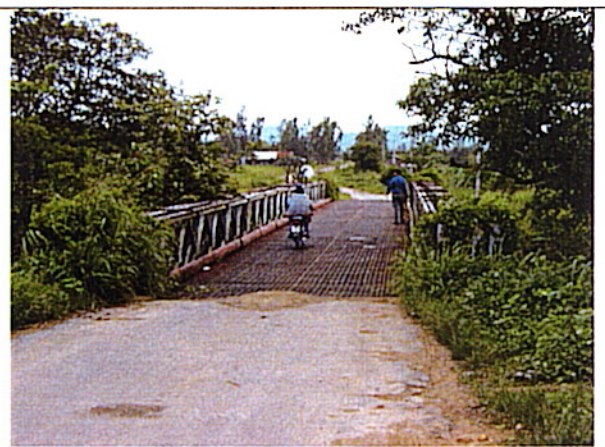
Photo 2 : Existing Bridge

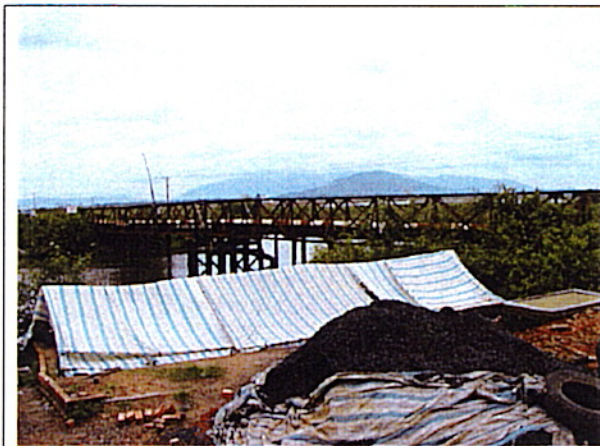
2) The existing bridge is an effel-type built in the 1960s. The damage level of it is observed as medium. The connecting points between the bridge and its access roads are seriously deteriorated.

Photo 1: Existing Bridge

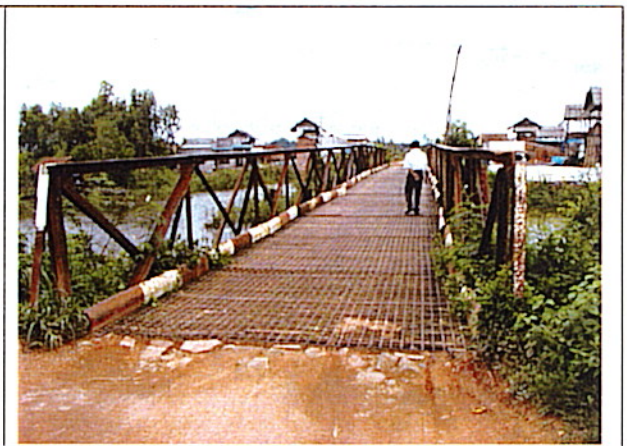
Photo 2 : Existing Bridge
