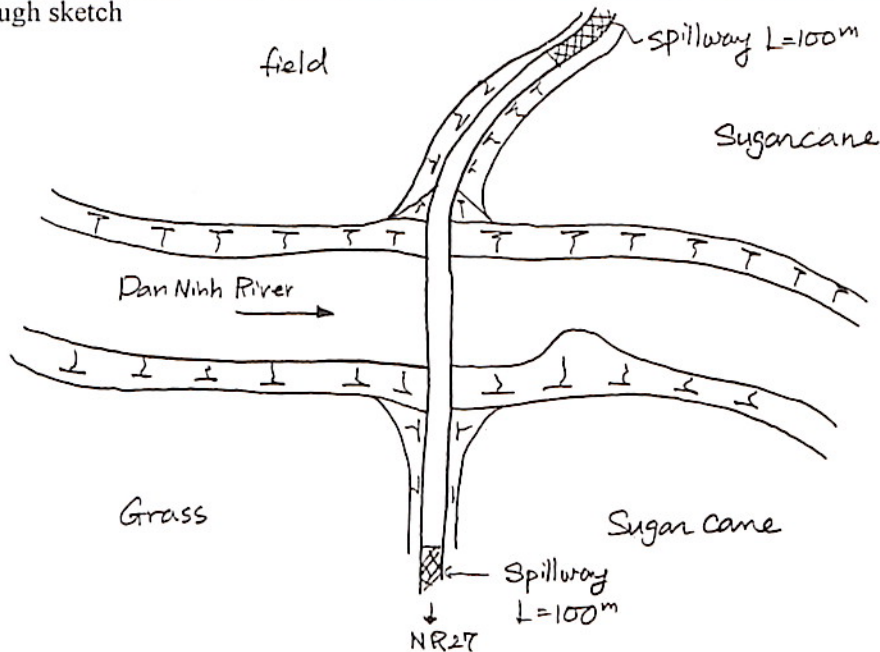
The site rough sketch

3) The discharge of a dam at the upstream side affects the HWL at the bridge site. The maximum discharge is 1,600 m³/s and the flow capacity of the river section at the bridge site is 400 m³/s. HWL is assumed to be 1.5m over the surface of the bridge. Impassable duration at flood lasts a few days a year.

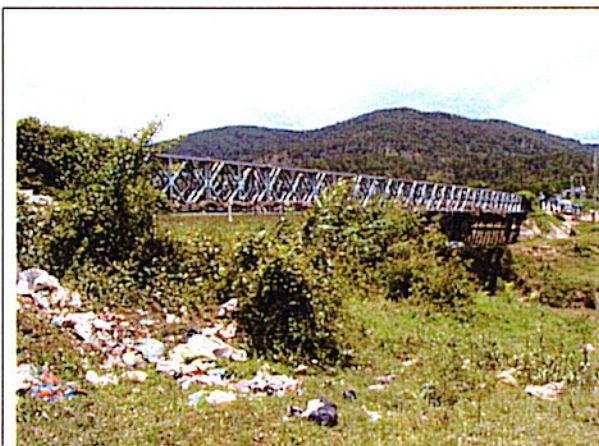
2) The existing bridge is a Bailey-type and little damages on the bridge are observed. The bridge moved aside due to the flood in 1993 and it was repaired. There are spillways with 100m in length on the both sides to flow the flood discharge.

Photo 1: Existing Bridge

5) Improvement of the river section is required because the only bridge improvement can not correspond to the flood flow in consideration with the maximum discharge.

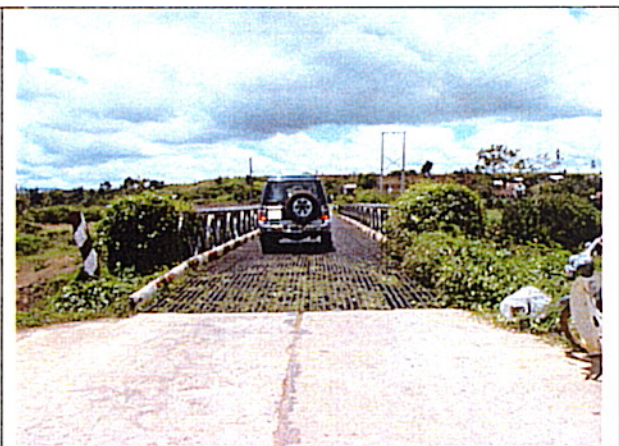
Photo 2: Existing Bridge

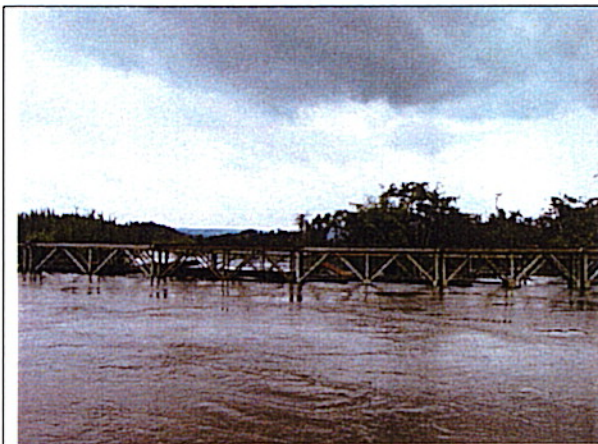
2) The existing bridge is a bailey type and it starts from the mountain edge to swamp area.

3) The flood overflows 1.0m over the bridge surface and it causes the bridge impassable for five and six times of a week a year. An access road on the right bank in the swamp allows overflow at flooding at the moment.

Photo 1: Existing Bridge

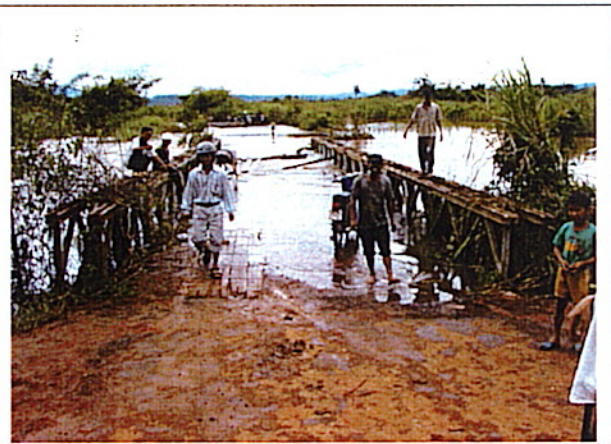
Photo 2: Existing Bridge
