**No.57 A Yun Ha Bridge**

**(Gia Lai Province)**

**No. 60 Suoi Boi Bridge**

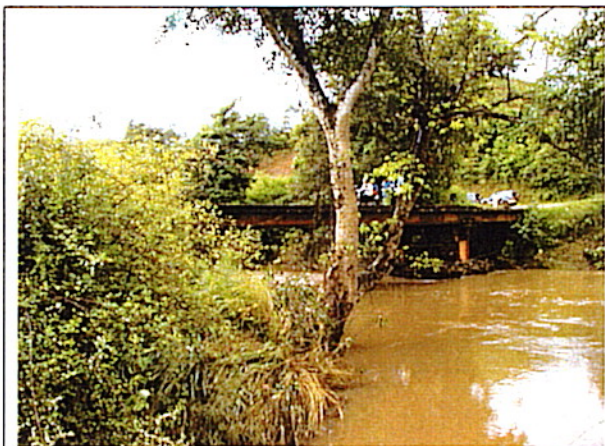
2) The existing bridge is a H-beam type and the progress of corrosion was observed. Protection work built by gabion matts around piers looks unstable. Although souring around the abutments were observed but not looks to reach serious damages

Photo 1: Existing Bridge

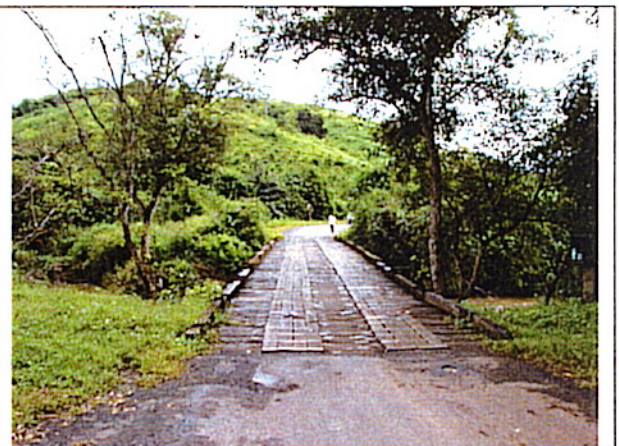
Photo 2: Existing Bridge

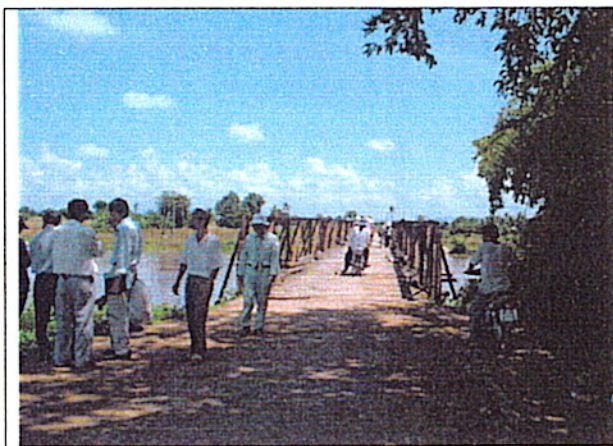
Picture 1: On bridge center line

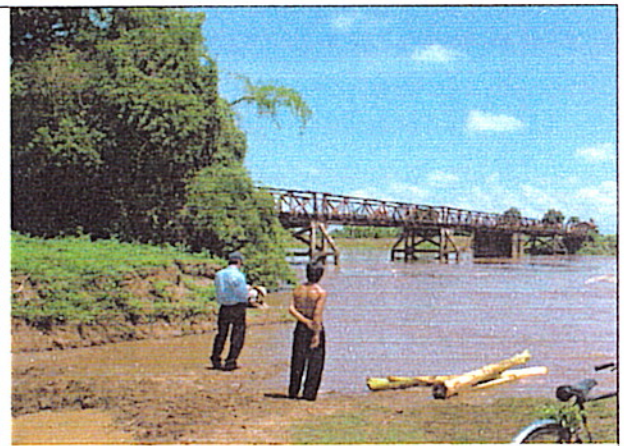
Picture 2: From the side
