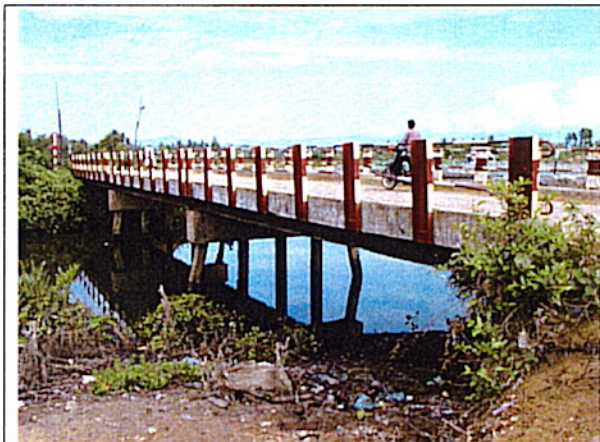
Photo 1: Existing Bridge

- 1) The access road to the bridge is an access route from 5 communes to NR1 bound for Nha Trang. However, there is another access route to NR1. There is transportation demand to carry agricultural productions such as sugarcane, banana, coconuts and mango.
- 2) The existing bridge is a H-beam type constructed in 1976. Corrosion on outer beams have been making progress but the inner beams still looks sound.
- 3) The existing access road is an earth road with 4-6m in width. The upgrade plan will be completed with 6.5m in width by 2002.
- 4) The bridge has suffered minor damages by flooding but overflow on the bridge surface occurred in 1986, 1998 and 1999. HWL is assumed to be 0.4 m over the bridge surface according to the interview result.
- 5) The centerline of the proposed bridge should be paid attention in order to avoid some houses on the left bank.

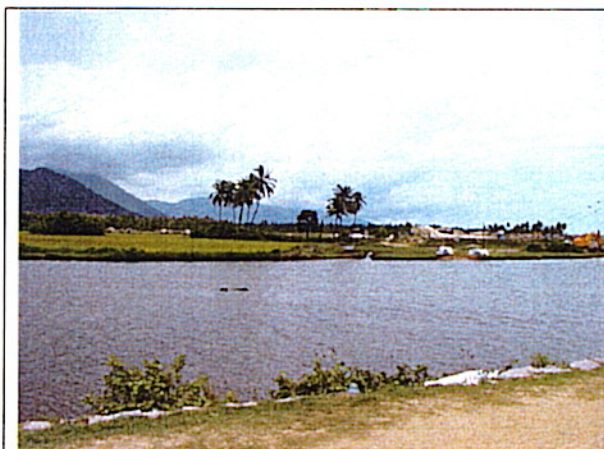
Photo 1: Crossing Point

2) There is no bridge crossing the river. This river has 75 m in width with slow flow and is affected by tide. There is one meter of tidal difference. The dike was strengthened by stone masonry after 1999 flood. There has been no flood passing over the dike.

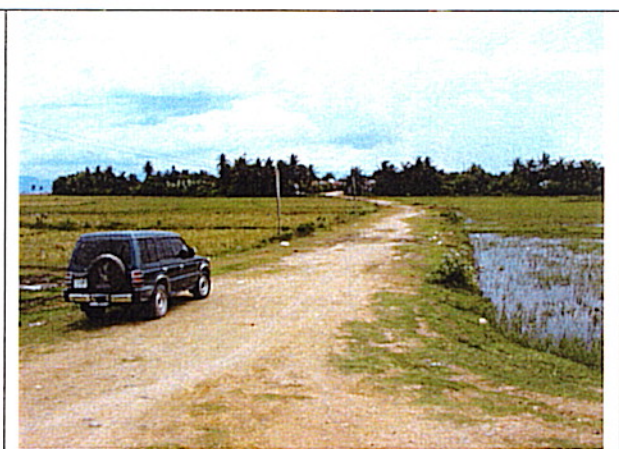
Photo 2: Approach road to the proposed bridge

3) The local government has been looking for the fund for a 500m approach road to the bridge on the left bank. The alternative route to the district center has poor condition at the moment. The access road on the right bank was not upgraded but has a plan to improve by 2001.

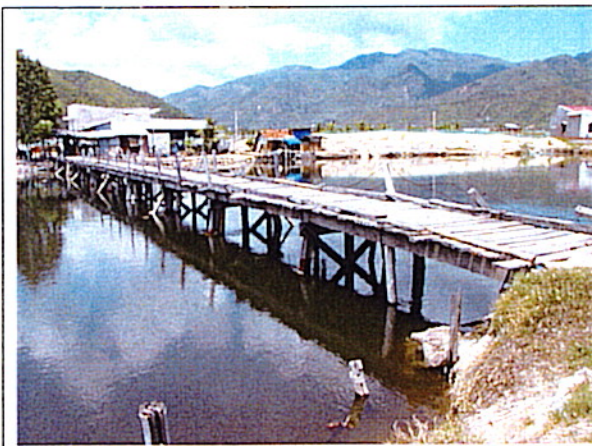
Photo 1: Existing Bridge

2) The existing bridge is a wooden type constructed in 1994. Nha Trang city constructed it and entrusted management of it to the commune.

3) There is little damage on the bridge by flooding. HWL is assumed to be 0.1m over the bridge surface. There is one meter difference in the water level by tide.
