# Report on

## On-Site Survey for Building Construction in Kathmandu Valley

(Assessment of Ongoing Building Construction Technology)  
by Site Visit Team Members from JICA Study Team and NSET-Nepal

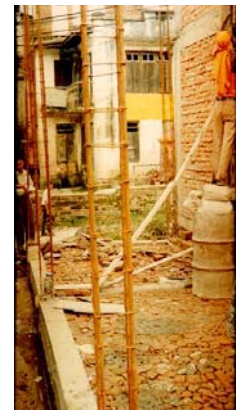
- Insufficient column bars for four story
- Insufficient column ties  
(small size 4.75mm, spacing 150mm c/c )
- Poor ductile detailing (Tie hooks bends at 90°)
- Poor concrete work

Concreting work in column

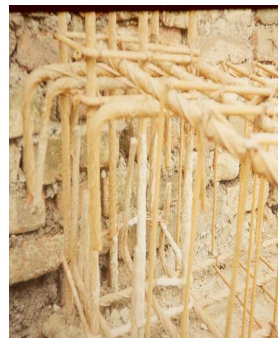
- Insufficient and improper anchorage of beam bars
- More spacing of column ties near beam-column joint
- Over sand in concrete mix (1:2:3)

Improper anchorage of beam bars

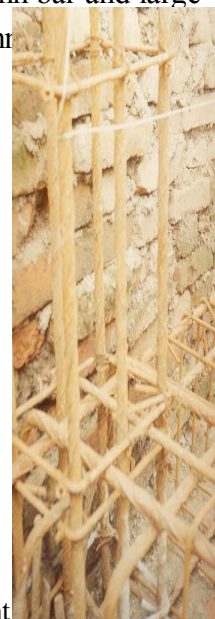
Use of column ties in joint, More spacing of column ties near beam-column joint

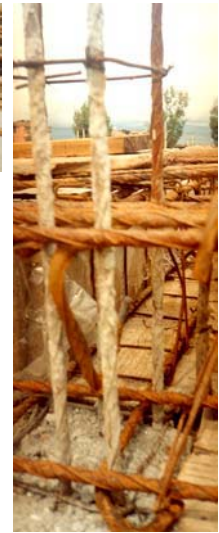
Column tie hooks bent at 90°

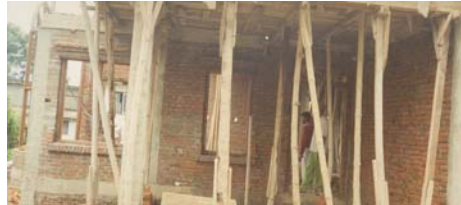
- Insufficient and improper anchorage of beam bars
- Large spacing of column ties
- Improper tie hooks (bent at 90°)
- Improper joint detailing
- Poor form working

Column ties and beam bars anchorage

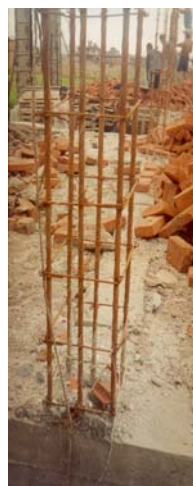
- Insufficient and improper column ties
- Column bars splices will be just above the slab
- Poor quality control in concreting work

Column Reinforcement

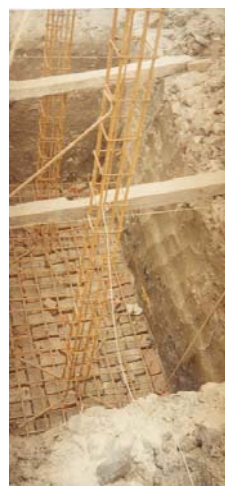
Foundation base reinforcement

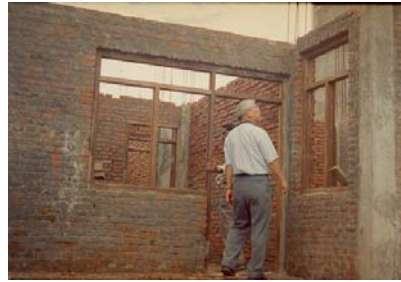
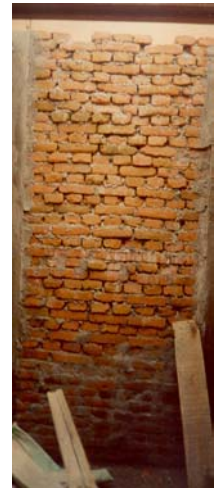
- Insufficient and improper column ties
- Column bars splices will be just above the slab
- Poor quality control in brick work

Ground floor column and Brick work

Poor quality Brick work

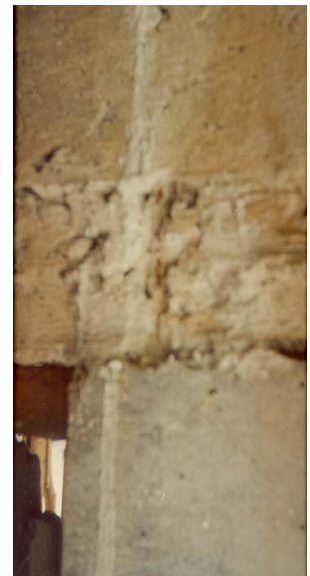
- Insufficient and improper column ties
- Column bars splices just above the slab
- Poor quality control in brick work (Vertical joint in the same line)
- Poor quality control in concreting work (No cover, honey combing)
- Unnecessary extra bars in slab in comparison to column bars  
(4 number. 12 mm dia bars in column, 10 mm dia bars at 150mm c/c in slab)

Slab Reinforcement

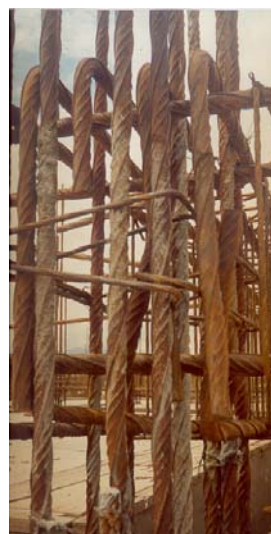
Proper tie hooks

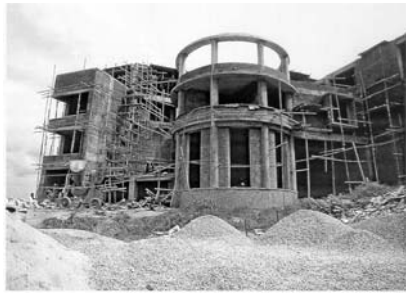
- Insufficient beam bars anchorage
- Improper tie hooks
- No connection of column bars in beam in top floor
- Column bars splices not staggered and no sufficient lap for development length needed

An engineered Building. Design and supervision by Engineering consulting firm, Construction by class A contractor.

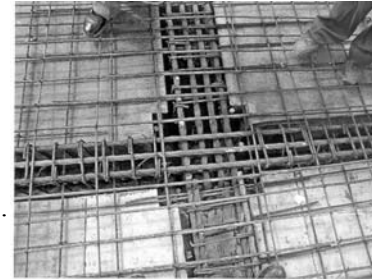
Columns bars just cut in slab level, no anchorage (Pin joint effect).  
Stirrup hooks at 90°.

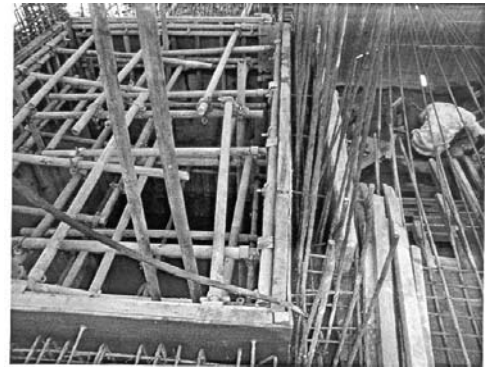
- Column bars not staggered for splices
- Excessive bars at joint very difficult for concreting works

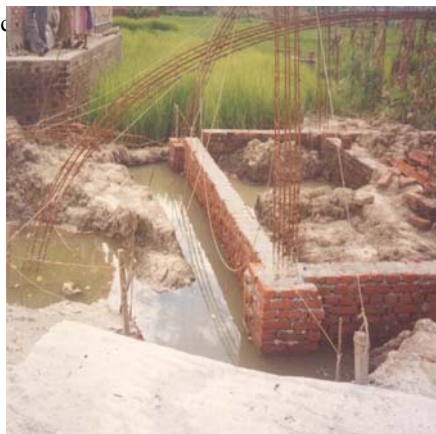
- Insufficient and improper column ties
- Poor quality of concrete

The work was just left since many days

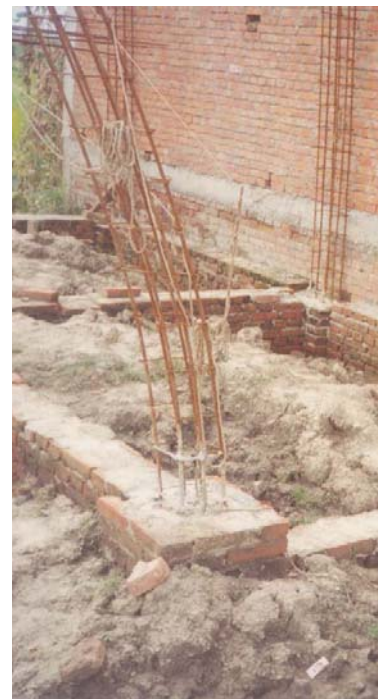
Erection of column bars

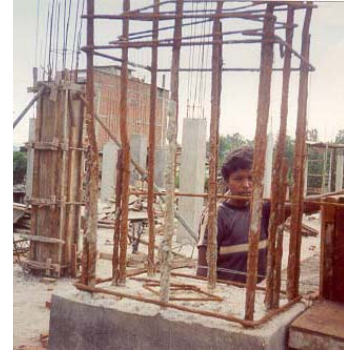
- Column bars splices at same level (not staggered and near slab)
- Beam bars connection (joint) in improper place

Column bars splices at the same level

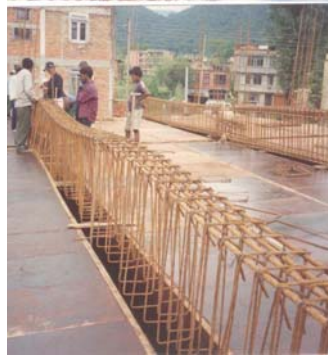
Beam Reinforcement with proper stirrups

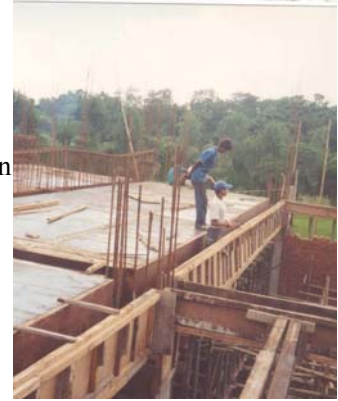
Location of column bars splices just above slab

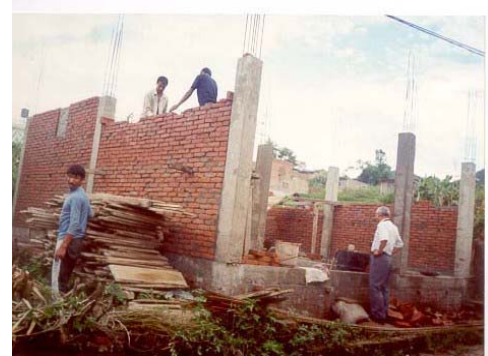
- Column bars splices at same level (not staggered and near slab)
- Very less column ties and large spacing

Construction of frame and inserting of heavy infill

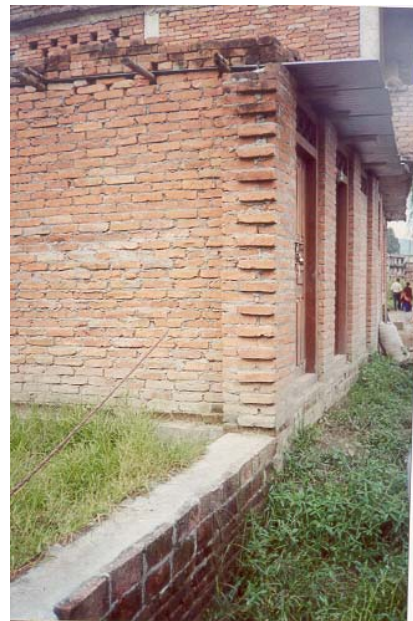
- No connection between wall to wall
- No connection between wall to floor
- Stage construction without extra measures

Projected bricks (toothing) for wall to wall connection

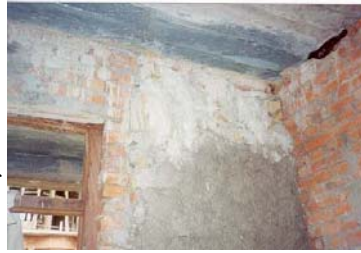
No connection between two walls, one in stone masonry and other in brick masonry

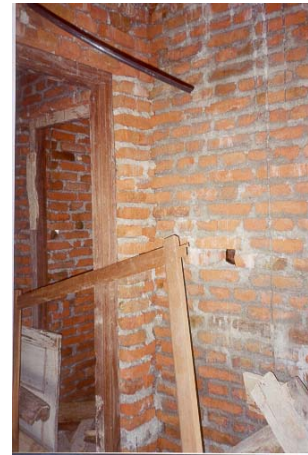
Very poor connection between two orthogonal walls

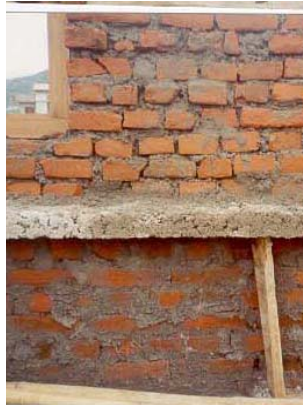
Improper bonds between walling masonry units

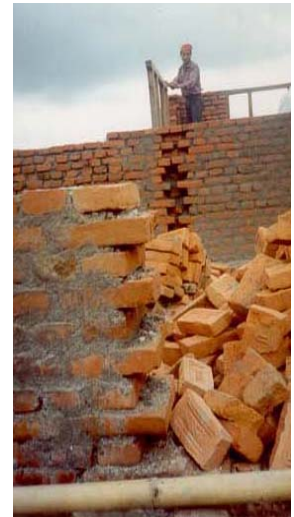
Construction Practice itself makes masonry buildings weaker in corner and joints

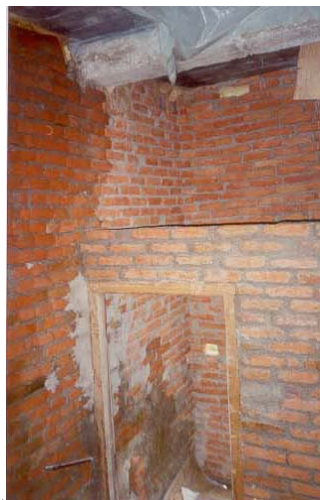
- No connection between wall to wall
- No connection between wall to floor and roof
- Stage construction
- Ground floor in mud mortar and upper floors in cement mortar
- Large size openings
- Use of poor quality mortar
- Unsupported 13' high wall without reinforcement

Unsupported 9" wall of about 13' height near staircase

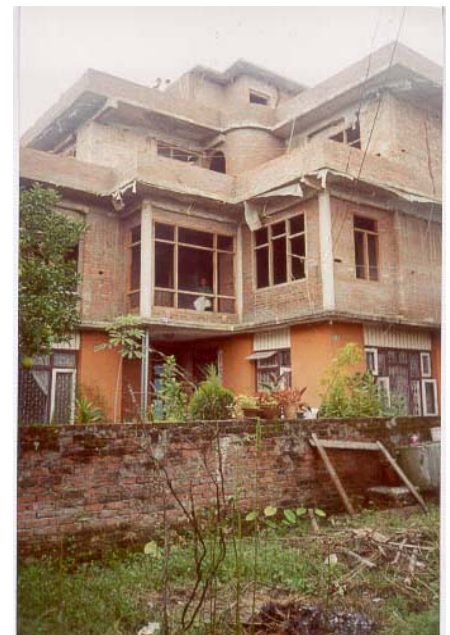
Four story masonry building under construction, Ground floor in mud mortar and remaining floors in cement mortar

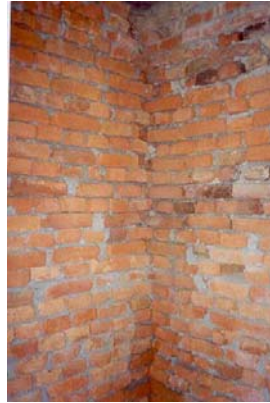
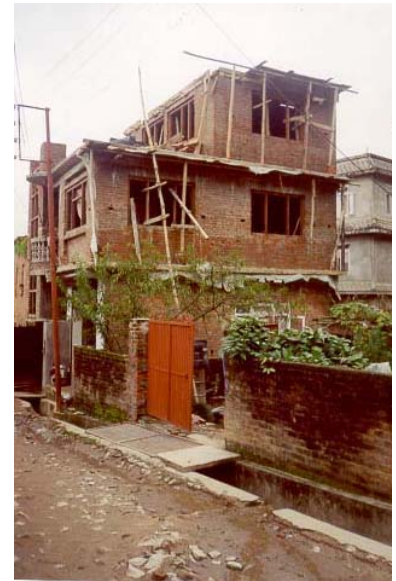
Improper bonding between walling units and there is almost no connection between two orthogonal walls

Three story masonry building under construction, Ground floor in mud mortar and remaining floors in cement mortar

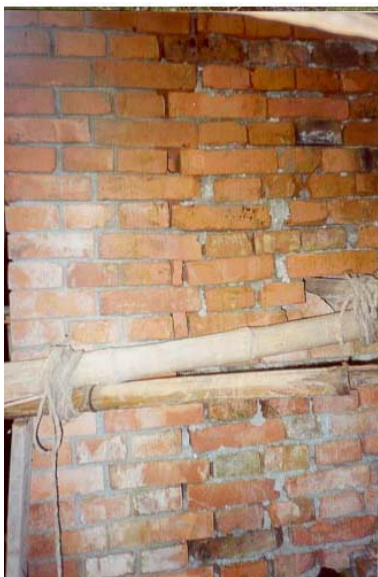
Vertically half portion of the wall was constructed first, the half other part was being constructed after 5 years and there was virtually no connection to these two parts

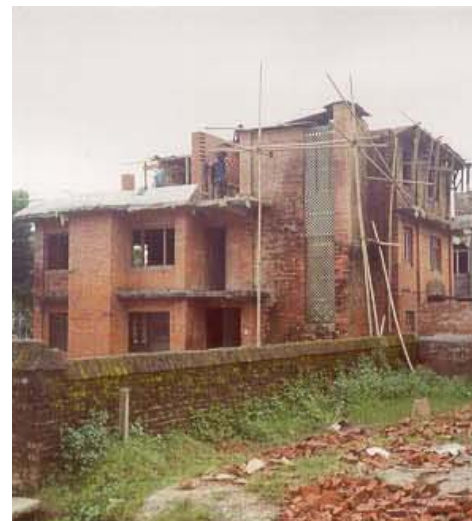
Three story masonry building, the construction practice of erecting two parallel walls first by leaving alternate brick projected out, which make the building weaker can be seen in top floor
