## 5. REPORTS on site observations to Hospital Buildings of Kathmandu Valley

Site-visit Team Members: Hideo Kagawa, JICA and Ramesh Guragain, NSET- Nepal

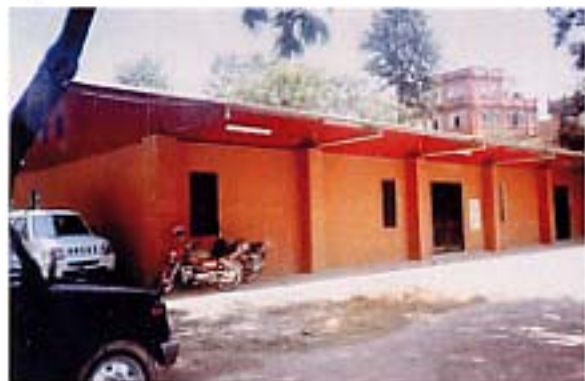
Earthquake resistant one story building of Bhaktapur Hospital

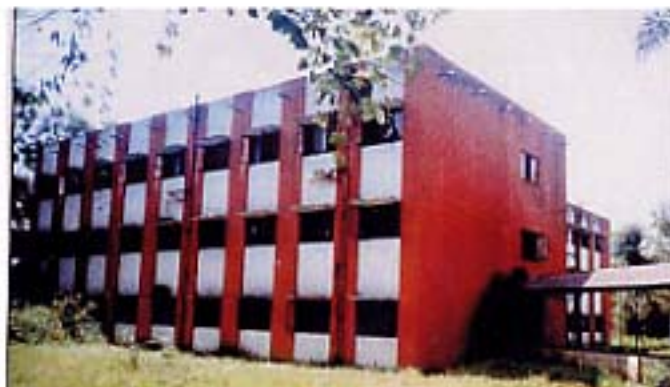
There is an one story earthquake resistant building but the main building of the Bhaktapur Hospital is three story masonry building and it is necessary to improve the building capacity for better seismic performance. Thus following are the steps towards improvement.

Main building of Bhaktapur Hospital: Three story masonry building

- ✔ Preliminary structural vulnerability assessment of main building in the complex of Bhaktapur Hospital should be performed. Such assessment should be based for different earthquake intensity scenarios.
- ✔ Detailed structural analysis for vulnerability assessment and to find out the appropriate method of improvement, based on the findings of the preliminary assessments, should be performed.
- ✔ Develop methods for reconstruction or retrofitting and implement it.
- ✔ Incorporate the findings into overall development plan of the Hospital.

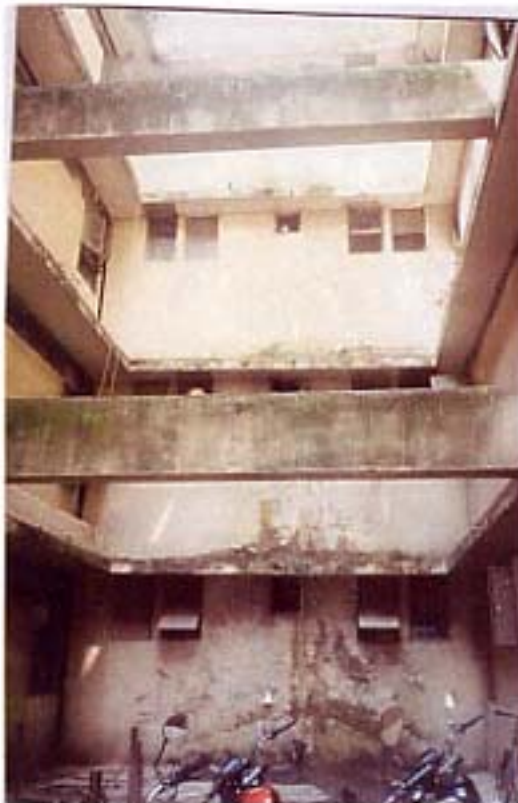
**Part of New Building: Almost no maintenance, start of deterioration**

- ✔ Preliminary structural vulnerability assessment of all buildings. Such assessment should be based for different earthquake intensity scenarios.
- ✔ Detailed structural analysis based on the findings of the preliminary assessments.
- ✔ Develop methods for reconstruction or retrofitting.
- ✔ Incorporate the findings into overall development plan of the Hospital.

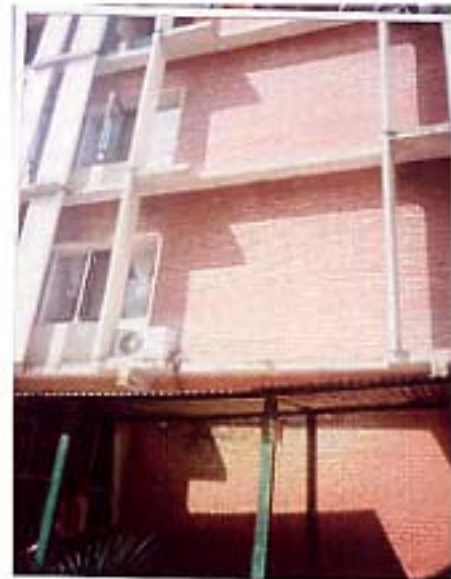
**Four story masonry Building: Needs some improvement**

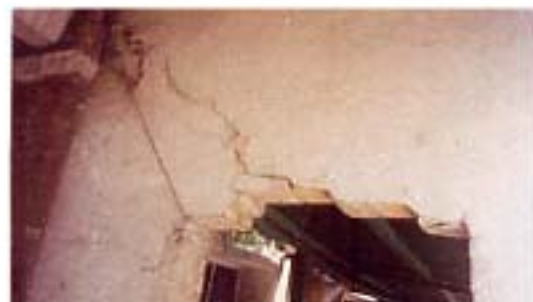
**Diagonal cracks from opening**

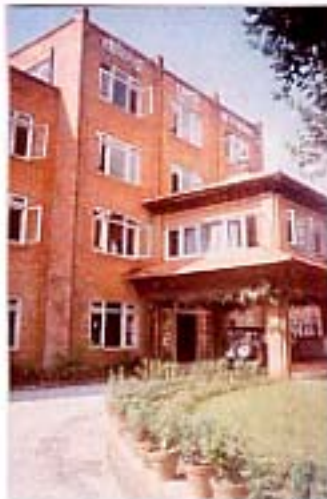
Four story Building of  
Birendra Police Hospital

- Preliminary structural vulnerability assessment of all buildings in the complex of Birendra police Hospital should be performed. Such assessment should be based for different earthquake intensity scenarios.
- Detailed structural analysis for vulnerability assessment and to find out the appropriate method of improvement, based on the findings of the preliminary assessments, should be performed.
- Develop methods for reconstruction or retrofitting.
- Incorporate the findings into overall development plan of the Hospital.

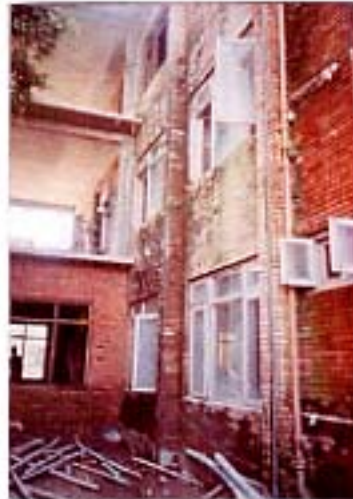
Grass on the wall; cause  
of deterioration

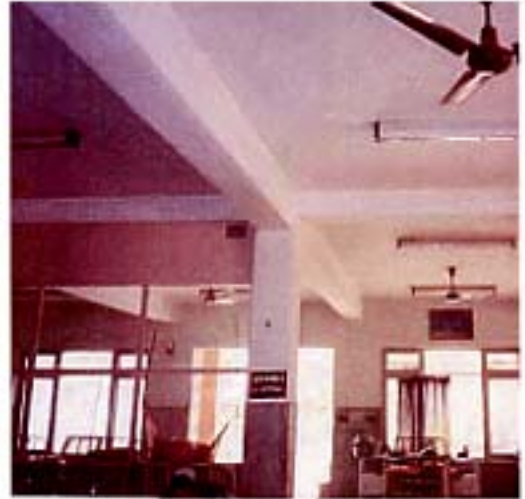
Very thin beam in transverse direction; may  
cause failure during big earthquake in that  
direction

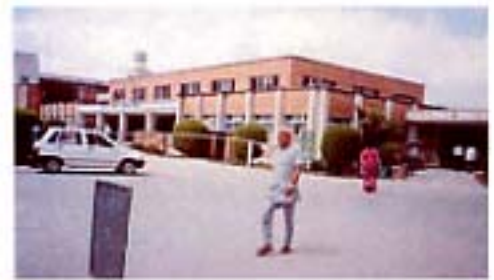
**Two story frame building of Teaching Hospital**

- ✔ Major buildings of Teaching Hospital were found to be better on visual observation.
- ✔ Preliminary structural vulnerability assessment of all buildings is not necessary. Only some buildings need.
- ✔ Detailed structural analysis of the buildings which are not designed considering seismic force, based on the findings of the preliminary assessments, should be done.
- ✔ Develop methods for reconstruction or retrofitting if necessary.
- ✔ Incorporate the findings into overall development plan of the Hospital.

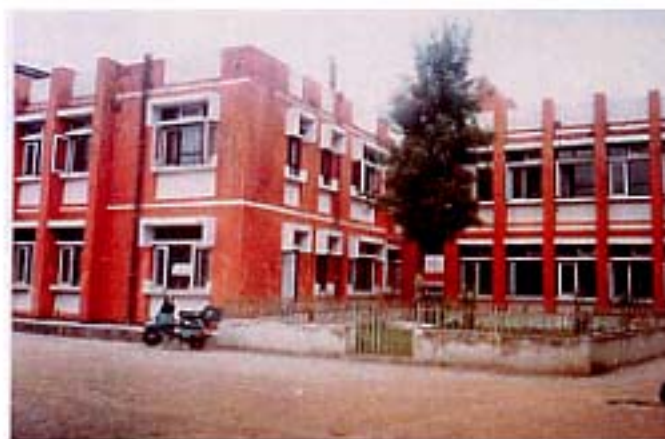
Although the major structure of Teku Hospital is only two story but sufficient reasons could not be made during visual observation, which can describe the safety of the structure during big earthquake. Following recommendations are applicable for seismic improvement.

**The major structure of Teku Hospital: Two story masonry building**

- ✔ Preliminary structural vulnerability assessment of all buildings. Such assessment should be based for different earthquake intensity scenarios.
- ✔ Detailed structural analysis based on the findings of the preliminary assessments.
- ✔ Develop methods for reconstruction or retrofitting.
- ✔ Incorporate the findings into overall development plan of the Hospital.
