SUPPORTING REPORT G
LANDSLIDE DAMAGE MITIGATION PLAN

**SUPPORTING-G
LANDSLIDE DAMAGE MITIGATION PLAN**

SUPPORTING-G

LANDSLIDE DAMAGE MITIGATION PLAN

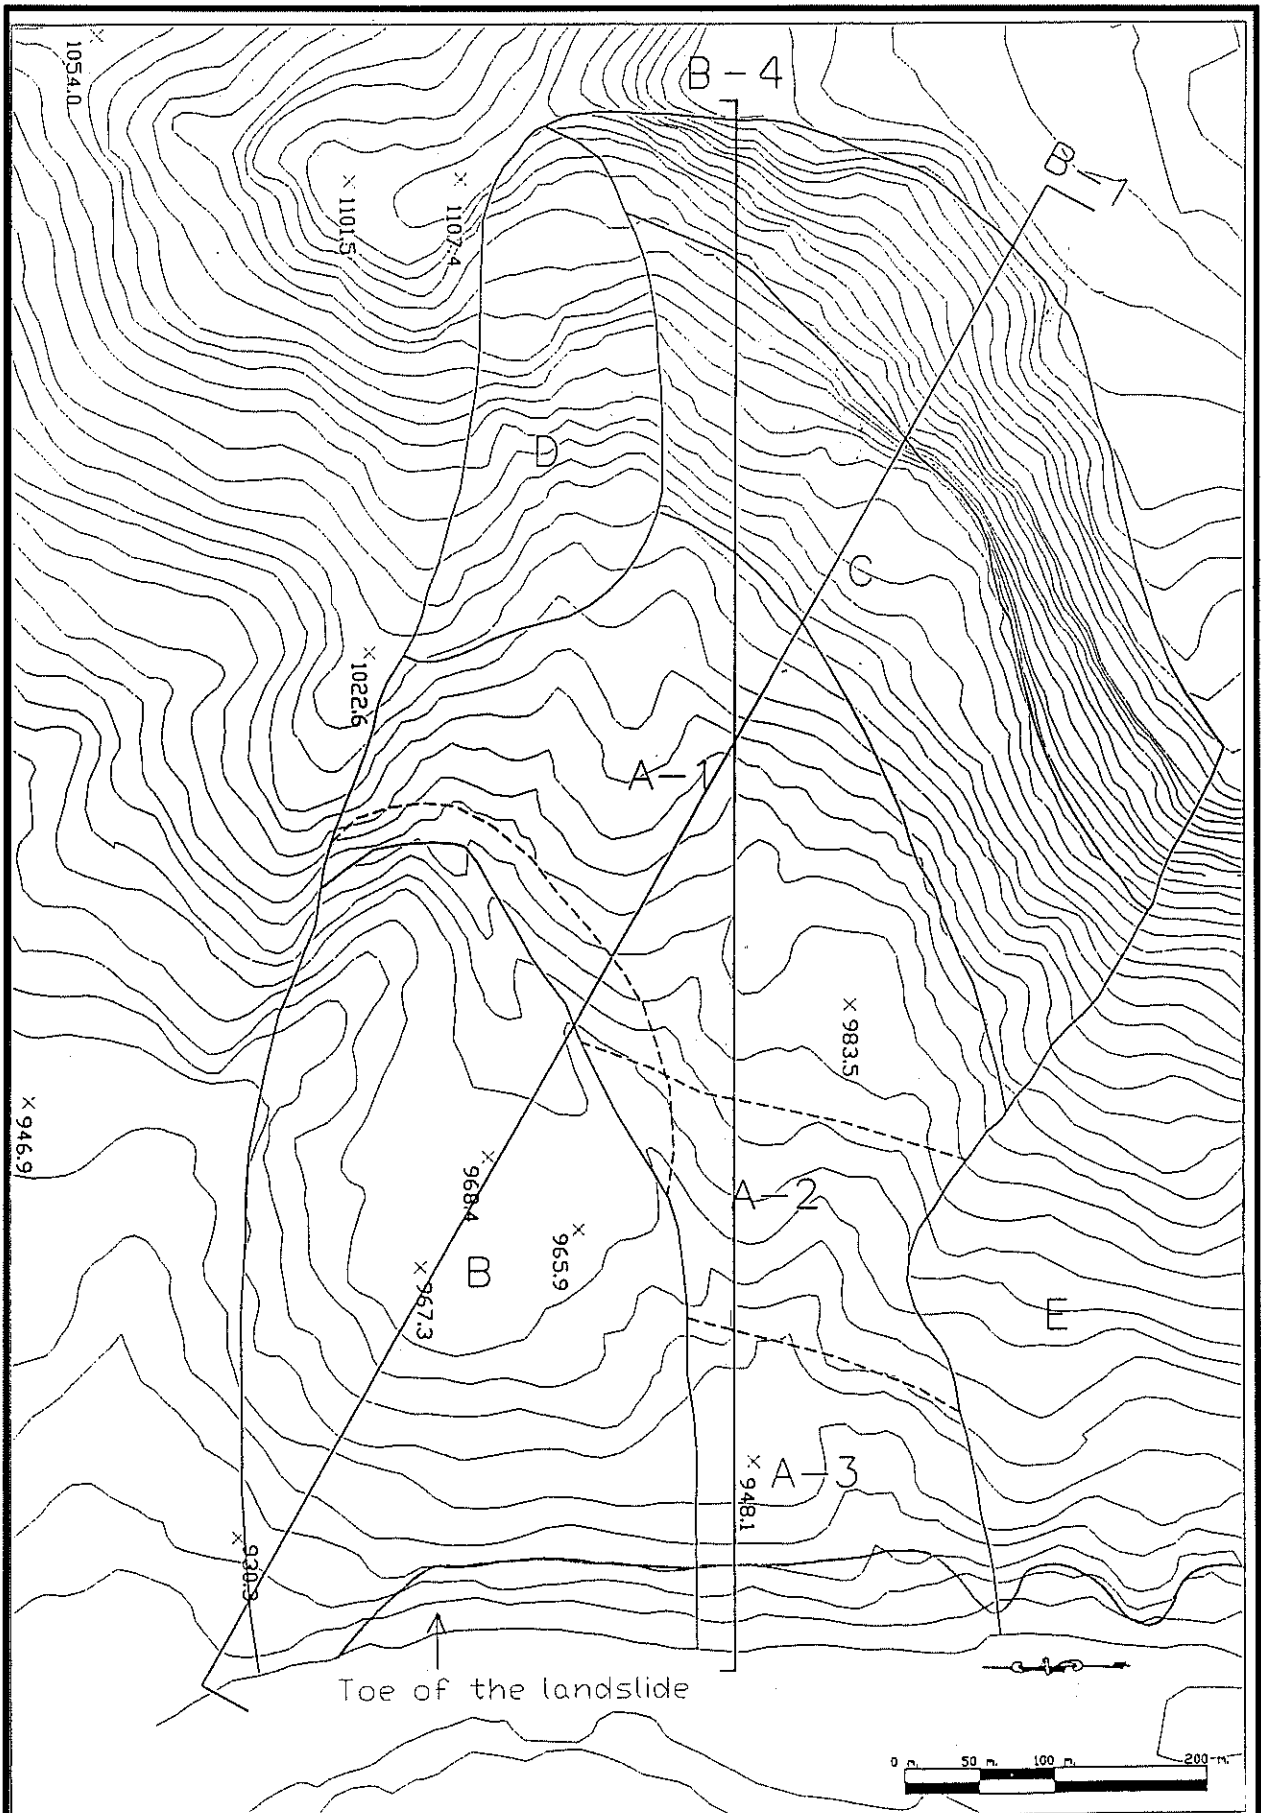
Figure G.2.1

By observing the topographic data before and after the damage caused by Hurricane Mitch, there is difference in elevation along the boundary between the landslide blocks A and B (refer to *Figure G.2.1*). This suggests that there were movements of the land. Eastern half of Block B is higher by some 10m while Blocks A and C are lower. This topographic feature may correspond to a mechanism of the landslide as described later. Block C may still be changing its shape as evidenced by groundwater dissipation, movements together with Block A-1 (servility), and formation of small ravine.

Landslide of Several Blocks (El Berrinche)

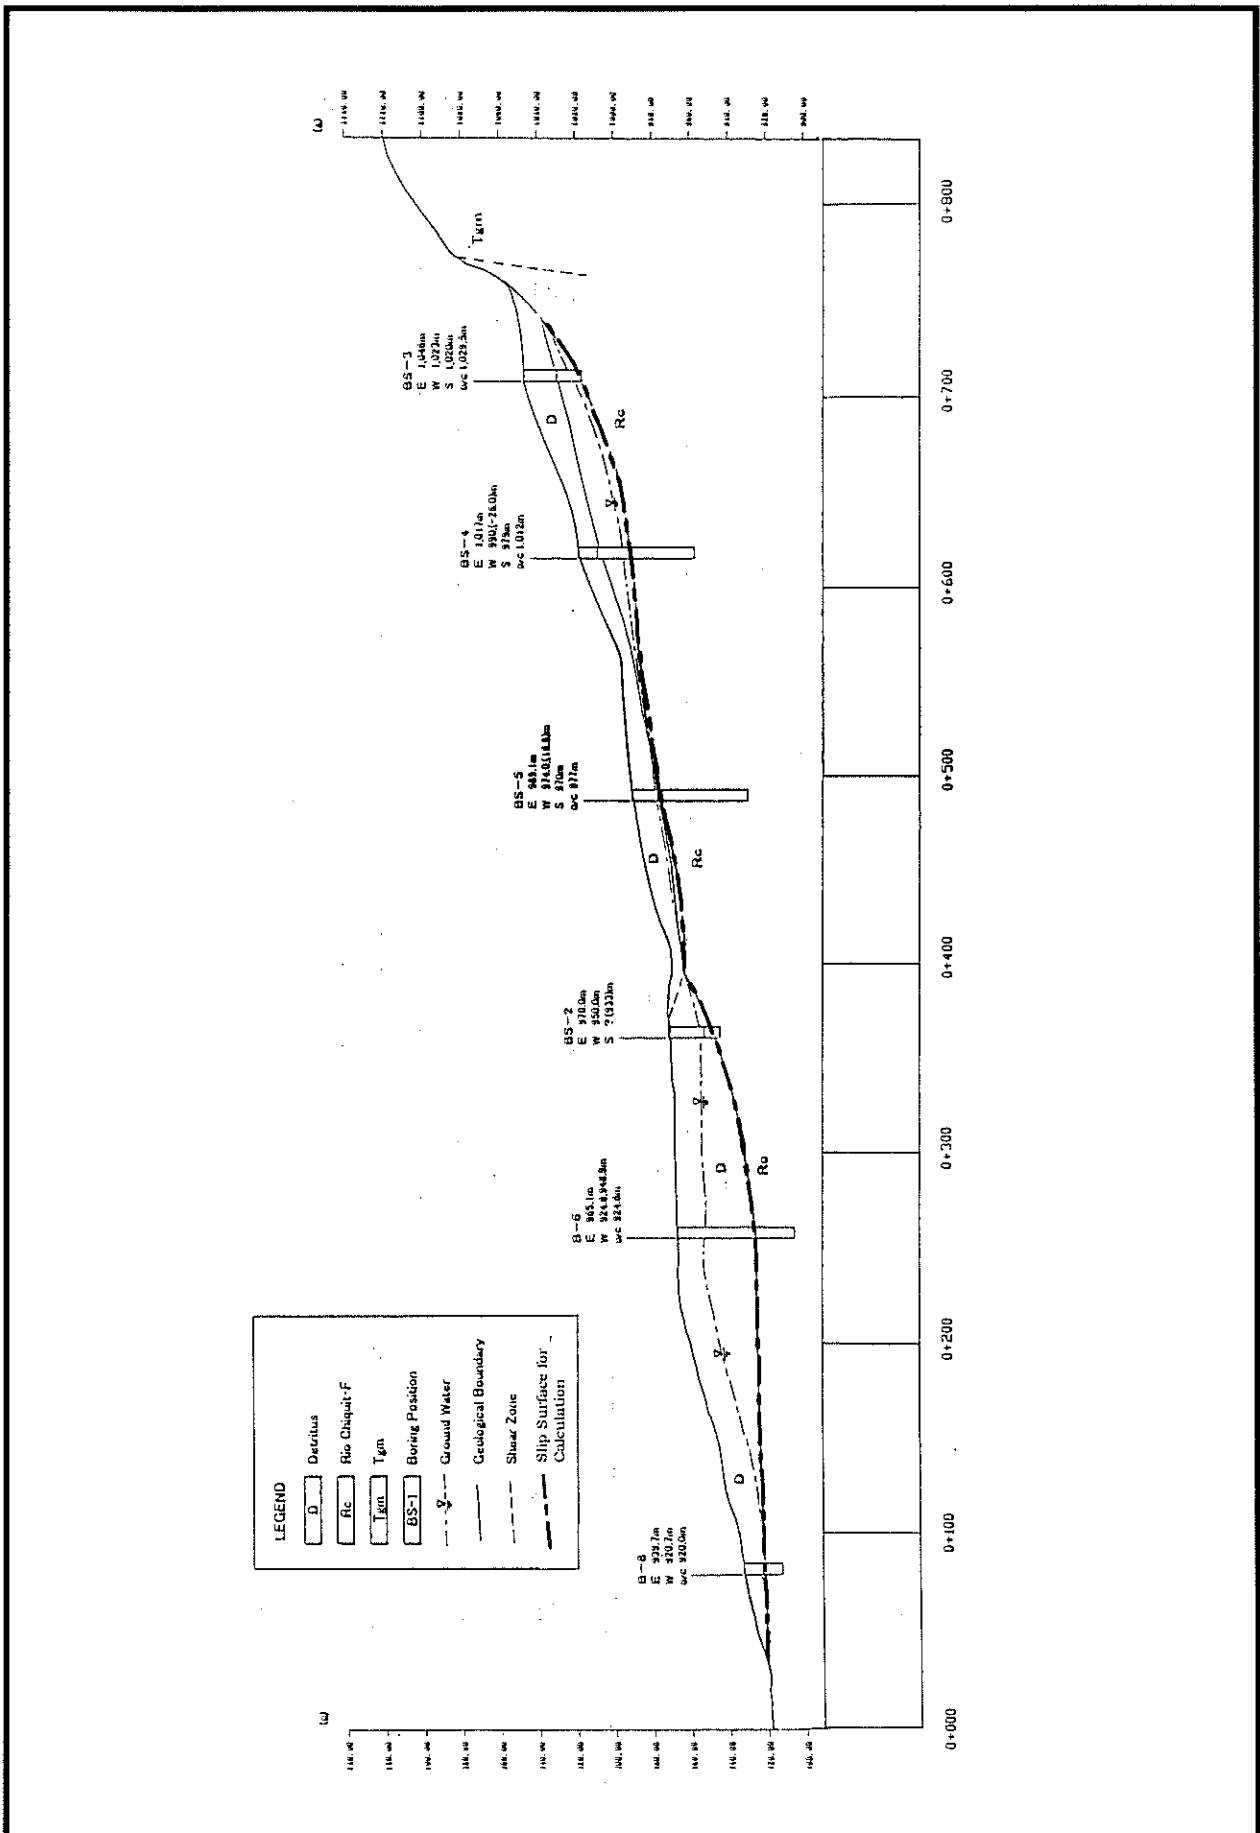
Figure G.2.3

- b. Block A1 started sliding. The major direction of the sliding movement was NW →SE direction as shown in the Soil Profile B-1.
- c. Block A1 pushed the lower block B. However, Block B did not slide. Block B was sandwiched and the central portion of Block B was uplifted to form the uplifted terrain.

Profile of El Berrinche (Section B-1)

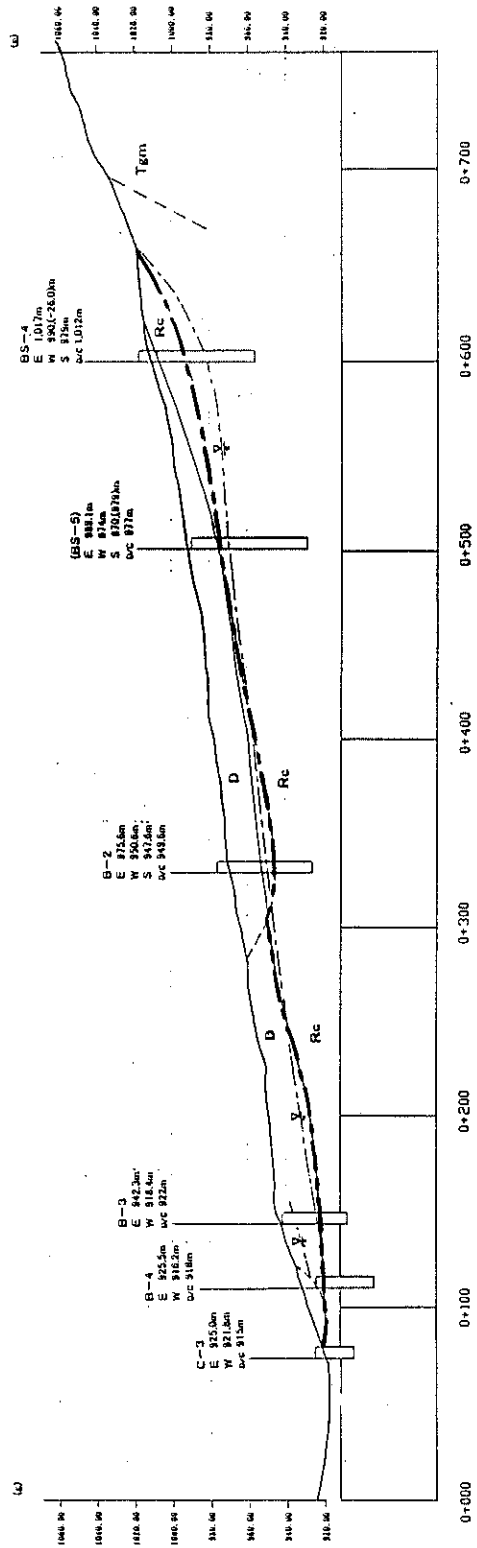
Figure G.2.4

- Conditions:
- a. A continuous sliding surface through A1, A2 A3 is considered.
 - b. The highest ground water level monitored is assumed.
 - c. The back calculation of the stability is based on the parameters below:

$$c = 25.0 \text{ kN/m}^2 \quad (c : \text{cohesion -- fixed})$$

$$\phi = 5.8814 \text{ degrees} \quad (\phi : \text{angle of internal friction})$$

The stability after completion of the countermeasures

- a; After lowering the ground water level by 5 m with a catchment well

$$F_s = 1.051$$

- b; After removal of soil mass (1,600 m² in section) at the head of the sliding mass

$$F_s = 1.112$$

- a+b; Combination of ground water lowering and removal of soil mass

$$F_s = 1.170$$

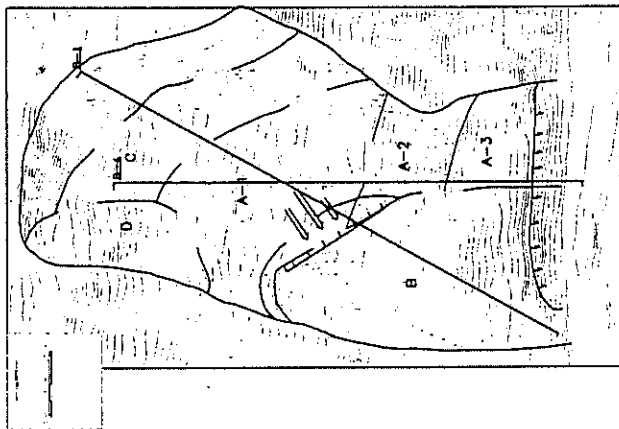
I
When the Hurricane Miche came, the landslide block A-1 began to move toward B block. The landslide block A-1 compressed the block B, then the toe section of block B where confront to the Rio Choluteca began to collapse. This landslide start to obstruct the flow of Rio Choluteca.

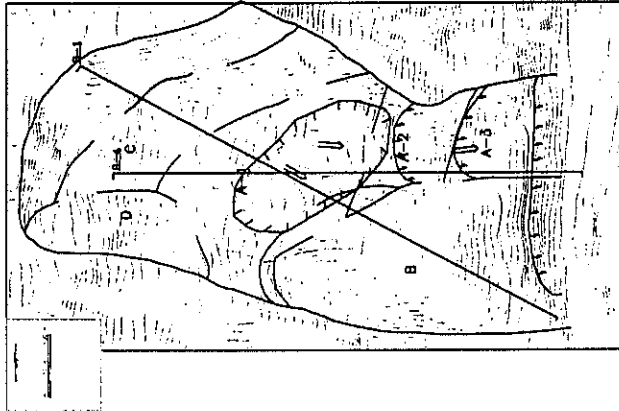
II
The landslide block A-1 changed its movement direction toward the block A-2, the block A-2 pushed the block A-3, the block A-3 slide toward Rio Choluteca, Then the block A-3 began to collapse into Rio Choluteca. The obstruction of river flow began to increase.

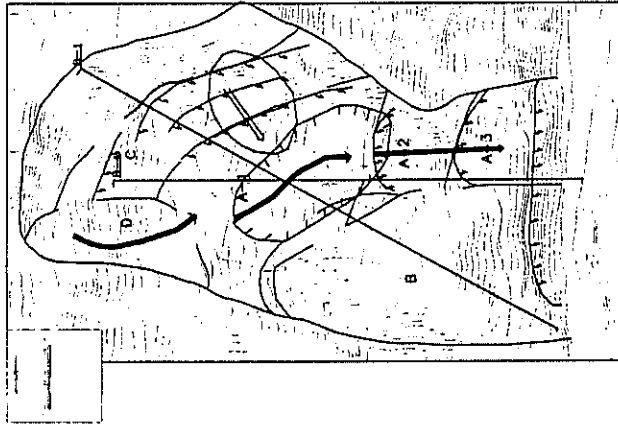
Figure G.2.5

- a. Due to a series of heavy rains brought by Hurricane Mitch, a large amount of surface run-off water and the ground water flew or seeped into the landslide area. Block C, which was located under the scarp of the landslide and consisted of boulder blocks fallen from the scarp and porous collapsed soil, contained a large amount of ground water. The water in Block C induced a relatively high water pressure acting on Block A1 located next to Block C.

III
The landslide block C began to move to landslide A-1. Mud and Debris flow from block D flows into the Rio Choluteca

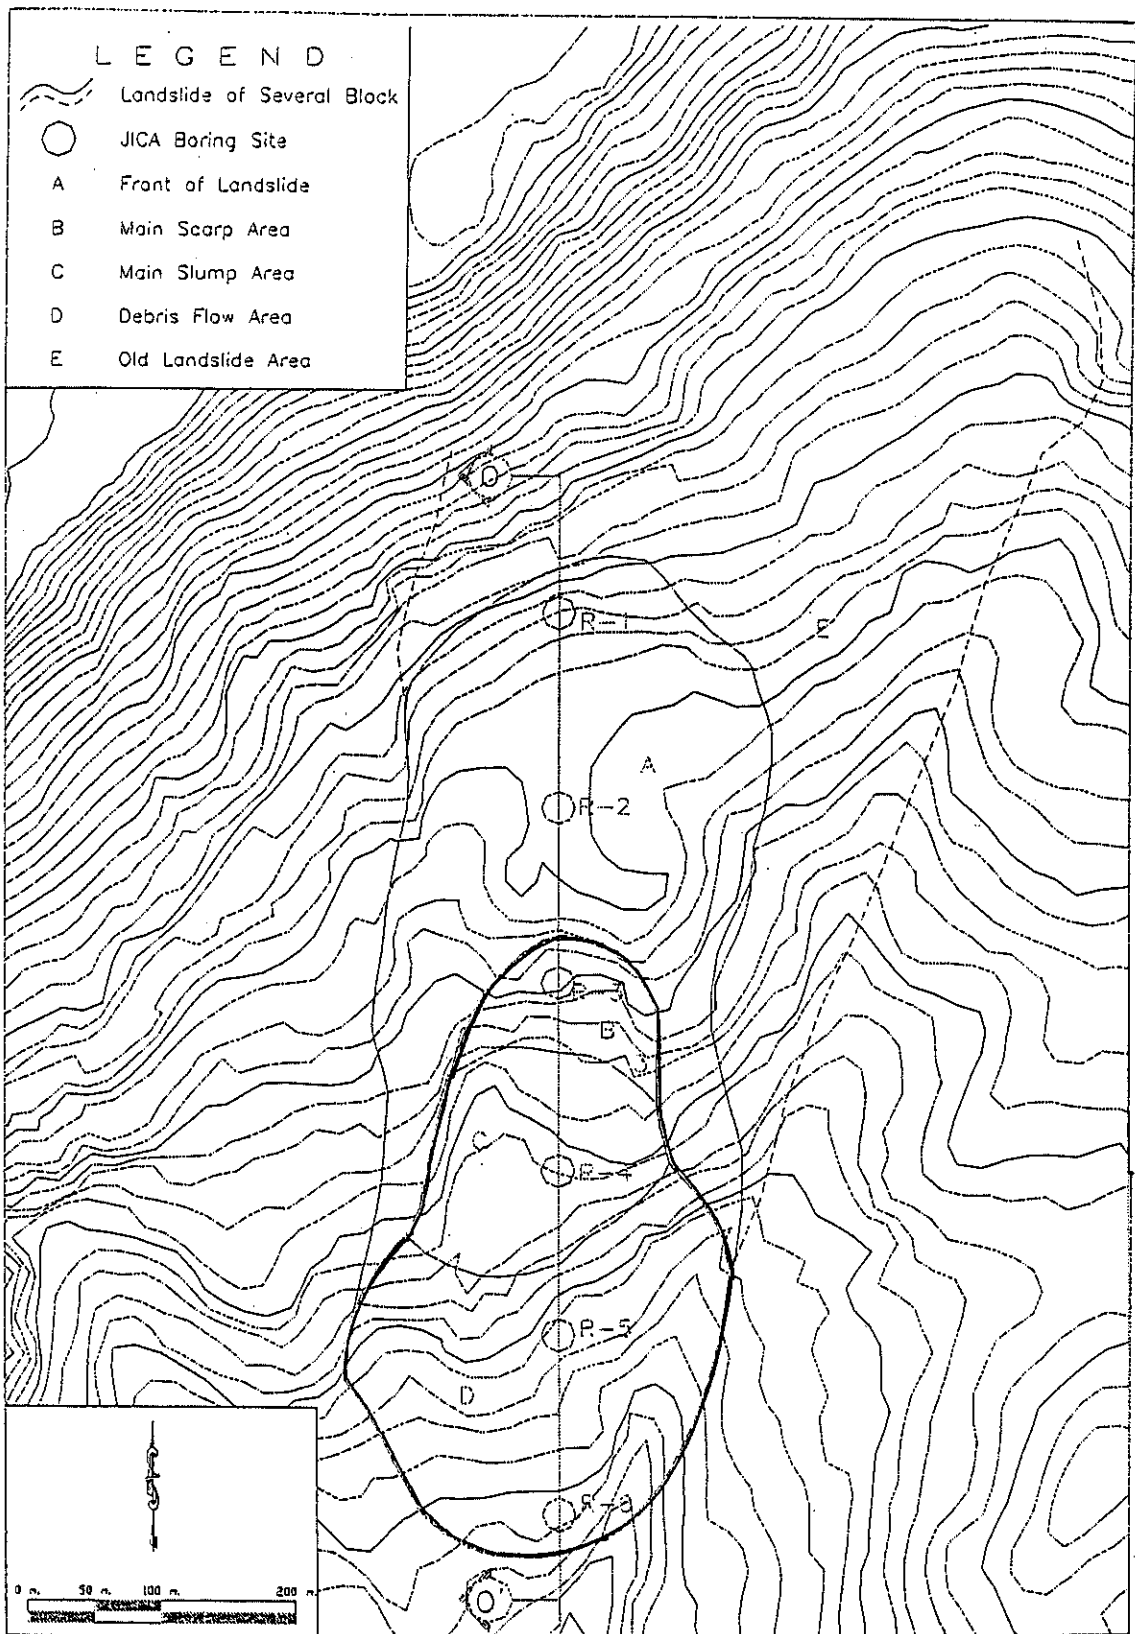
Figure G.3.1

As shown in *Figure G.3.1*, Barrio El Reparto landslide is divided into (1) Block E that is an old landslide block consisting of debris deposits derived from Cerro El Picacho, (2) Block A saturated with plenty of groundwater when hit by Hurricane Mitch, (3) Block B that is the scarp at the top of the landslide, (4) Block C that is major moving block, and (5) Block D that moved as debris flow. The landslide is judged to be a typical type of Debris landslide based on its shape. The geology at the base of the landslide is expected to be weathered zone of Rio Chiquito Formation judged from the surrounding geology. Most portion of the moving block consists of colluvial deposits from Tmp rhyolite and tuff. The profile of Reparto landslide area is described in *Figure G.3.2*

Landslide of Several Blocks (El Reparto)

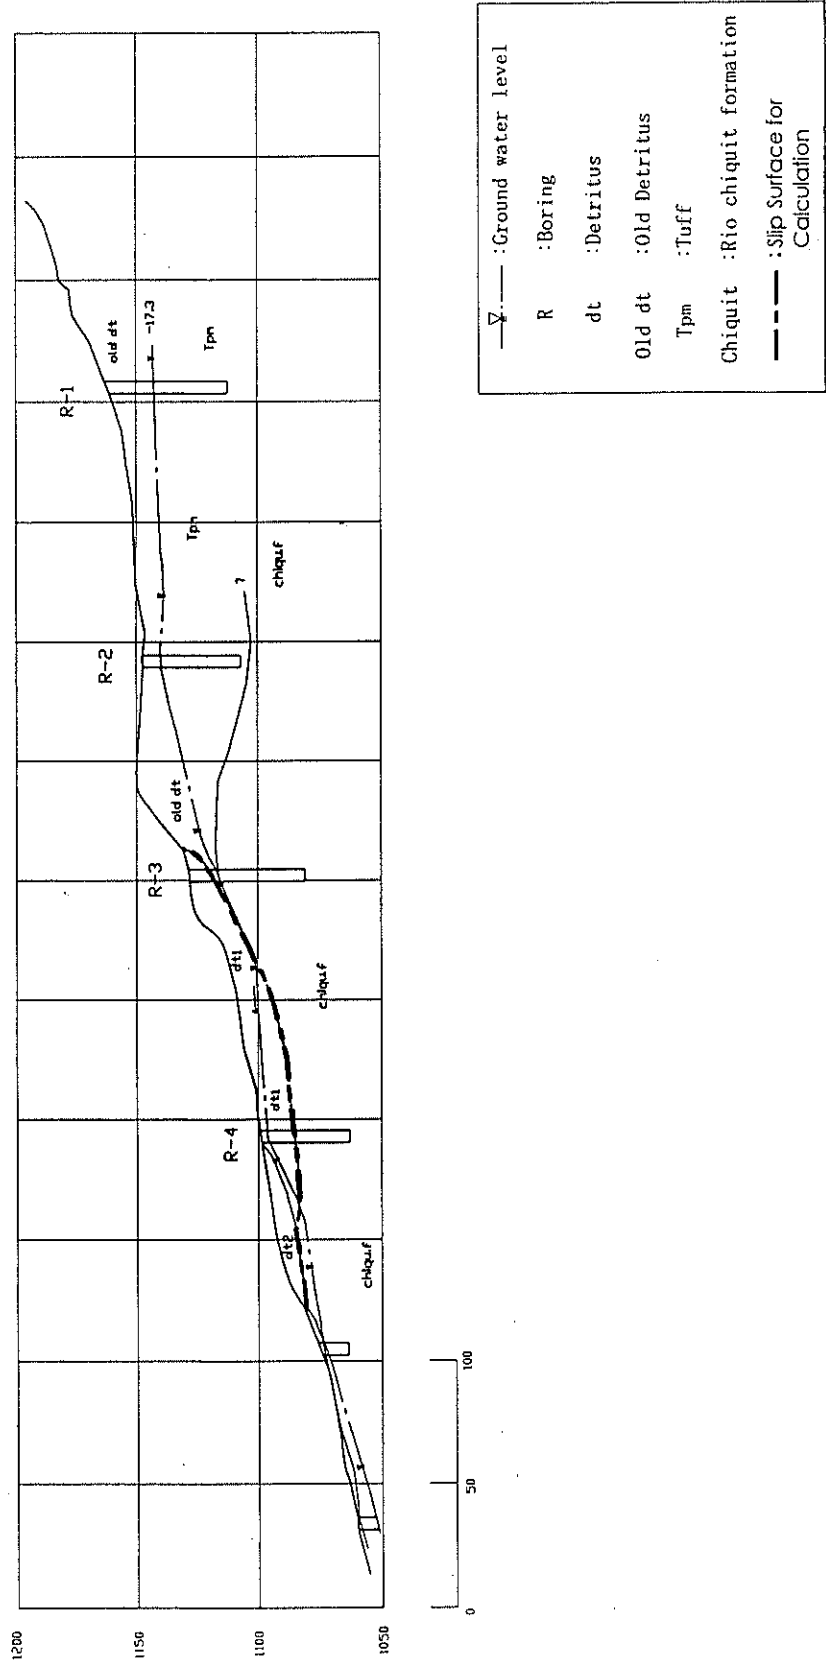
Figure G.3.2

Profile of El Reparto
