GEOLOGICAL LOGS AND PHOTOGRAPHS OF BORING

GEOLOGICAL LOG OF CORE DRILL

Project: JICA Study Team: Landslide Protection Page: 1 / 3
Core Drill #: Y-9 Site Location: Upper terrace near mountainside Ref. #: B-1
Elevation: 984.50 Inclination (Angle with respect to Horizontal): Vertical (90°)
Log Elaborated by: Ing. Raul Flores Peñaiba Date: November 17, 2001

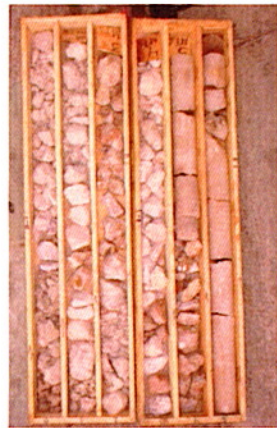
B-1 0.00-09.00m

0.00~9.00m
Detritus

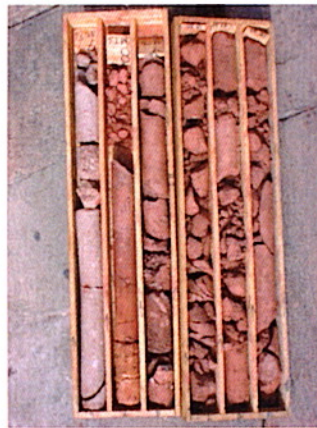
B-1 09.00-12.00m

9.00~
F. Rio Chiquito
10.00~10.50m
shear zone

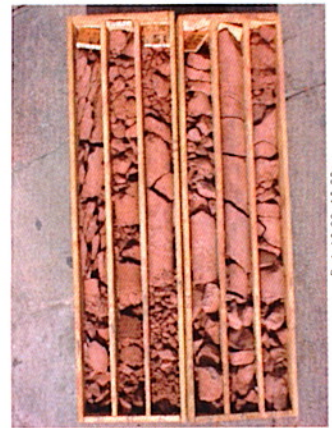
B-1 12.00-14.00m

13.00~14.40m
shear

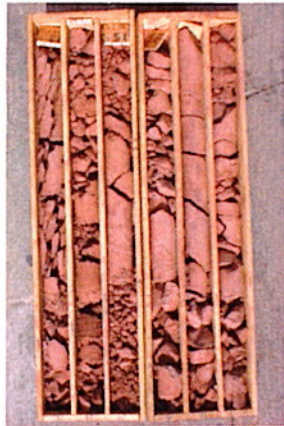
B-1 12 00-18 00m

19.00~21.00m
shear

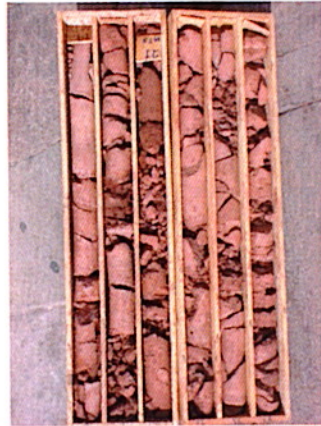
B-1 18 00-24 00m

24.50~ m
Hard Rock

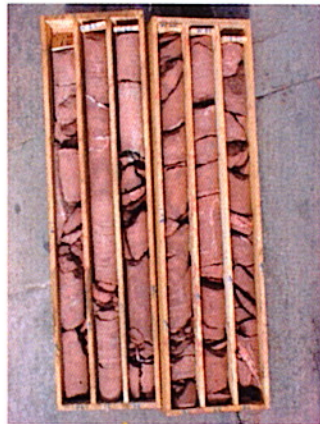
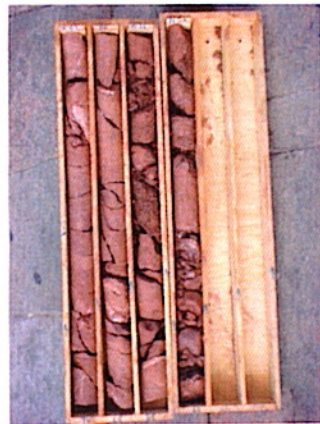
38.50~39.00m
shear

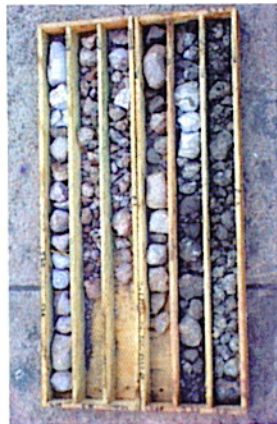
2.00~26.00m
Detritus
